## **Ageing rigs**

Review of major accidents

Causes and barriers

Report no. P-055481-B-32  
Issue no. 0  
Date of issue 20. November 2003

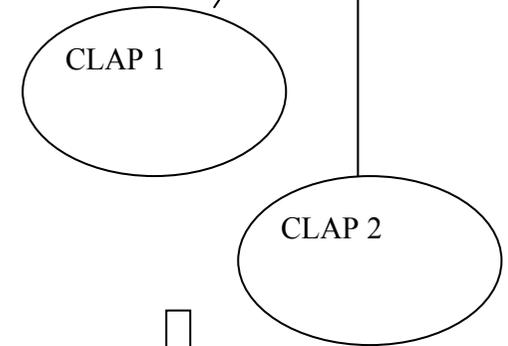
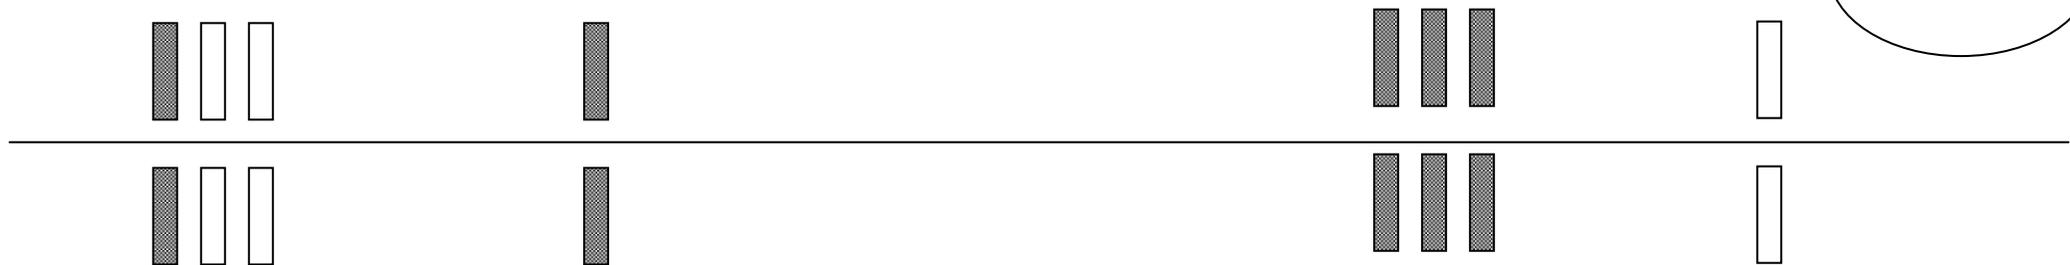
## 11.1 Trans Ocean III

Description of critical elements of the design (here wedges) was missing in operational manual

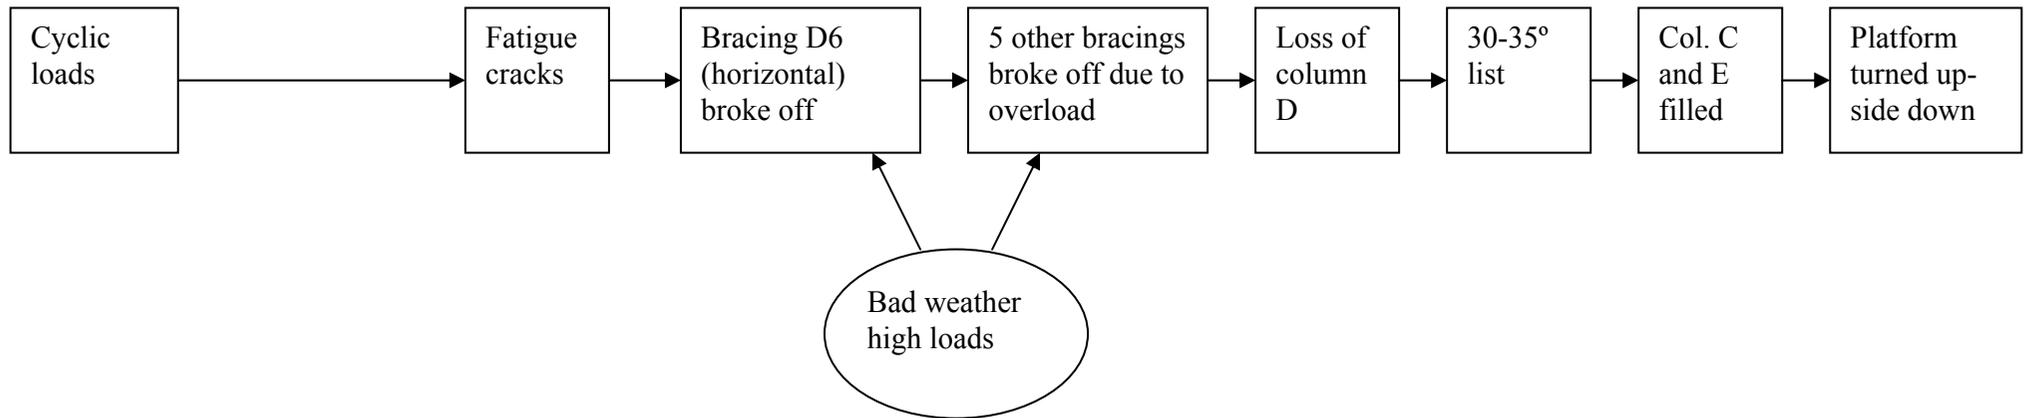
## 11.2 Alexander Kielland

Fatigue calc. at design stage

Watertight bracing with leak detection

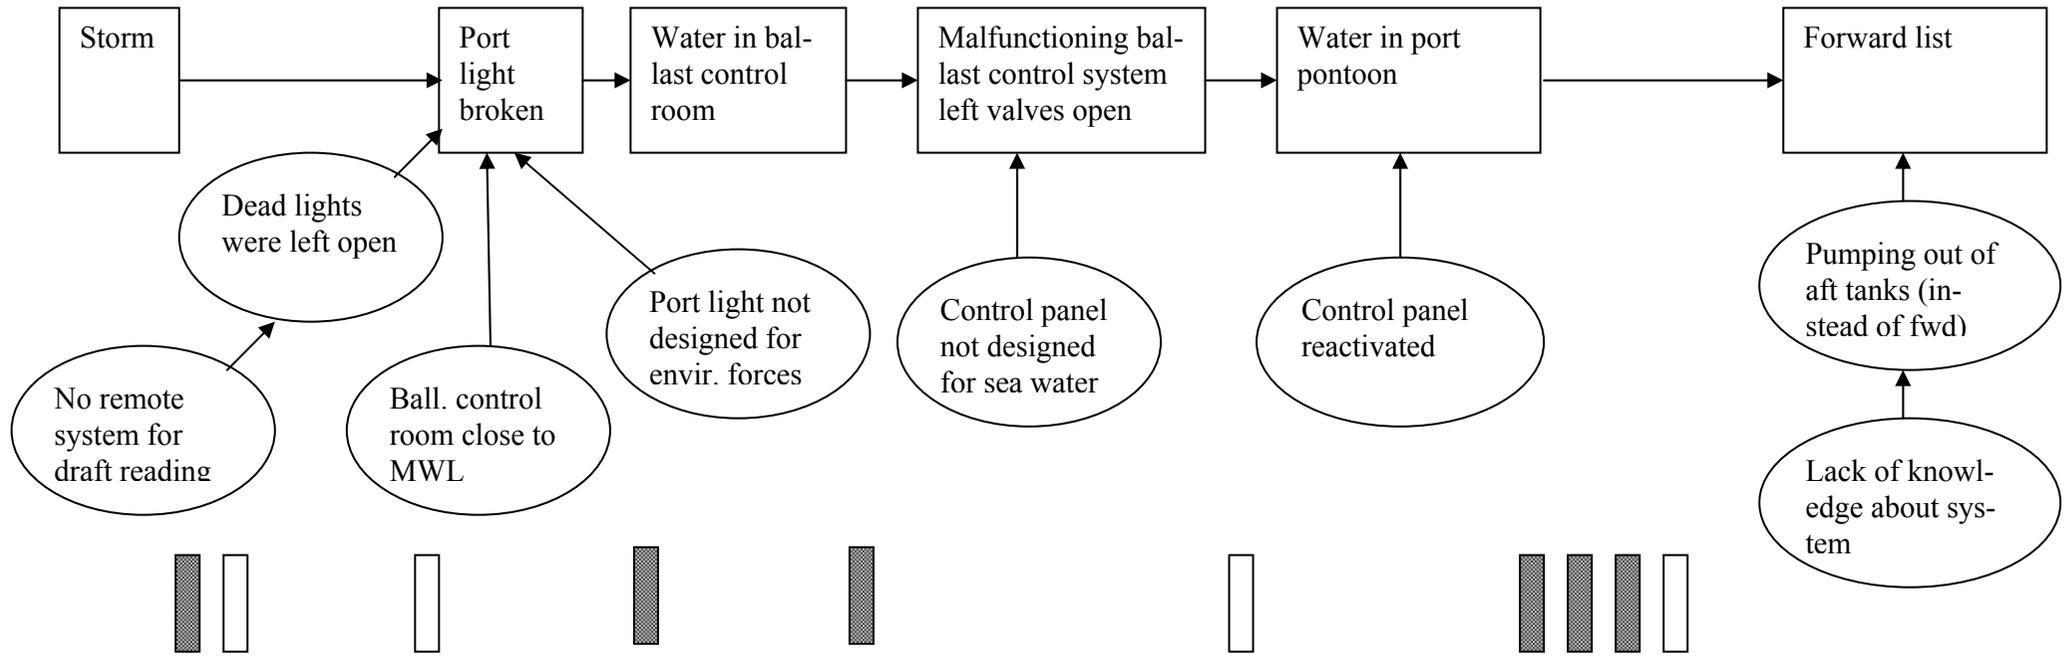
### 11.3 Ocean Ranger

Operational practice to close dead lights during storm

Location of ballast control room

Remote draft reading

Two separate methods for tank level gauging

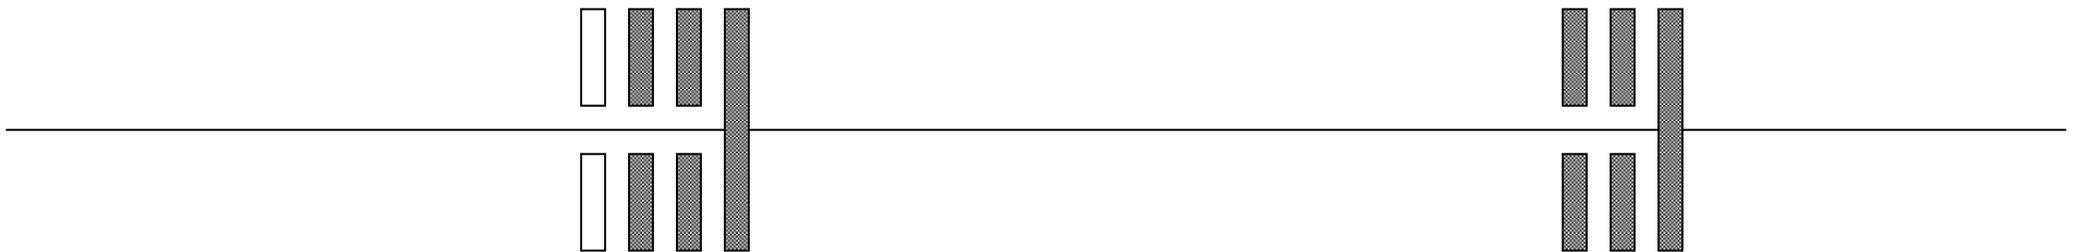
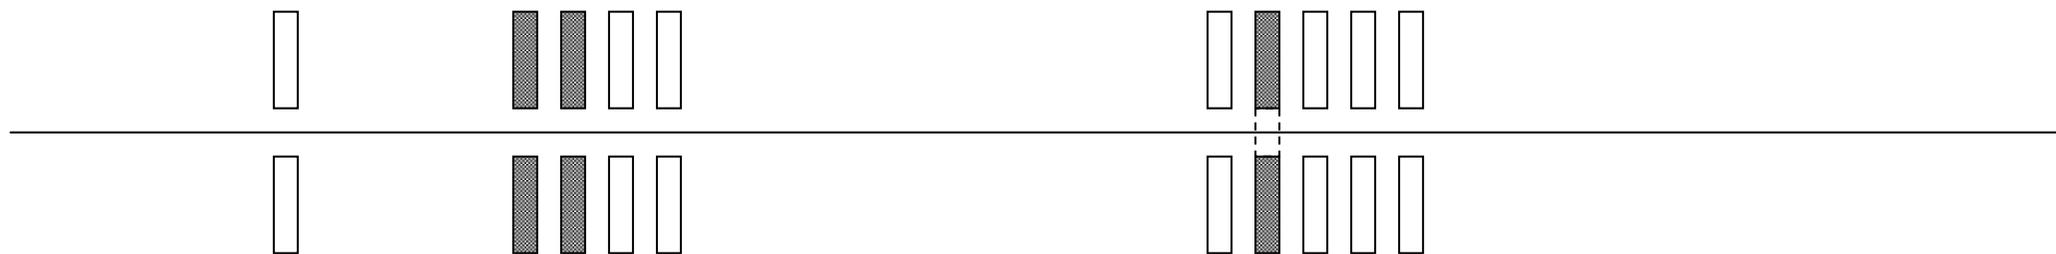
### 11.4 West Vanguard

No flow check performed

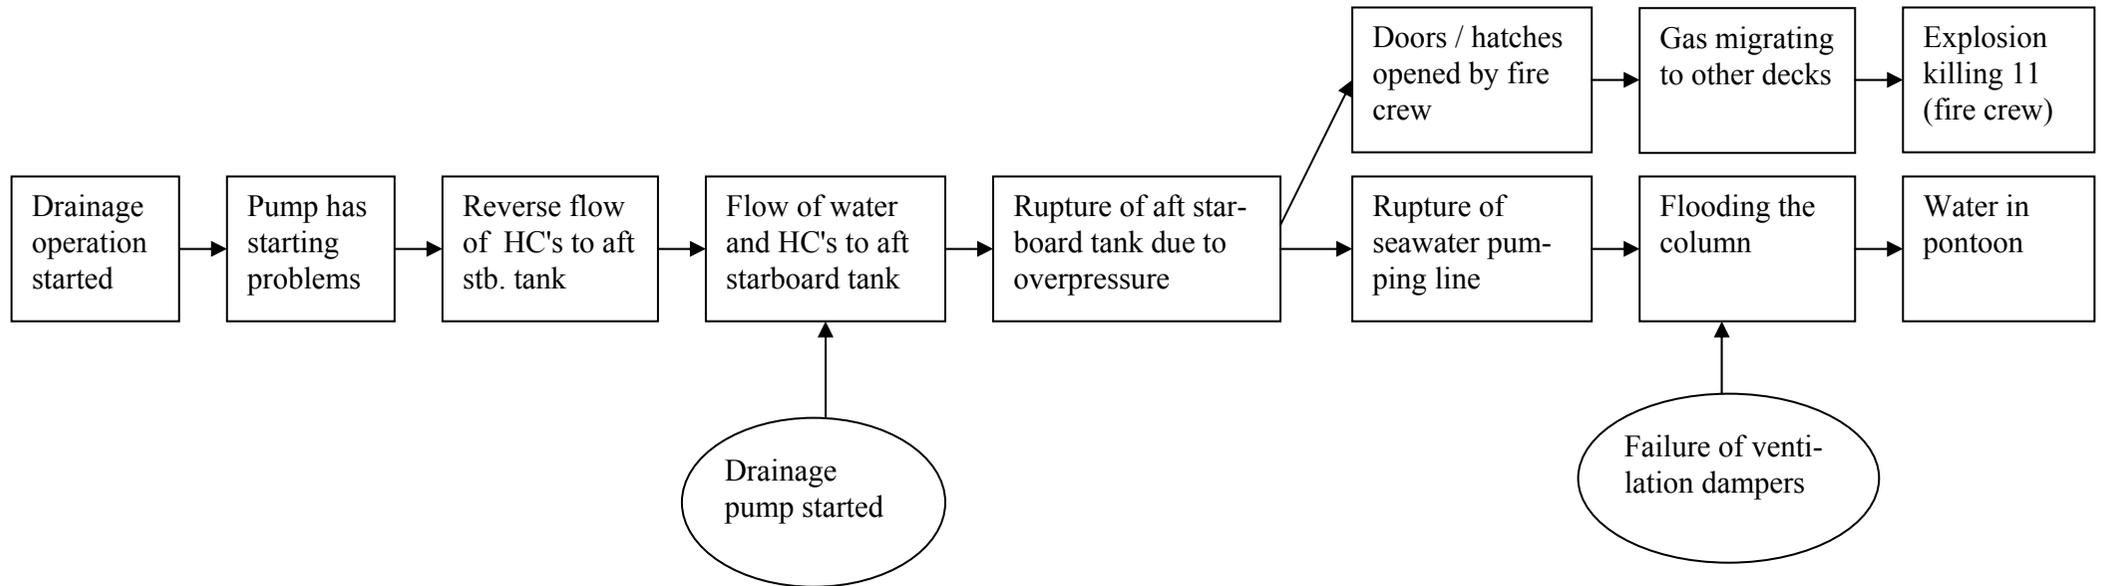
11.6 P-36 1/2

Failure to close or maintain intake valve of aft stb. drain. tank (not fail safe)

Failure to maintain the actuators of vent. dampers

Failure to contain the water

Bilge system defective
