# Investigation report

Report	
Report title Lifeboat incidents on Veslefrikk B and Kristin	Activity number 001052005

Summary
<p>Problems with releasing FF1000S-type freefall lifeboats were identified during testing on the Kristin and Veslefrikk B installations in December 2008 and January 2009. These incidents led to the FF1000S-type lifeboats on both installations being taken out of service on 7 January 2009, with a consequent workforce reduction on Veslefrikk B and a workforce reduction and production shutdown on Kristin. The faults identified during testing have caused no harm to people or the environment.</p> <p>The potential consequences should it have been necessary to evacuate the installation(s) with the aid of lifeboats during the period between the last test of these craft and their removal from service are likely to have been serious injury or loss of life. That would naturally have depended on the circumstances which gave rise to the possible requirement for evacuation.</p> <p>The investigation team's most important observations can be summarised as follows:</p> <ul style="list-style-type: none"> <li>• Deficient or faulty design of the FFH13 release mechanism.</li> <l

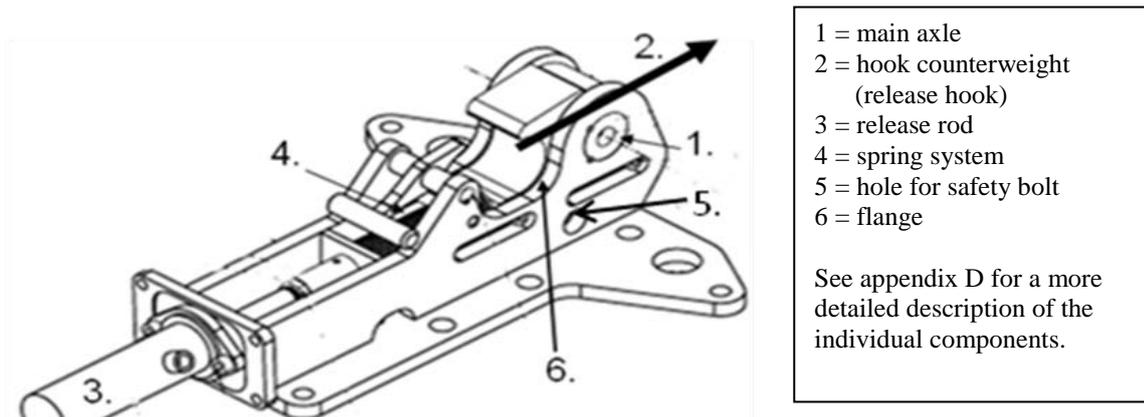
**Figure 4:** Sketch of the FFH13 release mechanism (Source: SH, ref /2/)

In the optimum position, the axis of the link is about 3.5mm below the rotation point. See figure 4. The link then lies with a self-locking moment against the hook and in the area indicated as “+ deviation” in figure 5. If the gap between rotation point and link axis increases in the direction of + deviation, the amount of power to turn the hook – in other words, the self-locking moment – will also rise. Combined with the extra weight of the lifeboat, the need for hydraulic power will increase to provide the necessary turning moment for the release hook and free the lifeboat.

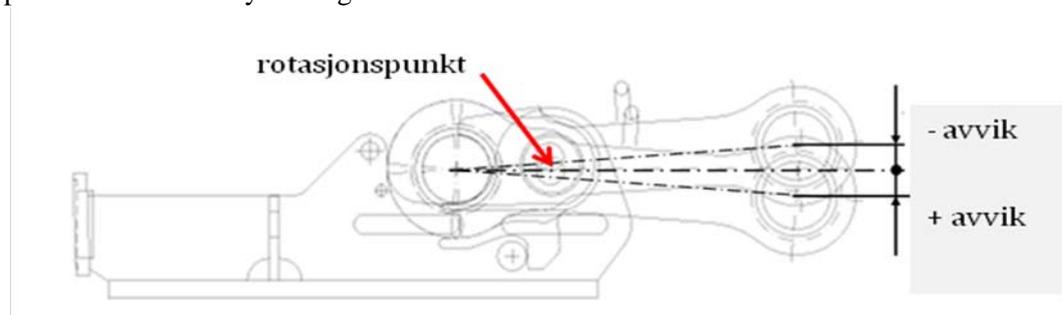
**Figure 5.** Angle of deviation for the link between hook and installation (Source: SH, ref /28/)

The direct cause of the incident on VFB on 30 December 2008 was corrosion of the spring system. The direct cause of the incident on VFB in the early morning of 7 January 2009 was that the link and hook were outside their geometric tolerance, and the weight of the lifeboat was too great in relation to the available hydraulic pressure to release the lifeboat with the release mechanism.

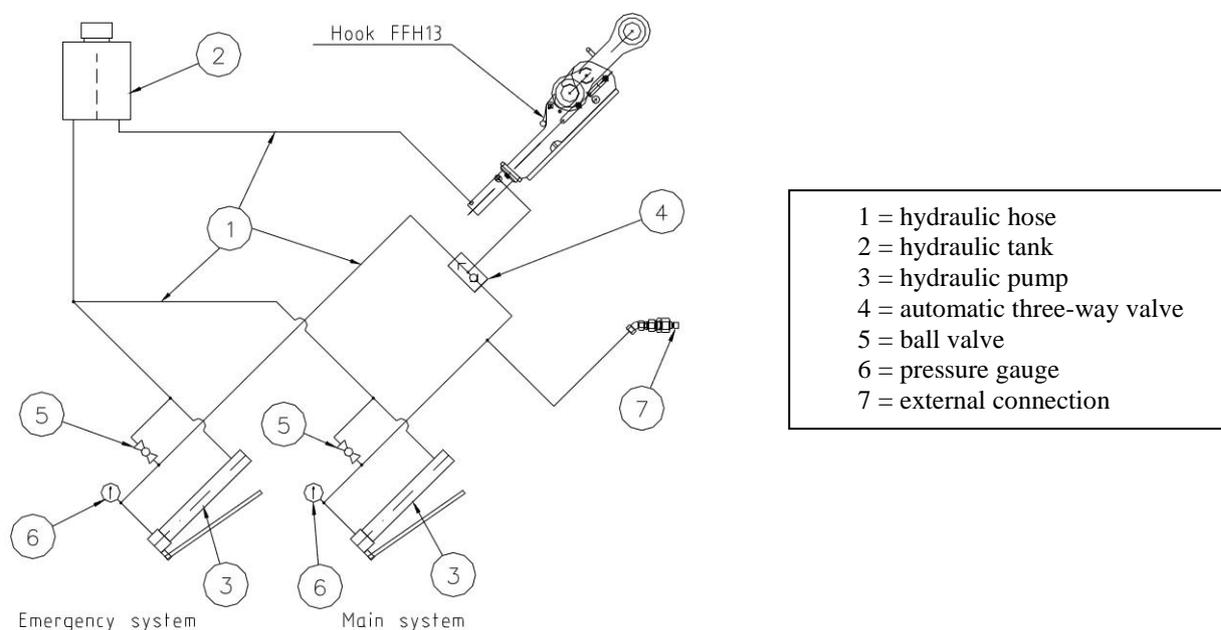
**Figure 6. Diagram of the hydraulic part of the release mechanism. (Source: USH, ref /51/)**

The FFH13 release mechanism comprises two “partly” independent and redundant systems for pumping up pressure into the automatic three-way valve. See figure 6. “Partly independent” means that parts of the hydraulic hose and tank are shared. The remainder of the release mechanism, from the automatic three-way valve, consists solely of individual components in series. A failure or fault in one of these components could mean that the release mechanism is unable to function as intended. No alternative methods exist for launching lifeboats with this type of mechanism.

1. As discussed in chapter 4 on the potential of the incident, and as illustrated in figure 6, the FFH13 release mechanism consists only of individual components in series from the three-way valve right through to the hook counterweight. A functional failure or fault in any of these components, such as the three-valve, the flange, the spring system, the release rod or the hook counterweight, could mean that the boat fails to release as required or that the mechanism cannot be reset after testing.

4. Routine replacements and improvements to individual components could improve the reliability and availability of the lifeboats. So long as the release mechanism consists of individual components in series, however, it will be impossible to exclude the possibility that an individual error or fault could prevent the lifeboats from launching when required. The LSA code /118/ requires two independent activation systems for initiating the release mechanism from inside the lifeboat. Such independence is provided only for the pump in the relevant mechanism, but not in the rest of it.
