Investigation report

Report	
Report title Undesirable incident with HTV Eagle pipehandling crane – Statoil Gullfaks B – 7 March 2017	Activity number 001050062

Summary
<p>The incident occurred at 15.25 on 7 March 2017 on the Gullfaks B (GFB) installation. The boom on the horizontal to vertical (HTV)) Eagle pipehandling crane, which weighed about 14.4 tonnes, fell 10 metres to the pipe deck after the steel rope failed. Two people had adjusted the grippers on the crane's gripper yoke down on the pipe deck immediately before the incident occurred.</p> <p>Drilling facilities on GFB were upgraded with a new HTV Eagle crane in 2015. This was part of a big project executed for Statoil by Aibel. MH Wirth was Aibel's subcontractor for the pipehandling equipment. Operations resumed after the upgrading in September 2015. KCA Deutag (KCAD) is the drilling contractor on GFB.</p> <p>The direct cause of the crane boom falling down was fatigue in the steel rope. This was one of the main components in the arrangement for the crane's vertical up and down movement.</p> <p>The underlying cause was weaknesses in the design of the crane's hoisting arrangement, which consists primarily of the winch, she

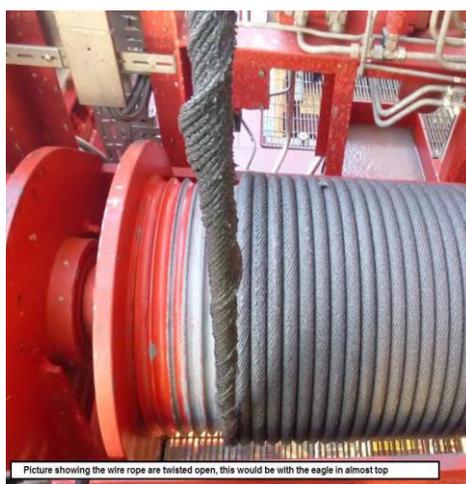
Four of 34 strands proved to have parted, and the rope was deformed. A birdcage had formed. See figure 3. The reason for this damage was assessed to be the wrong type of rotation-resistant rope. While rope with a right-hand lay was used on the winch drum, this was designed to handle left-hand lay.

Figure 3 Damage to the steel rope on the HTV Eagle crane. (Synergi # 1461090, January 2016)

MH Wirth drafted a major operational failure report on 10 January. The rope was replaced with a left-hand lay type, and the problem was regarded as solved. MH Wirth ordered new rope from Kverneland Aqua AS, which received this from Westfalische Drahtindustrie.

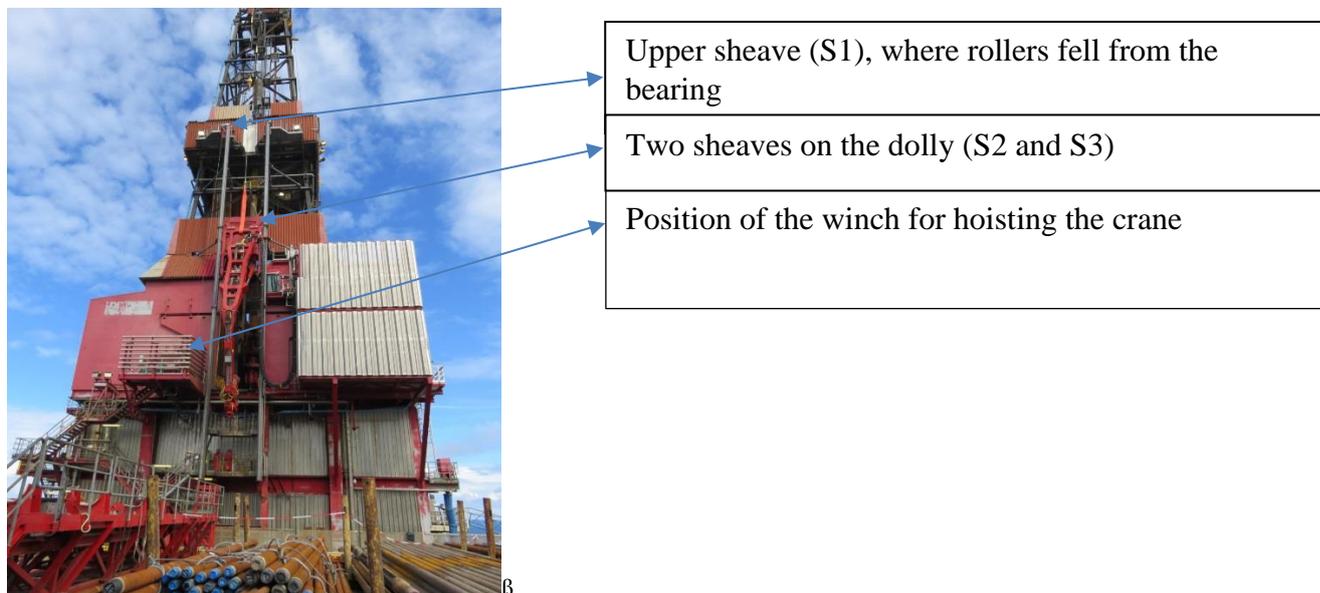
These proved to originate not from the winch but from the S1 sheave at the top of the guide beam. Soon afterwards, while the crane was in use, rollers from the sheave bearing fell to the winch deck.

Figure 2 The HTV Eagle crane when bearings were replaced in S1. (Synergi # 1480757)s

The bearing of S1 on the guide beam was replaced on that same day.

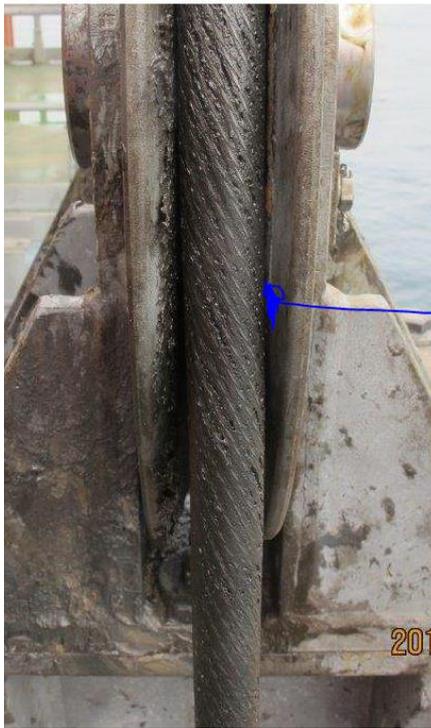
KCAD submitted a major operational failure report on 1 August covering the damage to the bearing in S1. This identified the fleet angle of the steel rope from the drum to the sheave as the cause of the roller bearing failure. Furthermore, the sheave was to be replaced every six months (established as the maintenance interval).

Figure 5: The steel rope bearing against the sheave.

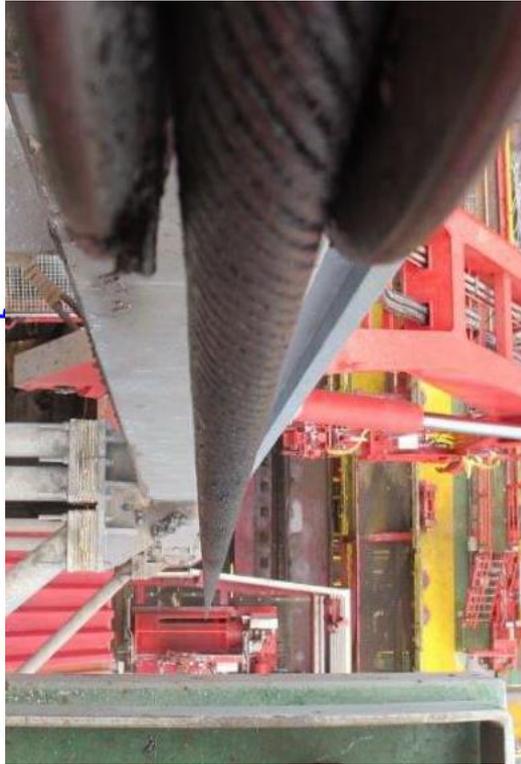
In an asset integrity report of 17 January, the KCAD field engineer for crane and lifting expresses concern that the fleet angle of the steel rope from the electric winch drum to the upper sheave (S1, see figure 4) atop the one guide beam is at the upper limit of the tolerable and must be followed up. MH Wirth responded that the fleet angle was within the sheave's tolerance.

Figure 6: The fleet angle between drum and sheave.

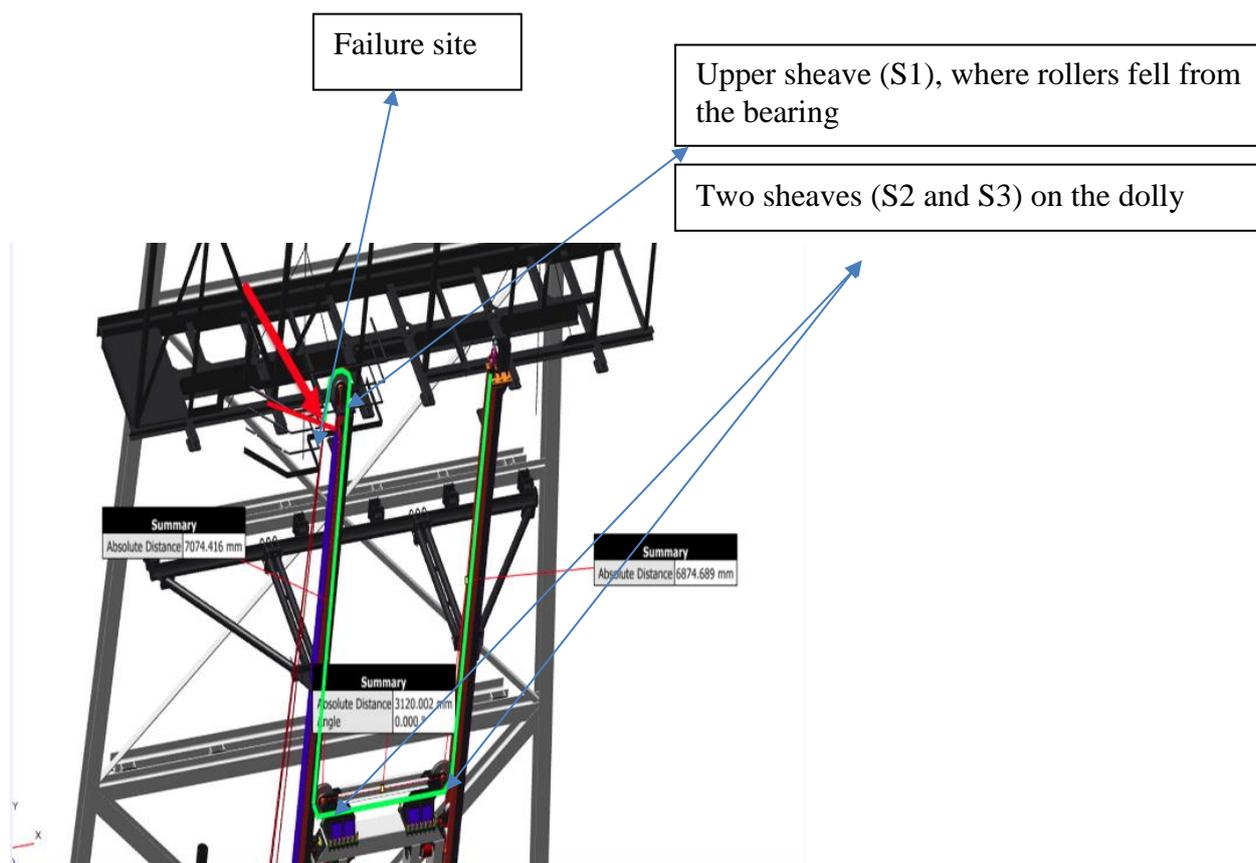
15.25. Without warning, the steel rope failed and the crane boom fell 10 metres to the pipe deck.

Figure 7 The red arrow shows the point where the steel rope failed.

The direct cause of the boom falling to the pipe deck was fatigue in the steel rope. The rope is a safety-critical main component in the arrangement for the up and down crane movement. It carries the whole weight of the crane's hoisting and boom arrangement – a maximum of 17.9 tonnes with load and about 14.4 tonnes without load.

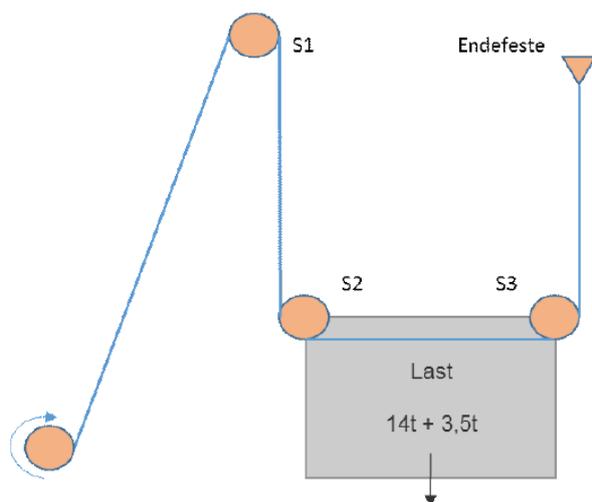
The winch drum on the HTV Eagle was underspooled in relation to S1, which was underspooled and thereby gave rise to an S bend (reversed bend) on this sheave. S2 was also underspooled, and the rope acquired a further S bend from S1. S3 is spooled the same way as S2, producing a total of two successive S bends for S2 and S3. See figure 9.

Figure 9 The winch arrangement for the HTV Eagle crane. (Statoil investigation report)
Key: Endefeste = end attachment; Last = load

According to W Giertsen Service AS, it is unfortunate that the angle between S1 and the drum means that the rope is only in contact with one side of S1. That creates rotation in the rope, which reduces service life while greatly enhancing the threat of a kink (birdcage/twist), particularly with slack rope. While the winch is underspooled and S1 is overspooled, the big

The combination of rotation-resistant steel rope of high tensile strength, led over multiple sheaves of a small diameter ($18 \times D/d$) and subject several times to S bends during each crane operation, with a relatively high fleet angle between winch drum and upper sheave has resulted in loads which have resulted in a short service life for the rope. No service life calculations were carried out for it. The investigation found that the fatigue occurred in the area subject to the largest number of passes over several sheaves during each work operation by the crane.

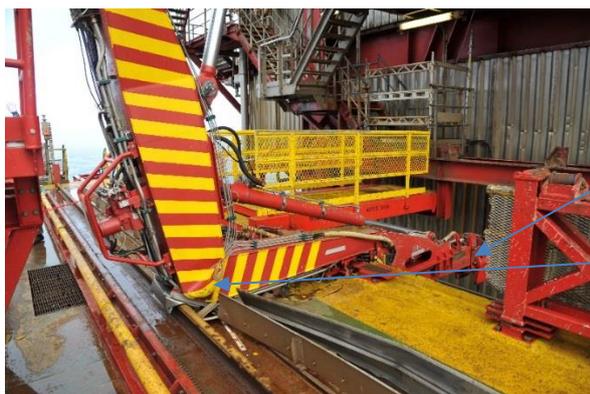
The gripper arrangement has been fractured. One of the grippers is detached and lying on the other side of the outer jig.

The crane with a bent outer boom segment.

Figure 10 The crane with bent crane arm and broken gripper arrangement.

Figure 10 shows the outer boom segment of the crane after it fell to the pipe deck. The segment (striped red and yellow) has been bent by 90 degrees. The cable tray for the traverse crane is deformed, while the gripper arrangement for loads hangs over the edge of the deck. The railing broke off and fell towards the BOP deck, where it landed in the safety net. Figures 11–13 show other material damage.

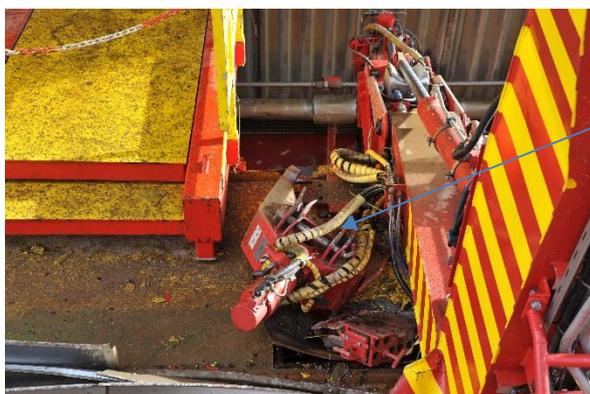
The detached gripper arrangement after it broke in two.

Figure 11 The outer jib with the broken and detached gripper arrangement.

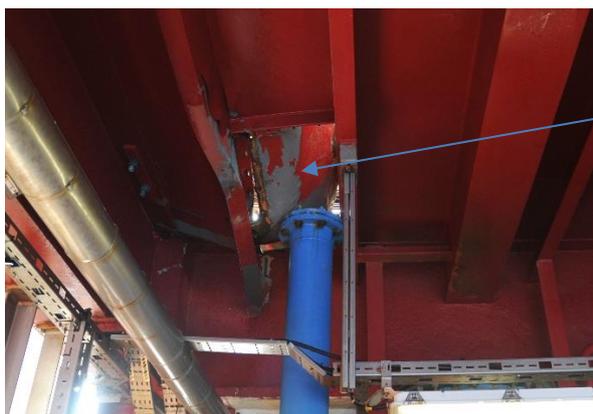
Damage to the underside of the pipe deck after the crane boom fell.

Figure 12 Photograph taken from below, under the pipe deck. Damage after the crane boom hit the deck.

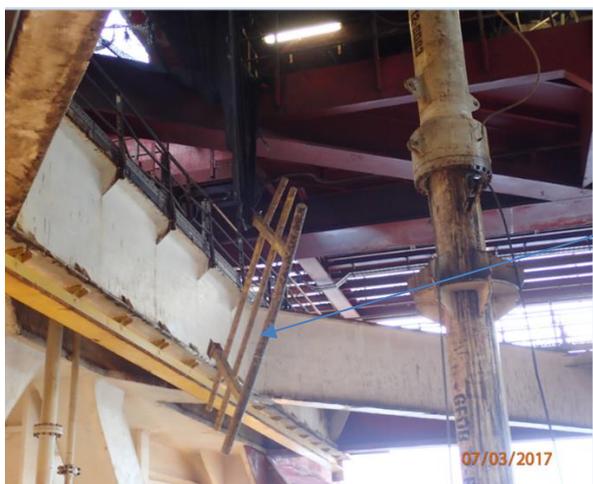
Railing caught by the safety net over the BOP deck.

Figure 13 The railing was broken off and fell towards the BOP deck, where it landed in the safety net.
