Investigation report

| Report title Report of the investigation into the man-overboard incident on <i>Scarabeo 8</i> on 20 February 2015 | Activity number 401003010 |

A man fell overboard from the mobile drilling unit *Scarabeo 8* at about 04.08 on Friday 20 February 2015. The Petroleum Safety Authority Norway (PSA) was notified at 05.45 on the same day.

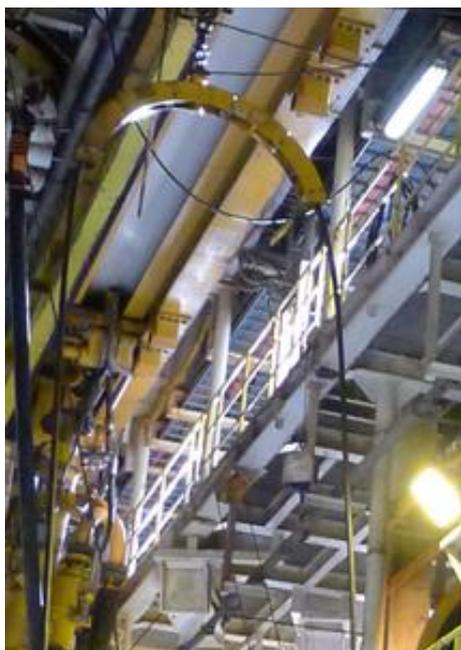
Figure 2 Banana sheave installed on podline in normal use

Banana sheaves on *Scarabeo 8* have no dedicated stowage location when not in use. Three of these sheaves are used on *Scarabeo 8*, coloured yellow, white and blue. The white and blue were stowed on the actual BOP carrier deck, while the yellow was located at the time of the incident on the BOP carrier platform. This placement meant that the senior SE had to descend to the platform to check the yellow sheave's condition. See improvement point 6.2.1.

Space on the BOP carrier's lower platform is limited, and at least two people need to be present during disassembly/assembly. More appropriate stowage could help to improve conditions for inspection and maintenance work.

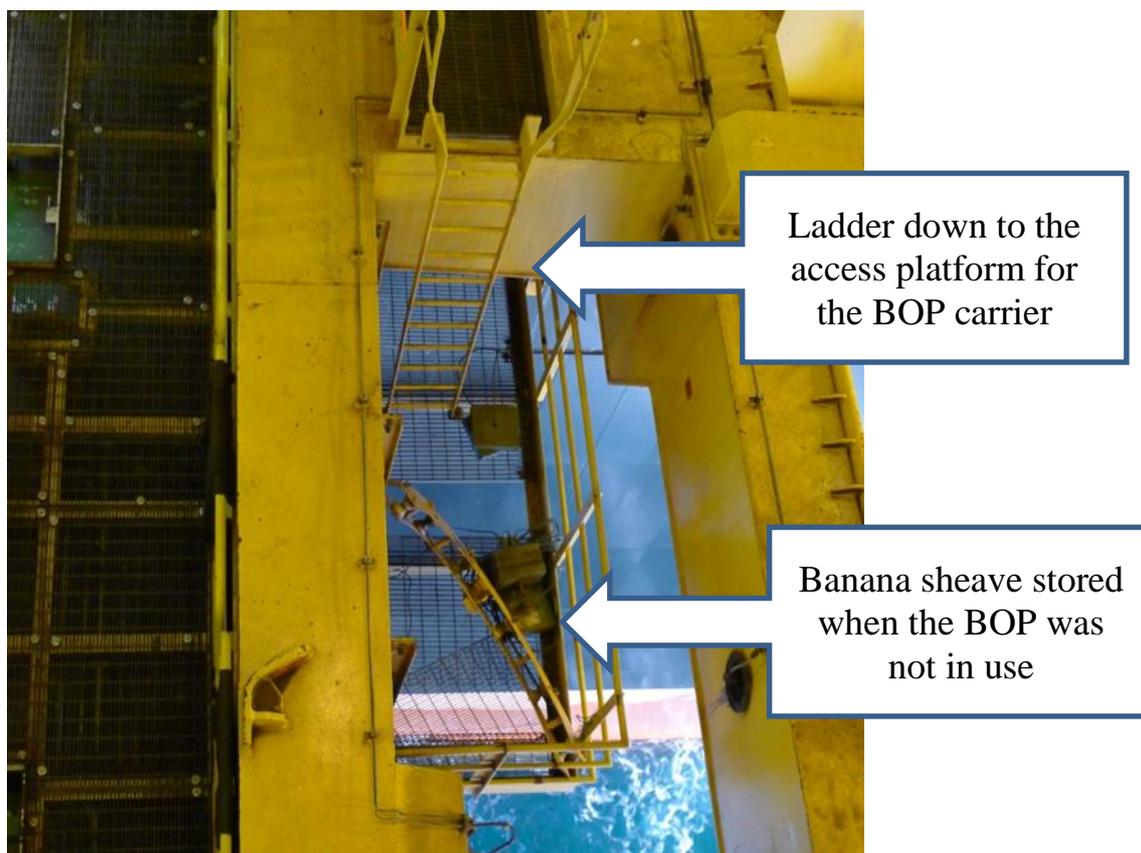
The yellow banana sheave (for the yellow podline) due to be installed in connection with readying the BOP lay on the lower access platform on the fore starboard side of the BOP carrier (hereafter called the site). The access platform is shown in figure 3.

Figure 3 View down to the cordoned-off site/access platform for the BOP carrier.

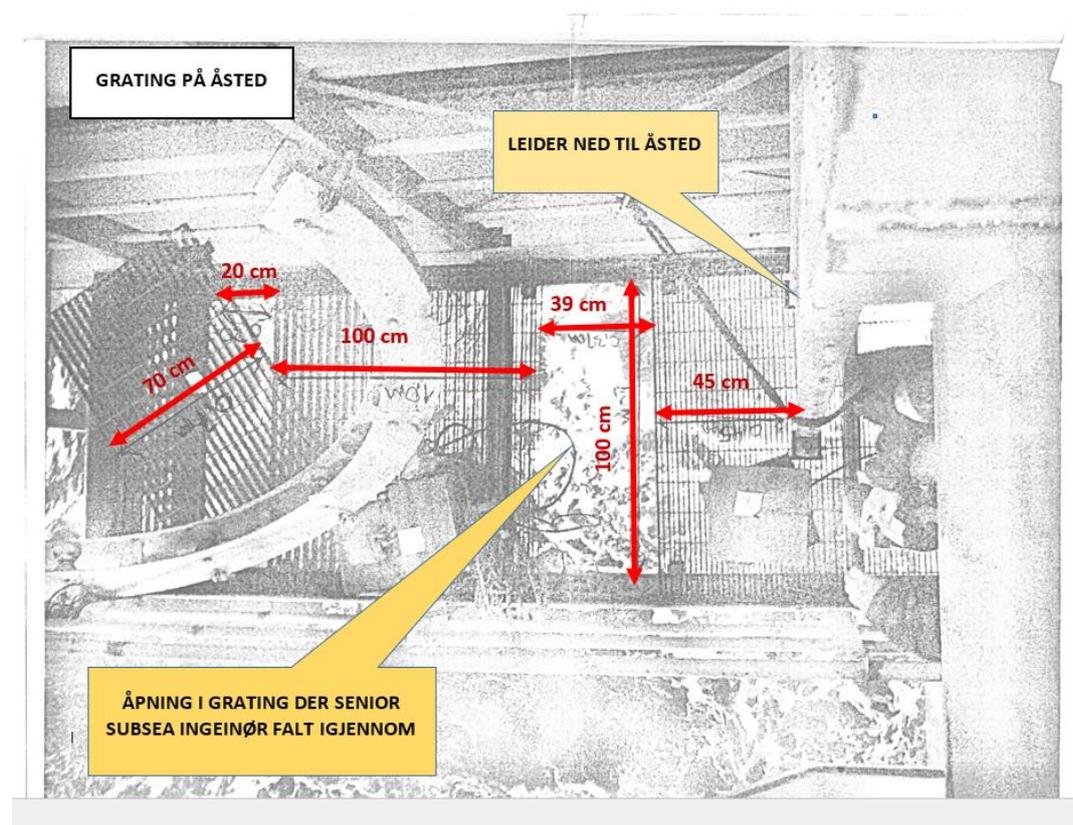
Figure 4 show the site in daylight after the incident when the senior SE fell through the missing grating.

Figure 4 Site with measurements.

Key: Grating at the site; Ladder down to the site; Gap in the grating which the senior SE fell through.

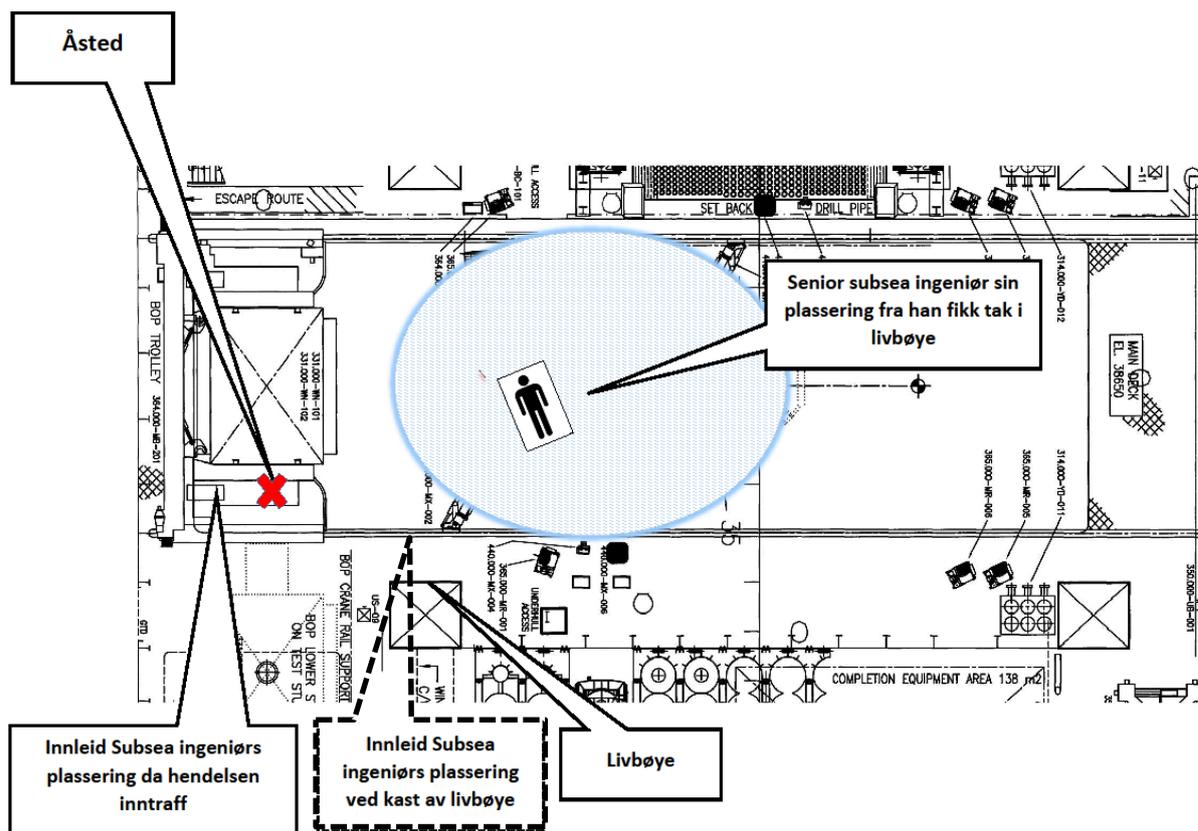
Figure 6 Overview of moonpool area when the incident occurred.

Key: Site; Senior SE's location after he secured the lifebuoy; Hired SE's location when the incident occurred; Hired SE's location when he threw the lifebuoy; Lifebuoy

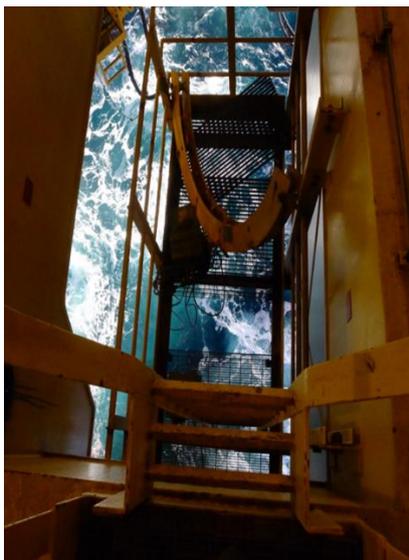
The direct cause of the incident was the missing grating on the BOP carrier platform.

Figure 7: The gap in the grating on the BOP carrier platform which the person fell through.

The most probable cause of the man-overboard incident on 20 February 2015 is that high waves have displaced the grating. On the other hand, it is not clear whether waves, high winds or a combination of these caused damage to gratings higher up the outside of the facility.

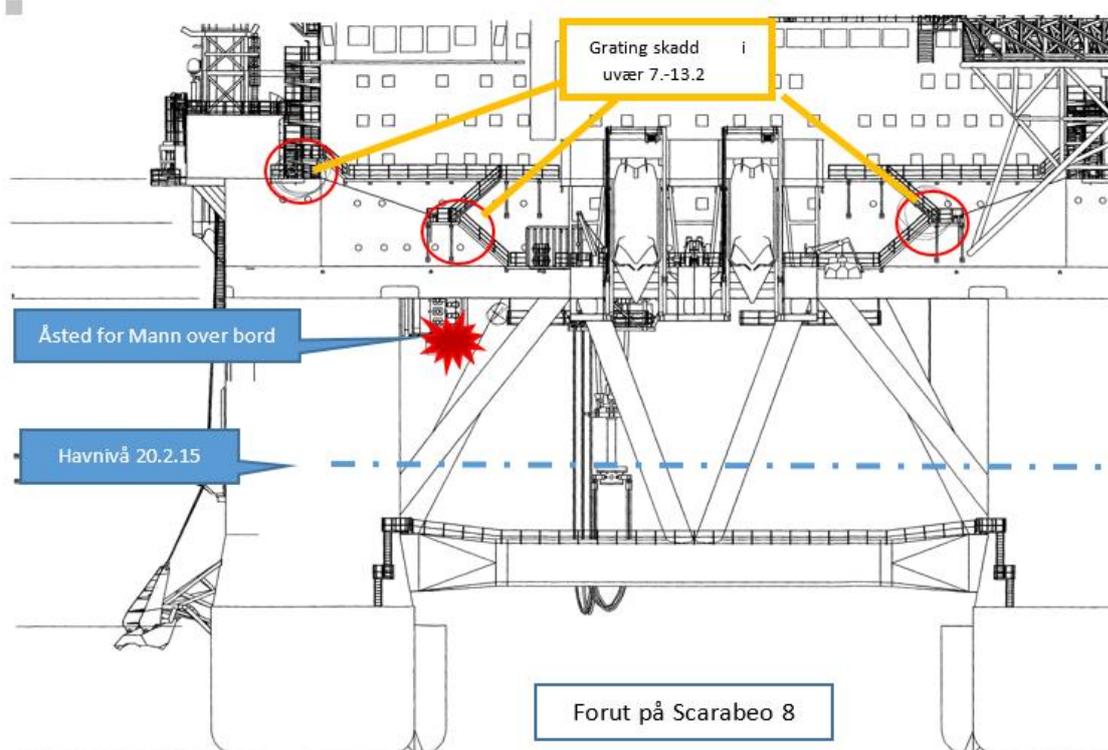
Much bad weather was experienced in the area where *Scarabeo 8* is operating during the two weeks before the incident. Damage to gratings at the aft end of *Scarabeo 8* is documented on 7 February. A separate report dated 12 February documented further areas of damage. This damage was caused by a combination of heavy weather and design of the unit. The shape of its six columns, with broad vertical surfaces combined with fairly fine-meshed gratings on external gangways, has given wind and waves good conditions to build up with great force. The bad weather probably also displaced part of the grating on the BOP carrier access platform. That left gaps somebody could fall through. See nonconformities 6.1.1 and 6.1.2.

Figure 8 Overview of damaged gratings at various levels following the bad weather on 7-13 February 2015.

Key: Grating damaged in bad weather 7-13 Feb; Man-overboard site; Sea level 20 Feb; Forepart of Scarabeo 8

Gratings were damaged as a result of bad weather from 7 to 13 February 2015 in several areas, including the fore escape route on the upper deck, the stairs down to the lifeboat deck from the upper deck, the aft upper deck escape route and the platform at the ROV hangar level. An event report described damaged gratings on starboard and port aft steps, which was dated to 7 February 2015.
