| Report | |
|--|---|
| Report title Investigation of a work accident at the Mongstad refinery – personal injury after falling during work in the cracker on 29 November 2014 | Activity number 001902001 |

| Summary |
|---|
| A work accident occurred on 29 November 2014 at Statoil Mongstad in connection with preparations for maintenance of a compressor. An employee fell about three metres from a ladder and was seriously injured. He suffered serious head injuries in addition to broken bones. |

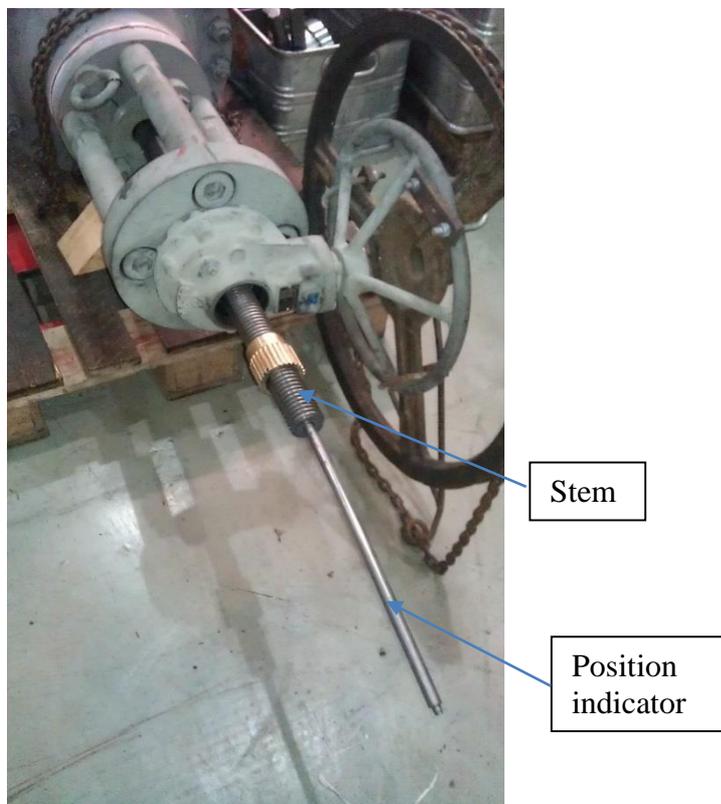
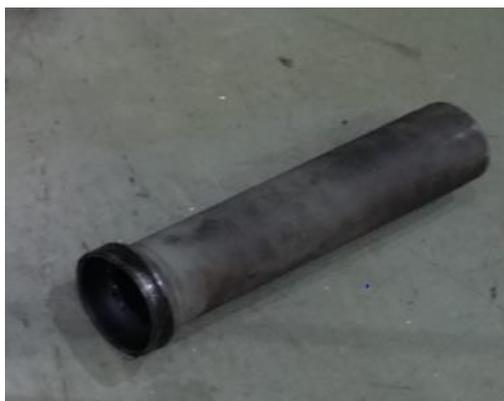
Metal sleeve

A position indicator is installed on the valve stem. The latter is protected by a metal sleeve. The indicator shows the position of the valve. The work team discovered that the sleeve was bent by about 45°, and discussed what could have caused this. They decided that it was safe to inspect the valve, and fetched a ladder to climb up. The ladder was placed against an H-beam at a height of 3.7 metres, and secured by an operator holding onto it. Another operator ascended to take a look. He banged on the sleeve with a pipe wrench, but could not see what was wrong. After descending the ladder, he called the assistant operations supervisor to help in assessing the valve. The latter ascended the ladder to look at the valve with sleeve. The others who were present then heard a bang and saw the operator falling from the ladder, a height of about three metres. He landed on a pallet jack and suffered serious head injuries and broken bones. The metal sleeve was found on the ground beside him
