Investigation report

Report	
Report title Hammerfest LNG Melkøya – LNG leak from road tanker, 17 June 2018	Activity number 001901036

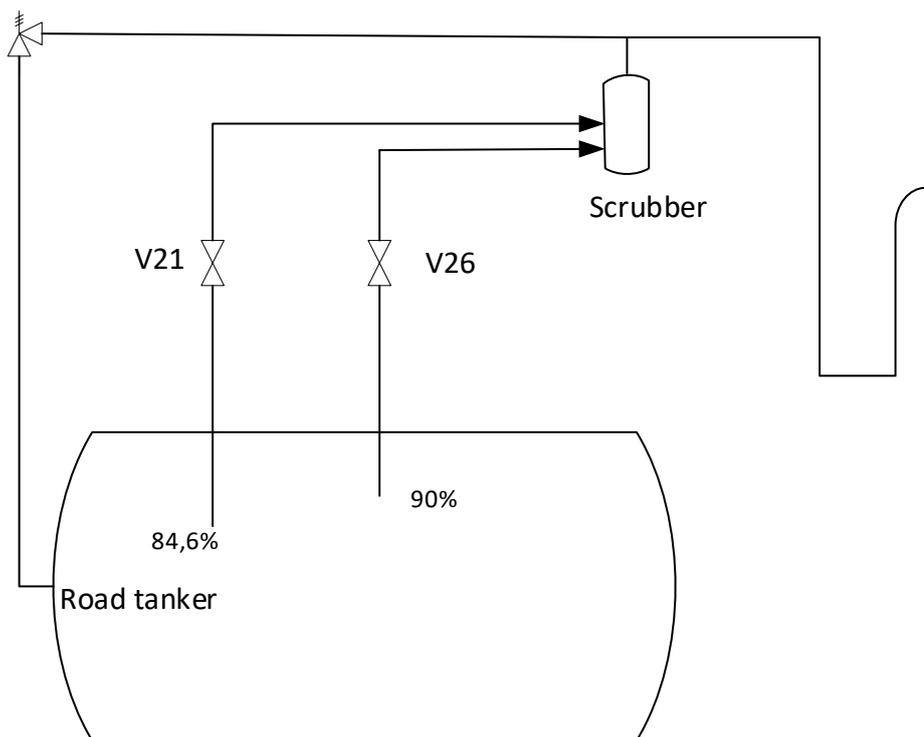
Figure 3 Outline of overloading protection on the road tanker.

A manual system called absolute overloading protection is used to ensure that the tanker does not become overloaded. The driver monitors the level measurements during the loading operation, and utilises the manual system when the level in the tanker approaches the defined limit. The manual system comprises two pipes inside the tank on the vehicle with try-cock valves (V21 and V26). See figure 3. Piping at the valve outlets (V21 and V26) is connected to a small scrubber tank, and the top-mounted outlet from this is connected with the outlet piping from the safety valves to the open air via a vent line at the rear of the vehicle. The level measurement piping stand with their openings down inside the tank at the level to be measured. In the relevant tank, these levels are 84.6 and 90 per cent respectively. When using the manual system, the first step is to open V21 cautiously and, based on the sound, identify whether the phase at the measuring point is liquid or gaseous. The valve is closed again, and may have to be reopened to confirm the liquid phase. This process is repeated with V26 when liquid is confirmed at V21. When liquid is identified through V26, the desired level in the tanker has been achieved. V26 is then closed and the loading process halted. During this manual level check, small quantities of LNG will be released through the vent line at the rear of the vehicle.

The system for overloading protection is designed in such a way that a single incorrect action can have unacceptable consequences, and the ignition source control system has deficiencies.

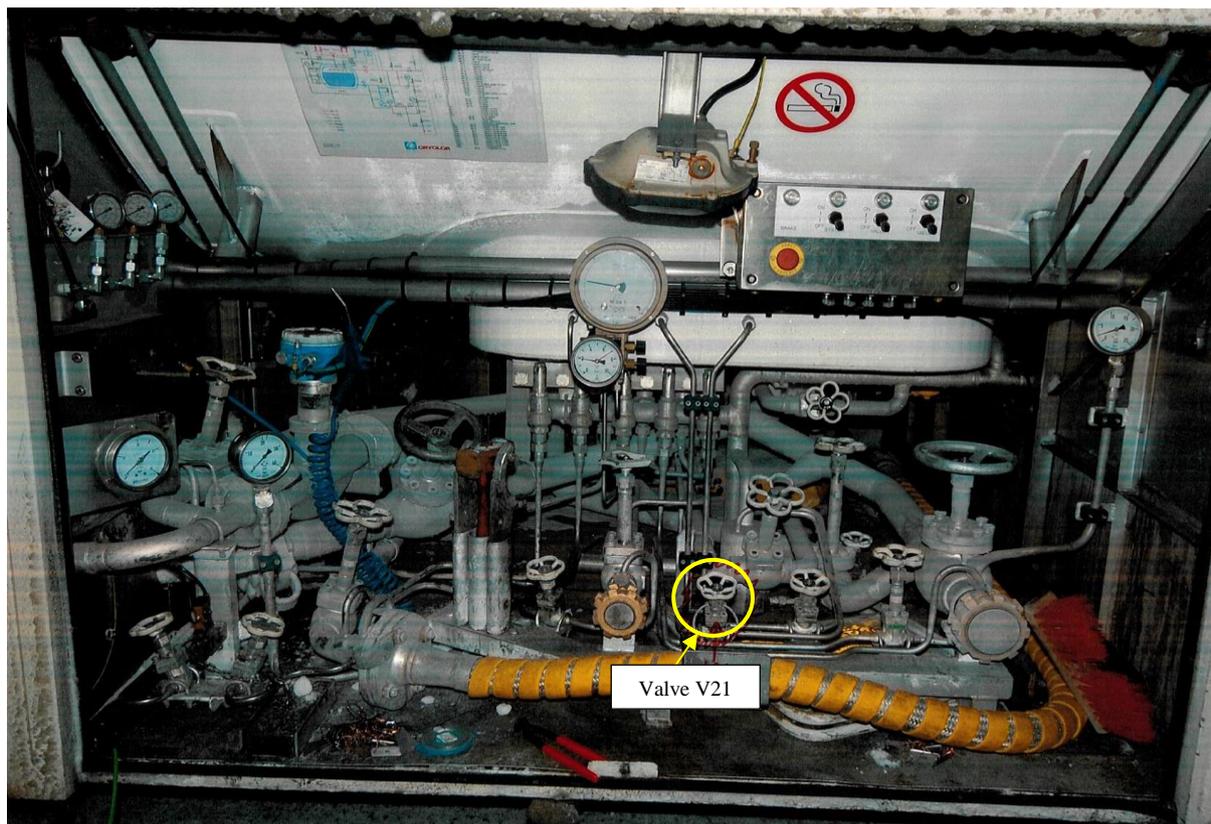
Figure 4 Valve layout on the road tanker. Source: BNG.

The direct cause of the leak was that valve V21 had not been closed during verification of the liquid level in the road tanker.

As described in section 3.4.2, the established method for overloading protection of road tankers involved manual operation of try-cock valves. In connection with this operation, small amounts of LNG will leak out via the vent line at the rear of the vehicle. When the liquid level in the tank is above the measurement level for the try-cock valves, each of these represents the only barrier against a major leak. If they are left in the open position, no opportunity exists to shut off from other locations, and LNG will continue to escape until its level is below the measurement point for the open try-cock valve, or the valve is closed.
