Investigation report

Report	
Report title Investigation of dropped riser joint on <i>West Bollsta</i> on 17 October 2020	Activity number 404011004

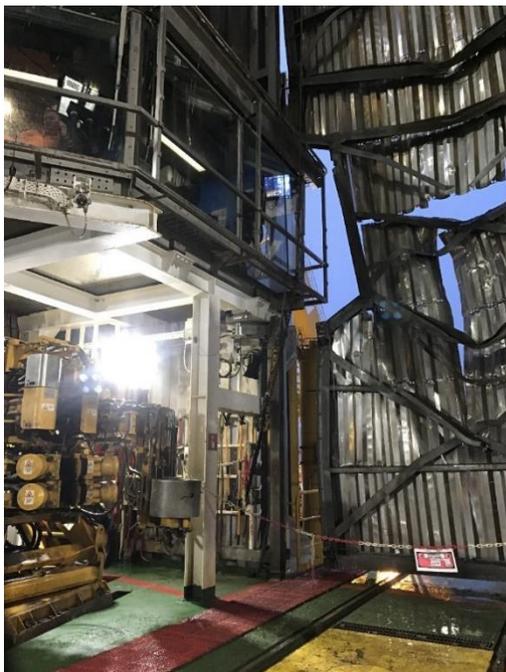
Photo 2: Driller's cabin and damage to the V door where the joint struck. Photo by the PSA team.

On dropping, the joint damaged the V door to the pipe deck and some of the equipment used to transport and handle the joint from the riser deck to the drill floor – including the gorilla arms. The joint was also damaged and had to be replaced.

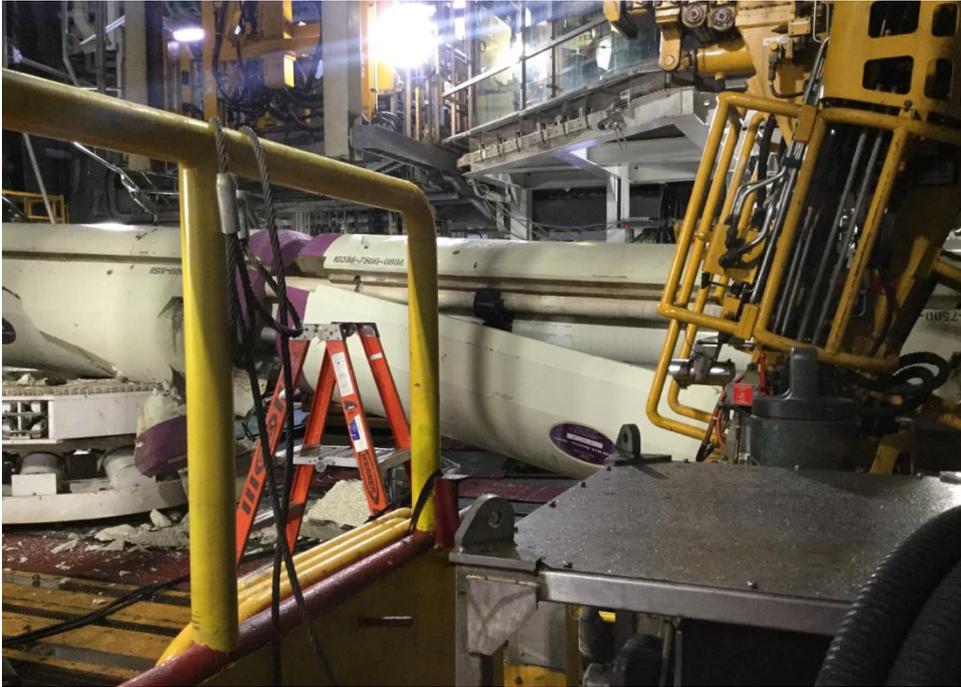
While the first joint was being lifted from horizontal to vertical, it became detached from the HRRT. The joint was almost vertical and dropped to the drill floor where it lay on the spider between the two V doors. It tore off parts of the V door on the other side of the drill floor towards the riser deck, and much of the buoyancy elements around the joint were damaged or ripped off.

Photo 3: The joint lying on the drill floor and on top of the spider after the incident. The driller's cabin can be seen at the top in the background. From Seadrill's presentation of the incident.

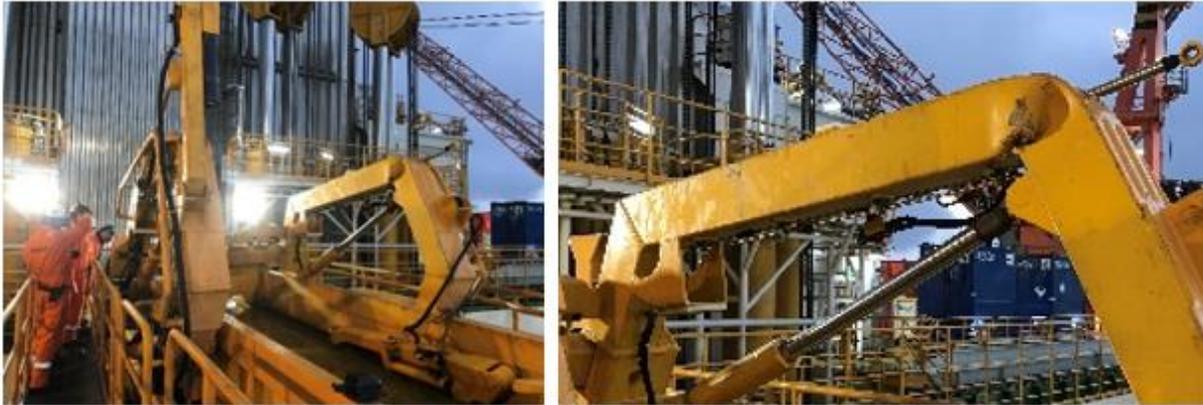
Photo 4: How the gorilla arms installed on the catwalk for handling joints were bent by the weight of the joint after the incident. Photo taken by the PSA investigation team.

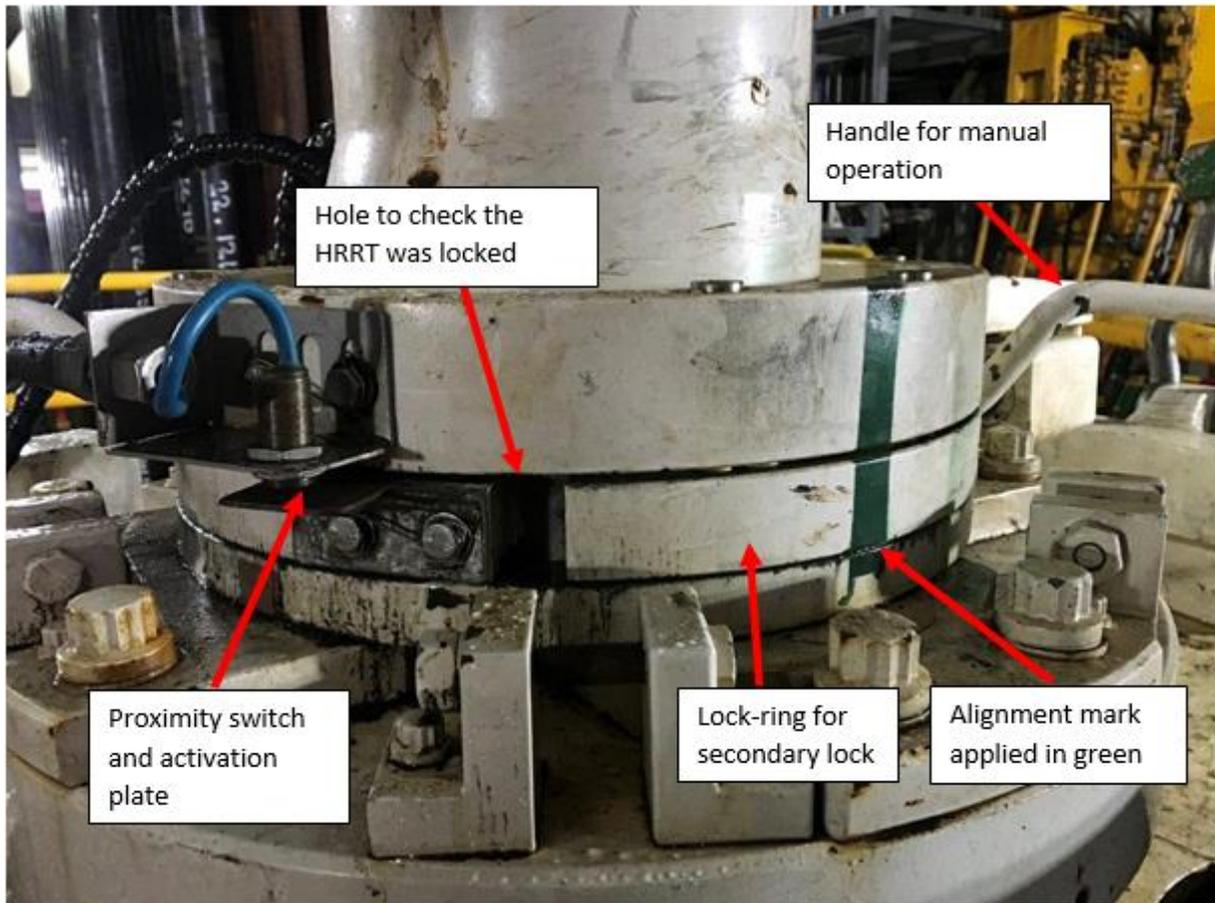
Photo 5 shows the top of the relevant HRRT in locked position. Alongside the proximity switch and activation plate is one of the holes which made it possible to see one of the rods on the piston if the tool was unlocked. The photograph also shows the secondary lock-ring, an alignment mark applied in green paint, and the handle which permitted manual operation of the secondary lock plate. These are described in sections 5.1.2 and 5.1.3

Photo 5: The HRRT involved in the incident. Taken on board by the PSA investigation team.

The investigation found several weaknesses in the design and operation of this switch, which had an important safety function in reporting to the operator whether the secondary lock was activated. It comprised an on/off switch activated when the HRRT locked. That occurred when a metal activation plate attached to the lock-ring for the secondary lock came close to the switch and activated it. This was only a simple switch, so it was not possible to establish whether the system had a fault or the switch was deactivated in the off position. No monitoring was conducted with the switch to check that it functioned as it should. The activation plate was also very large and the secondary lock-ring did not have to rotate much to activate the switch.

In addition to the signal from the proximity switch to the driller's control system, a small light also showed by the actual switch. It emerged from interviews that this light could be seen from the cabin. When it was not visible, the secondary lock was supposed to be activated. It also emerged that crew on board had found that the switch did not always function. It could signal to the driller that the HRRT was not locked when it actually was, and vice versa. Personnel on board had painted an alignment mark on the HRRT which was intended to make it easier to verify that the secondary lock-ring was rotated to the right position when the tool was locked. The mark comprises two stripes painted on the HRRT. One rotated with the secondary lock-ring while the other was on the fixed section of the tool. When in locked position, the stripe on the secondary lock-ring was immediately over the fixed stripe, creating a vertical line which could be seen from a distance of a few metres.

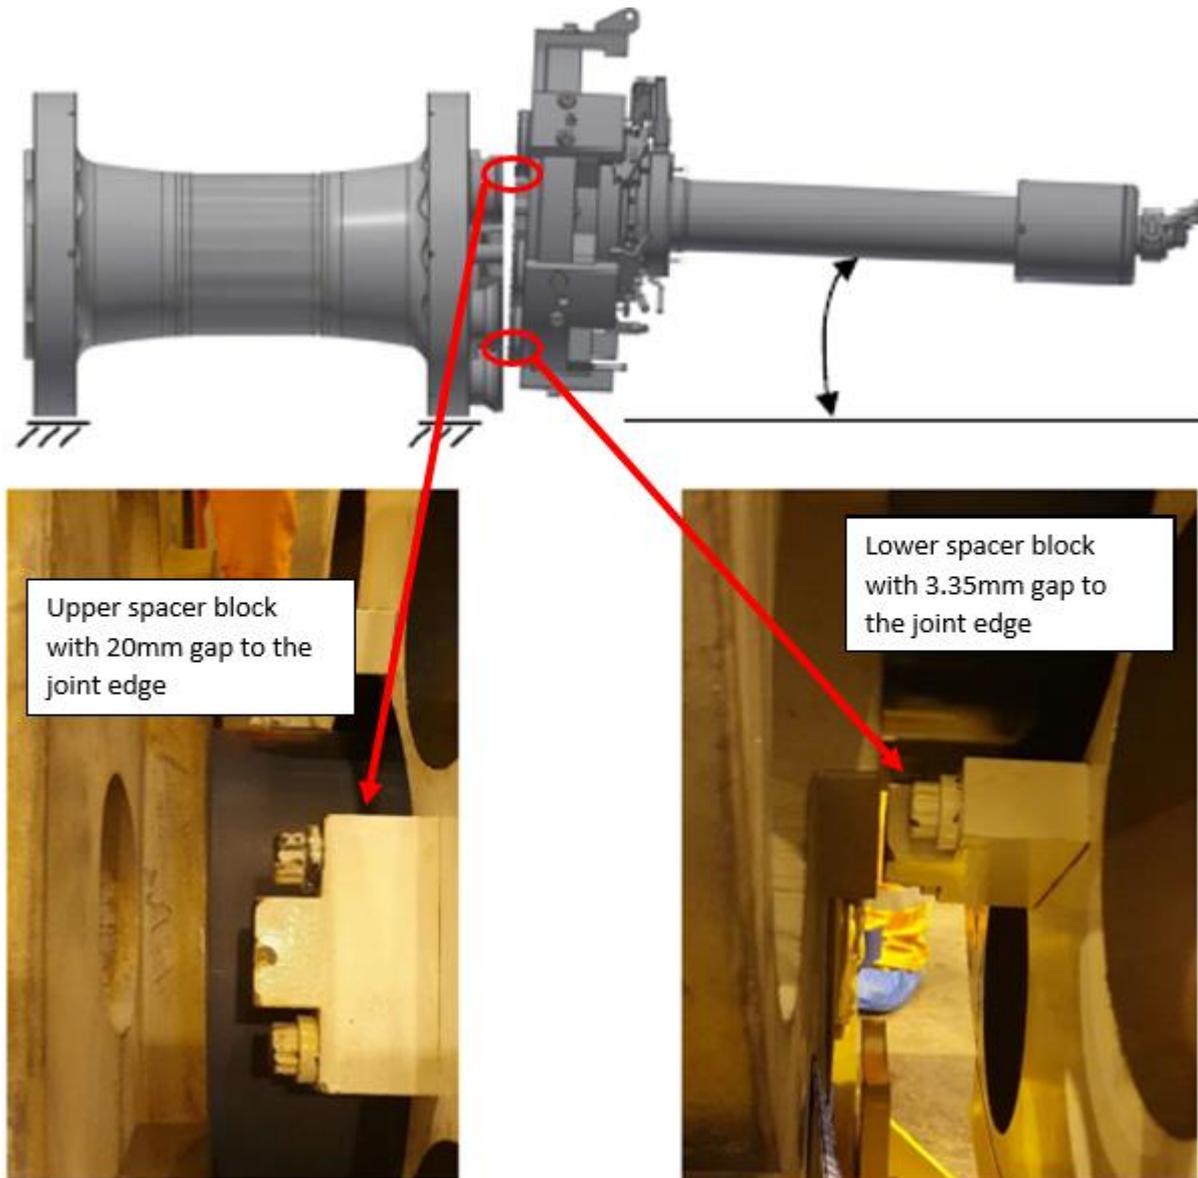
Tests on *West Bollsta* after the incident showed that feedback from the proximity switch to Cyberbase was unreliable. When the locking sequence started, the tests on land showed that even a small motion in the secondary locking lock-ring could produce an inaccurate signal to Cyberbase that the tool was locked. Testing also found that this could happen in cases where the HRRT was not sufficiently inserted into the riser. If the HRRT was not fully inserted, the split lock ring's profile would be clamped to the joint wall and thereby fail to engage with the groove in the latter. Thereby the piston would also be unable to move down the split lock ring and the indicator rods could not descend into the HRRT and be locked in place by the secondary lock-ring. Rotating the latter would be halted by the rods sticking up through their holes. However, the lock-ring would move a few millimetres before being halted by the rods. This small movement might be enough for the proximity switch to signal Cyberbase that the HRRT was locked.

This theory builds on the consideration that, although the locking mechanism was at one point fully inserted in the riser and the spacer blocks were tight against the joint, a displacement could have occurred later. This must have happened between the time the roustabout saw that the HRRT was inserted in the joint when it entered the drill floor, and when they observed the secondary lock-ring rotate during the actual verification. Testing on land shows that, if the HRRT was inserted in the joint and was not hanging from the top drive, it would be at an angle of between two to 2.2 degrees against the joint. During the test, the HRRT was withdrawn to create a gap of 20mm between the upper spacer block and the top edge of the joint. The bottom edge of the joint was thereby 3.3mm from the lower spacer block. Under these conditions, the HRRT was unable to lock to the joint during the test on land. This is shown in the diagram and photo below, which are taken from the Sub Sea Services test report.

Photo 7 Testing on land.

Sadrill's investigation has concluded that this is the most probable cause of the incident.
