# Investigation report

Report	
Report title Report of the investigation into the fire of 24 March 2015 in a HVAC unit on <i>Petrojarl Knarr</i>	Activity number 411003011

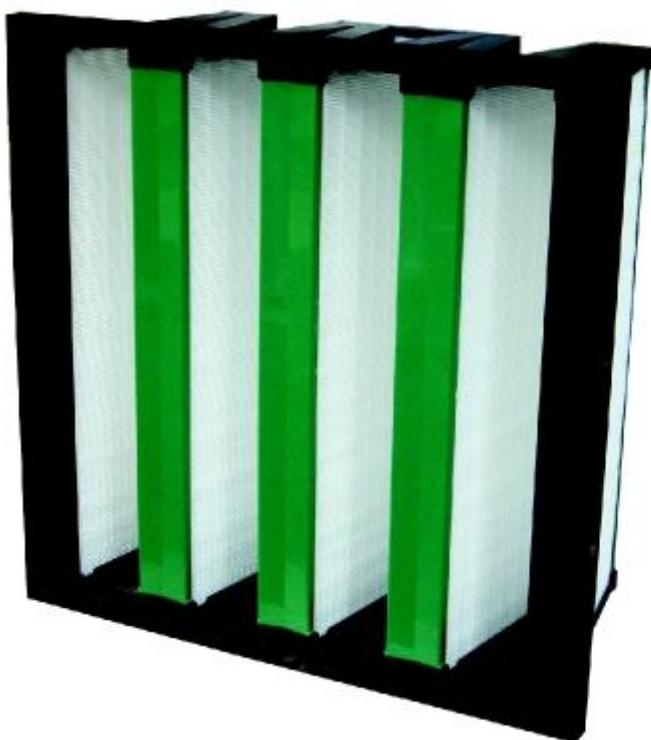
*Figure 1 Camfil Opakfil filter (source: [www.camfil.com](http://www.camfil.com))*

The HVAC unit which ignited consisted originally of a Camfil Ecopleat pre-filter and a Camfil Opakfil main filter. During docking in Haugesund before installation on the field, the pre-filter was replaced with a C-Cell Minipleat filter. After the filters come units for heating and cooling the air. Heating utilises a steam system. The HVAC unit has a separate housing with motor and fan before the air is distributed via automatic damper valves to the various rooms supplied by the unit. Sensors in the air stream in and out of the HVAC unit regulate the temperature with the aid of valves controlling the supply of steam and cooling medium.

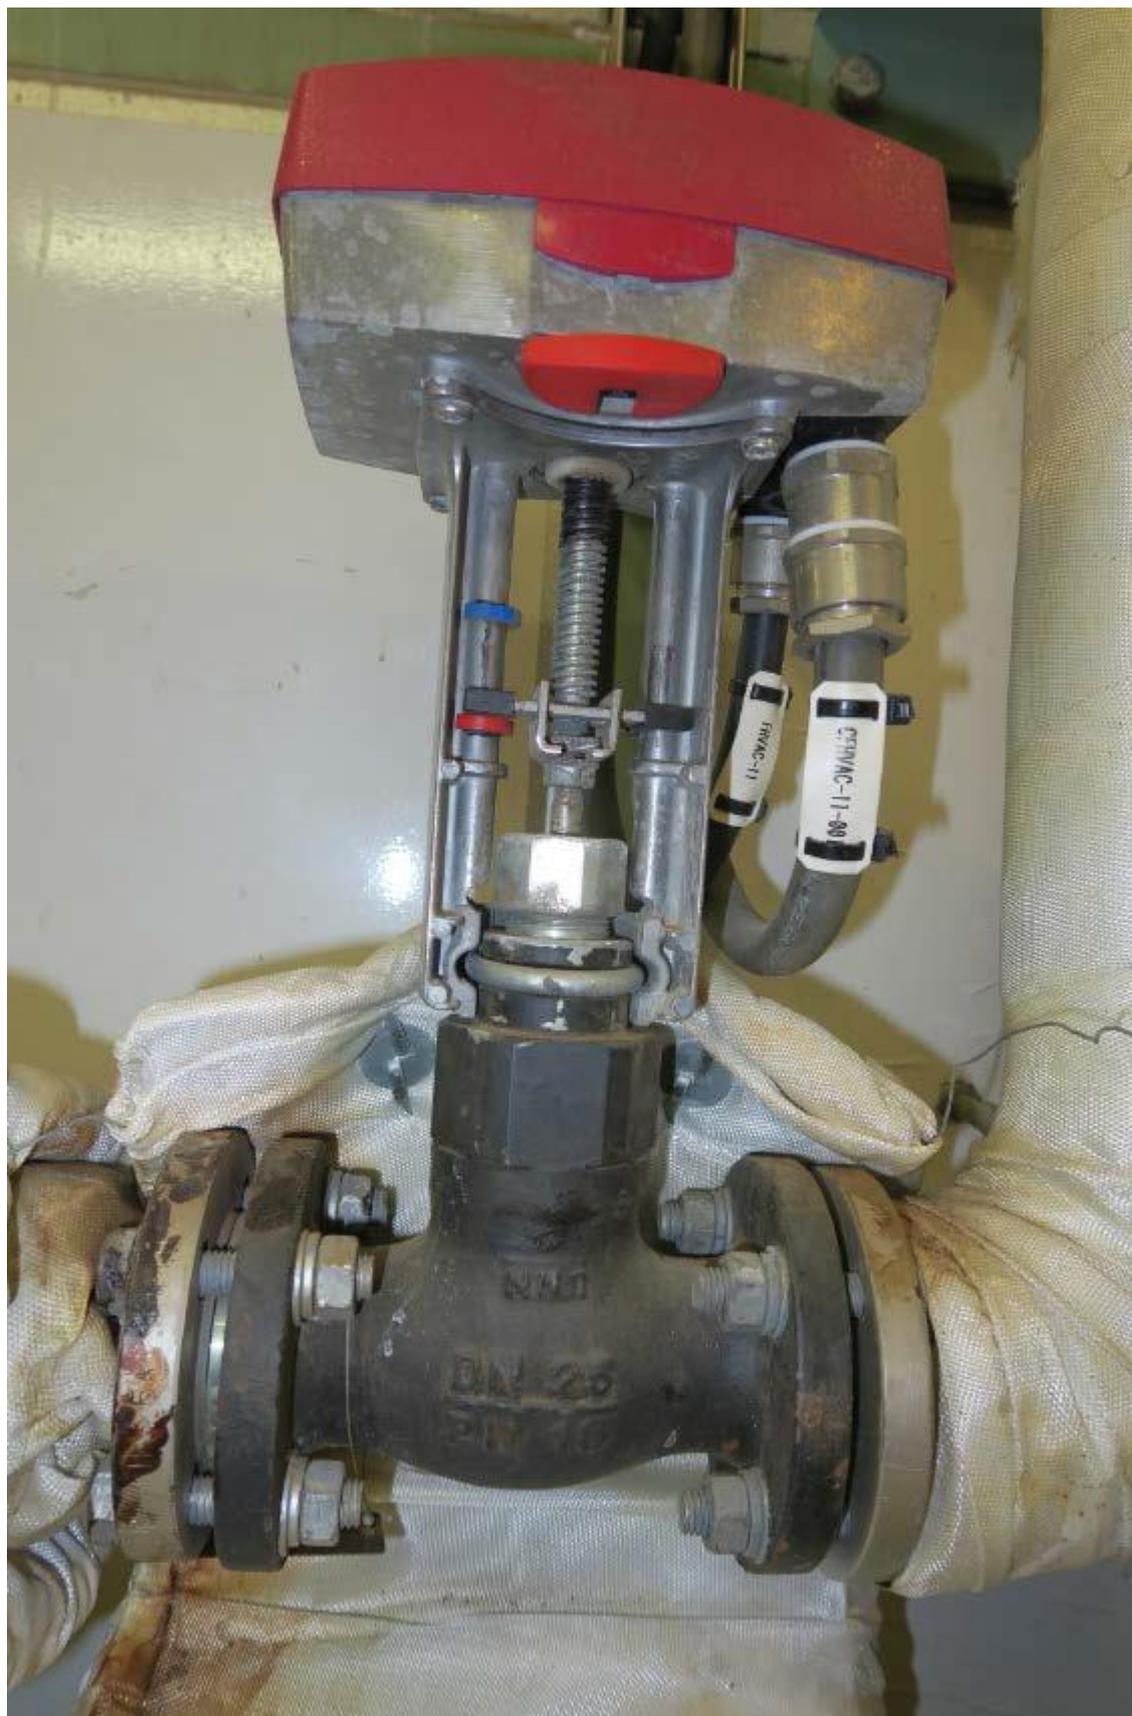
The unit is normally operated in automated mode, and the steam valve (see figure 2 below) regulates the temperature automatically on the basis of a desired set point. The manual mode is used for maintenance work, such as replacing fan belts in the system. In manual mode, the steam valve's position is determined via the local human-machine interface (HMI) control panel on deck 2.

*Figure 2 TAC-type steam valve, model number VGS211F-25-10, with Schneider M800 actuator (source: TKPJ).*

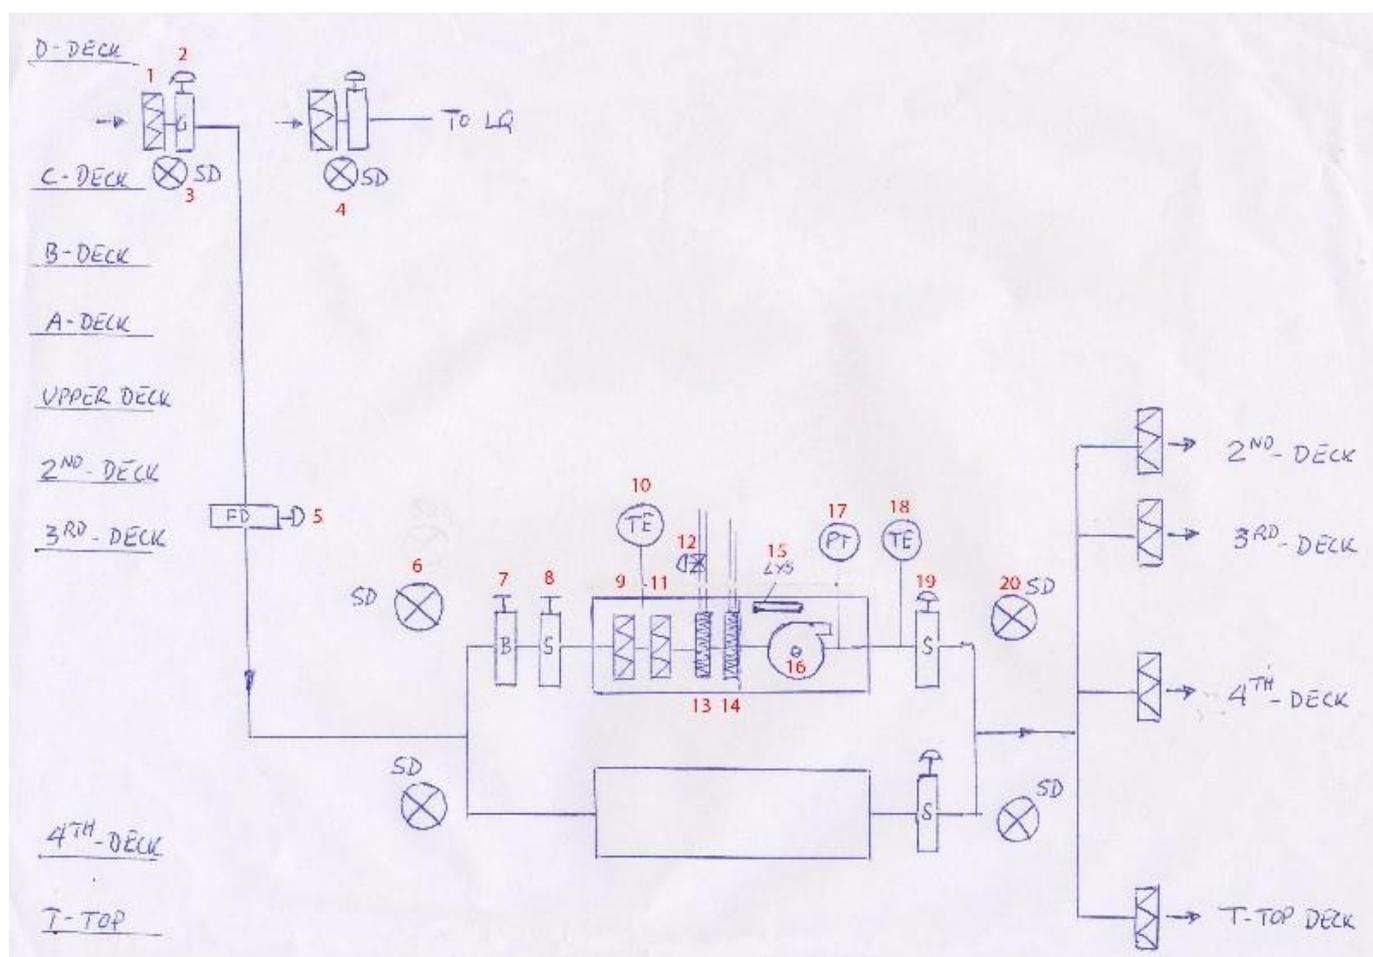
**Figure 3** Outline of the HVAC system for the forward engine room.

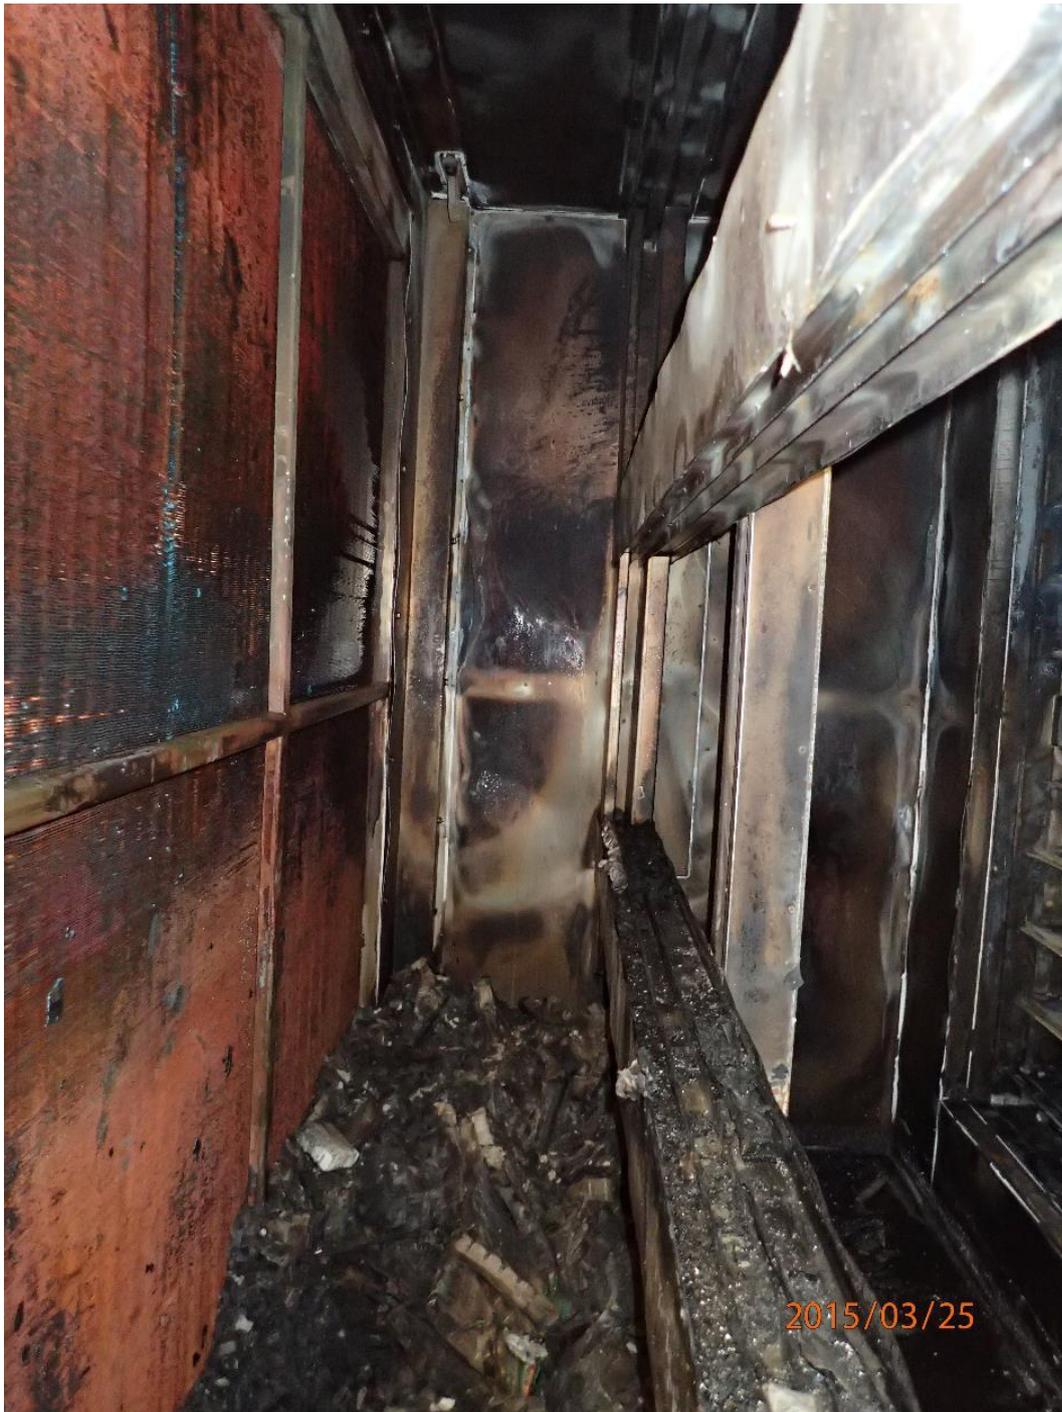
*Figure 4 - Burnt-out filter cassettes in AHU-A. (Source: PSA investigation)*

Filter cassettes were ignited in air handling unit A (AHU-A) for the forward (FWD) engine room as a result of design errors and faulty operation of the system.

Fire tests conducted by SP Fire Research (ref 18) have failed to identify clear ignition causes. A probable cause is self-ignition of the filter units, which were exposed to great heat for many hours. Traditional fire tests show critical ignition temperatures of more than 400°C for the materials used in the filter units. This is well over the estimated maximum temperature of 120°C.

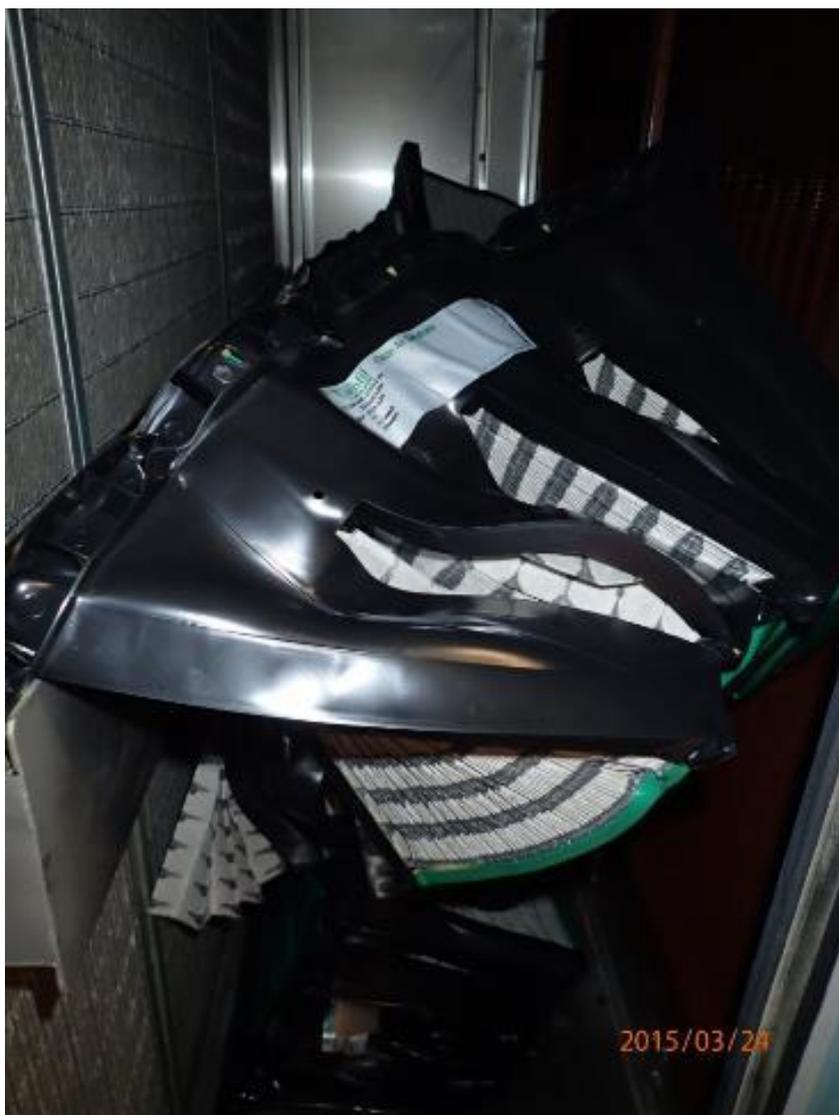
*Figure 5 - Deformed cassettes in AHU-B, which is immediately adjacent to AHU-A (Source: PSA investigation).*

The incident led to full mustering on board and mobilisation of external response resources. The AHU-A filter unit was burnt out. Similarly, the fire caused overheating in AHU-B, but material damage there was limited. HVAC ducts affected by the incident were coated with soot and required extensive cleaning. Equipment and ducts exposed to a high heat load (AHU-B) were returned to service relatively quickly after an overhaul.

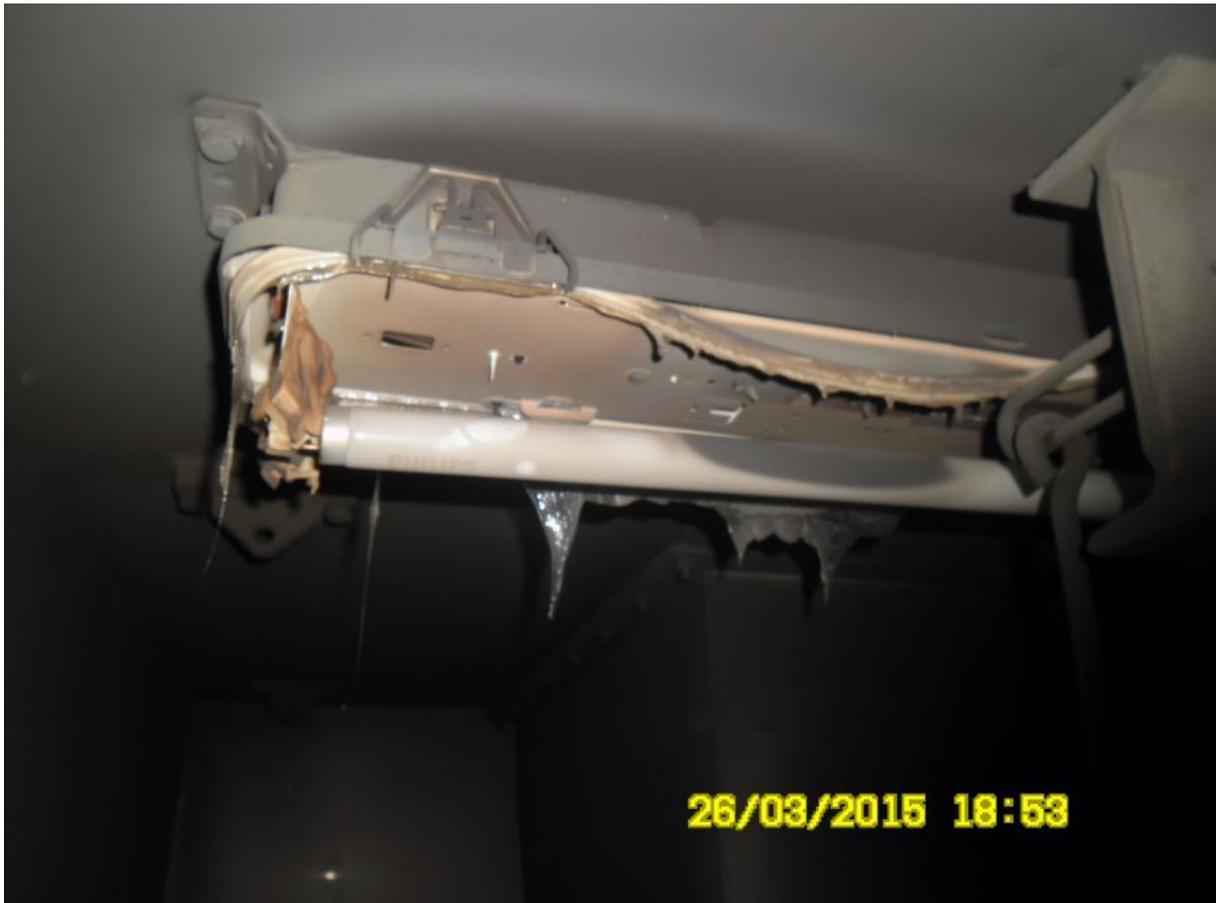
A number of investigations have been conducted with the light fitting in the fan room. This displayed damage after the fire which suggested that it might have been an ignition source. The background for this was that the fitting in the HVAC unit was certified for a maximum of 50°C and was, like the filter cassettes, exposed to high temperatures over a long time. The light was on during the incident and the fuse on the lighting circuit was afterwards found to have blown.

These investigations revealed that the fitting bore no signs of fire damage, short-circuiting or electric arcing which might have started the fire. Melting of the cover and damage to contacts can be explained by external heat from the fire. After the incident, soot formation was observed on one fluorescent tube and the component track in the fitting. A probable cause of this is smoke from plastic labels in the fitting which have melted from the heat.

*Figure 6 - Picture of light fitting in the fan housing in AHU-A (Source: PSA investigation)*
