Investigation report

Report	
Report title Investigation of a lifting incident on <i>Deepsea Atlantic</i> where a slip joint unintentionally ended up on the seabed	Activity number 405001011

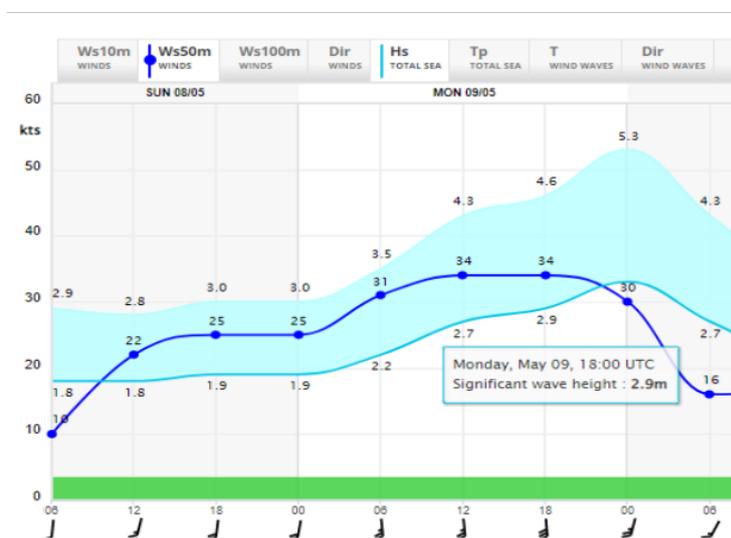
Figure 2 Weather forecast on the handover form on 8 May.

This forecast formed part of the shift handover document for the deck department. It showed that the H_s was more than two metres up to 04.00 on 8 May, declining thereafter to 1.8 metres. It was then due to rise above two metres again from 00.00 on 9 May until 11 May. Historical values obtained from the facility's own weather sensors confirm the forecast.

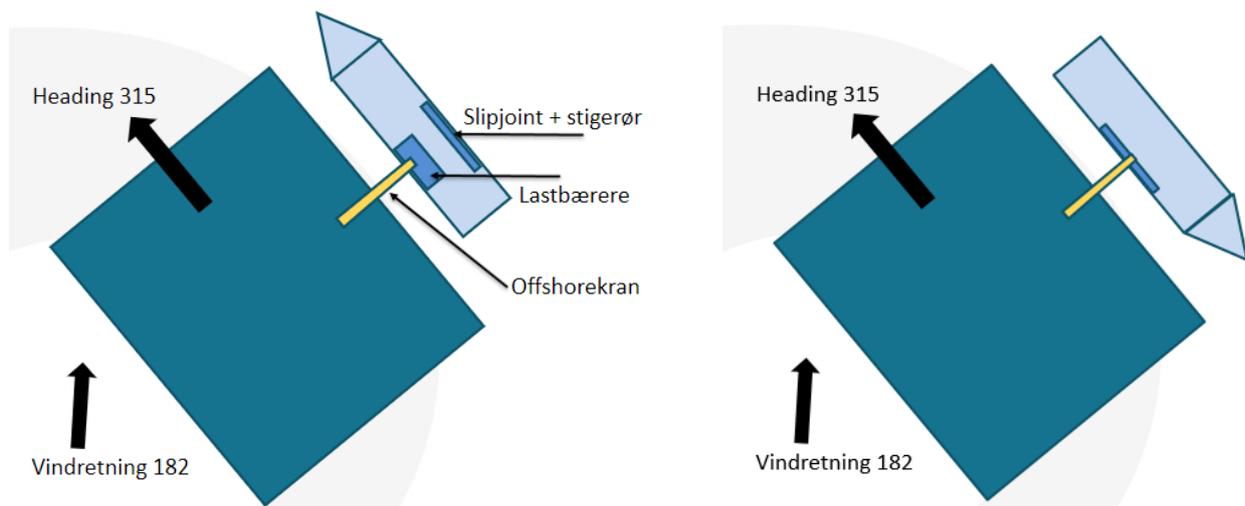
A riser with a buoyancy element was first lifted from ship to facility. The ship then lay with its port side against the facility. Before lifting the slip joint down to the latter, the ship was turned to bring its starboard side against the facility.

Figure 3 Left: headings of facility and ship in the first part of the lifting operation. Right: headings in the second part.

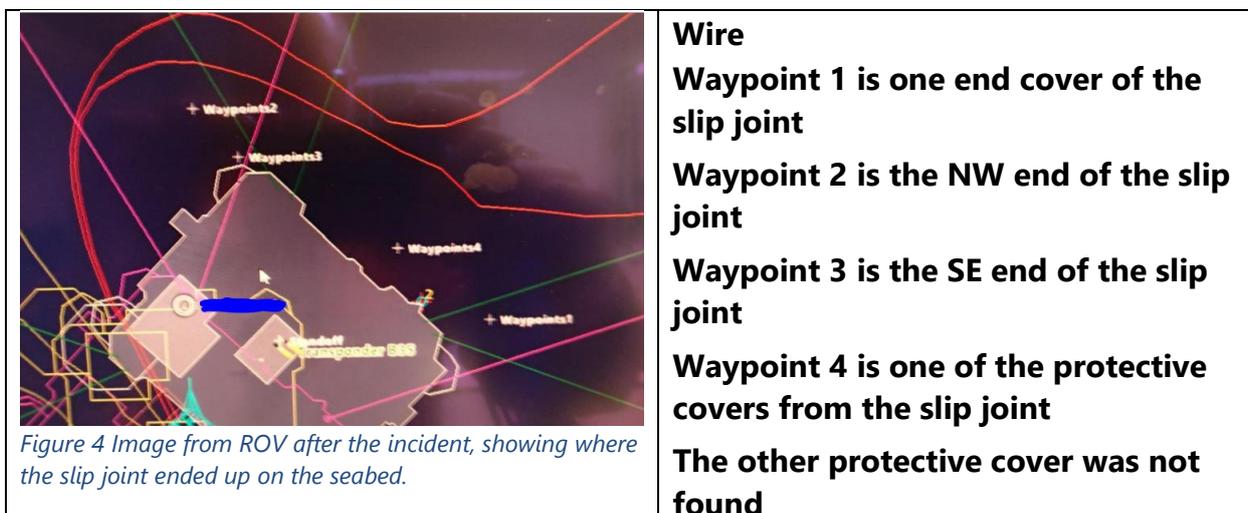
The starboard offshore crane was shut down and the crane operator went down to the deck office, where he was looked after by the deck personnel. After launching an ROV, the slip joint was found on the seabed at 12.56.
