# Investigation report

Report	
Report title Investigation of an oil spill from Gullfaks C on 26 April 2021	Activity number 001050081

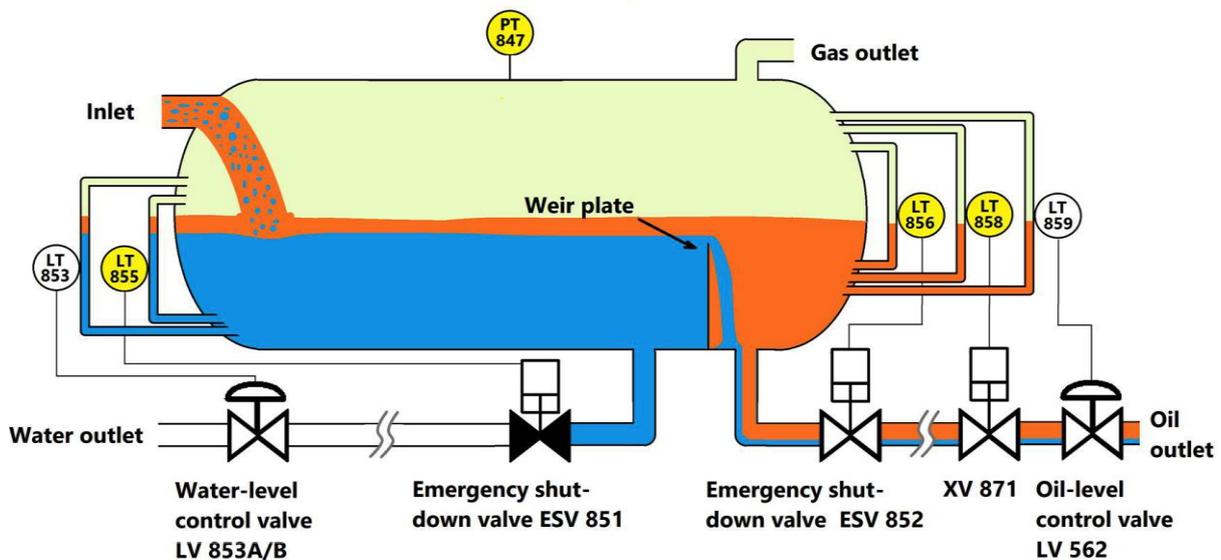
When starting up Tordis, the first step is to produce the stabilised oil out of the flowline before the wellstream comprising oil, water and gas arrives. The water outlets on the Tordis separators are kept closed during start-up, and are to be opened when wellstream with both oil and water flows into the separator. If the outlet is opened before water production begins, the water level in the separator can be lost should the valve controlling it be leaking. Until the outlet is opened, water flowing into the separator accompanies the oil through the oil outlet. Water can be sent together with oil on Gullfaks C because the stabilised oil is held in storage cells before transfer to shuttle tankers. This means the water separates out in the storage cells before transfer. The diagram below illustrates flow through the Tordis separators before the water outlet is opened and water flows over the weir plate together with oil.

Figure 6 Tordis separators A and B (illustrated by 20-VA06B) at startup.

Oil from the Tordis separators flows through a WiO meter. When this detects WiO, CCR operators know that the stabilised oil has been produced out of the flowline, and that the wellstream has reached the separator. The water outlet can then be opened.

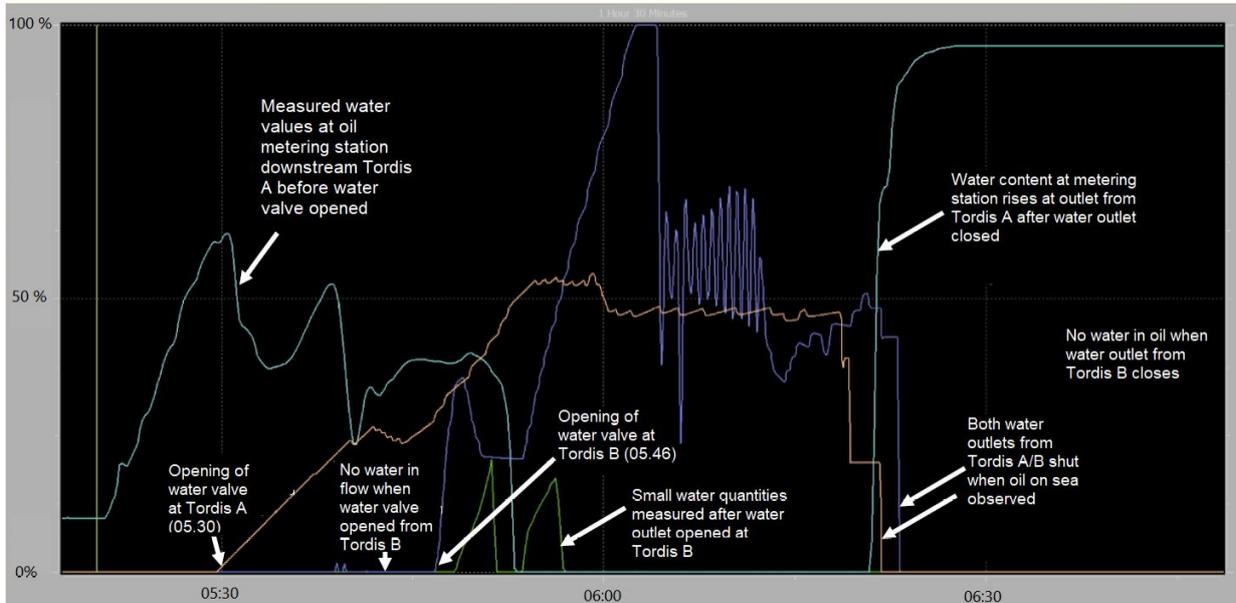
Figure 7 Trend curves for WiO from Tordis separators A & B. Source: Equinor

The figure shows that water content in the oil from separator A rose to about 90 per cent after the water outlet was closed, but that no WiO was detected from separator B after its water outlet was closed. This could indicate that water was still not being produced to the latter.

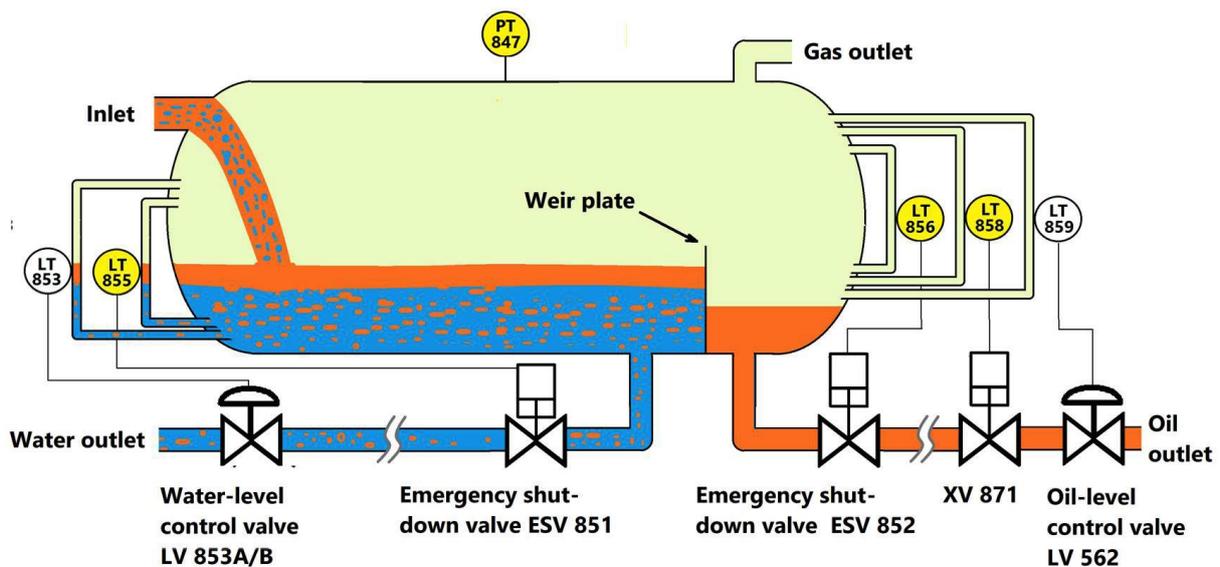
Figure 8 The position in Tordis inlet separator 20-VA06B during the incident.

The oil level sank below the measurement area of the level transmitters on the oil side when the water outlet was opened. At startup, the separators were filled with seawater. When the outlet was opened, the water level stood up to the top of the weir plate and was drained down to the desired level. This lowered the liquid level in the whole separator to the top of the weir plate. A combination of design and control inertia and leaks in the outlet valves caused the oil level to sink below the measurement area of the transmitters on the oil side.

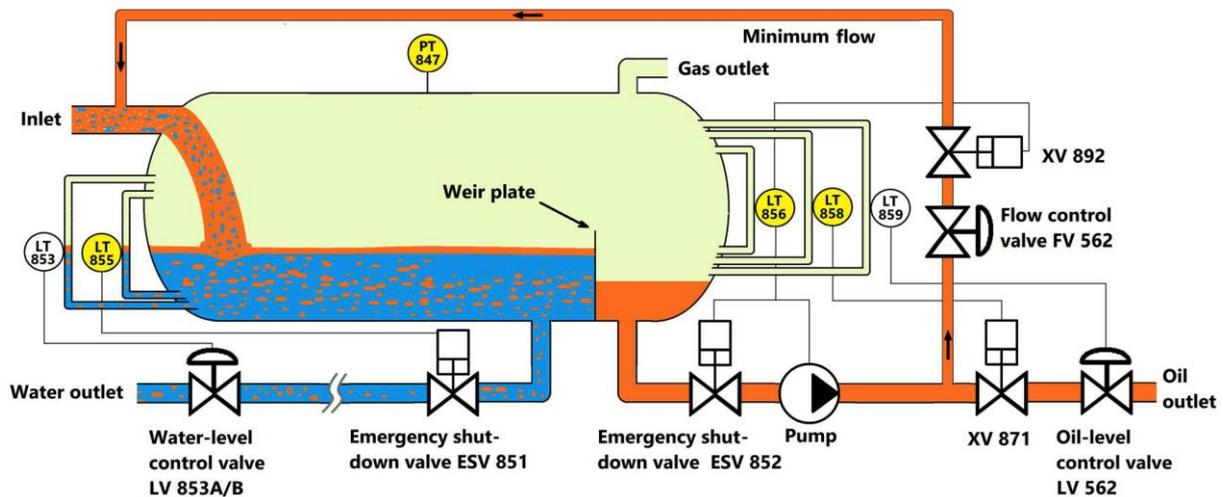
Figure 9 20-VA06B, including the pump installed on the oil outlet.

The diagram above shows the separator including the pump installed at the oil outlet. A return line is installed from the pump outlet to the separator inlet to ensure flow through the pump if the oil-level control valve closes because of a low oil level in the separator. When the water outlet was opened on the separators, the water level was higher than normal (to the top of the weir plate). The PCS thereby reduced the level. More liquid then flowed through the outlet than entered the separator, reducing the overall liquid level below the weir plate and halting oil supply to the oil side of the separator.

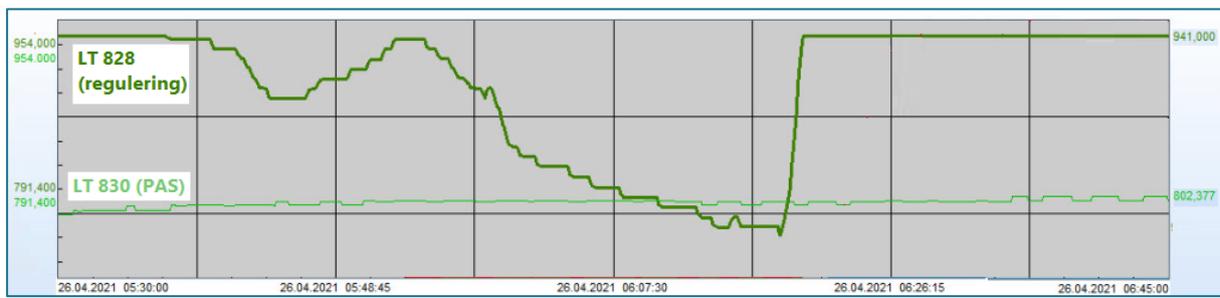
In addition to the overrides, trends show that PSD transmitter LT 830 for low water level in Tordis separator A was not working during startup. Its curve is flat in the figure below, while that for the transmitter controlling water level varies. Both devices measure the same level and should therefore have shown the same trend/variation.

Figure 10 Control and PSD transmitter for water level in Tordis separator 20-VA06A.
