# Investigation report

Report	
Report title Investigation of inadequate barriers at Hammerfest LNG	Activity number 001901039

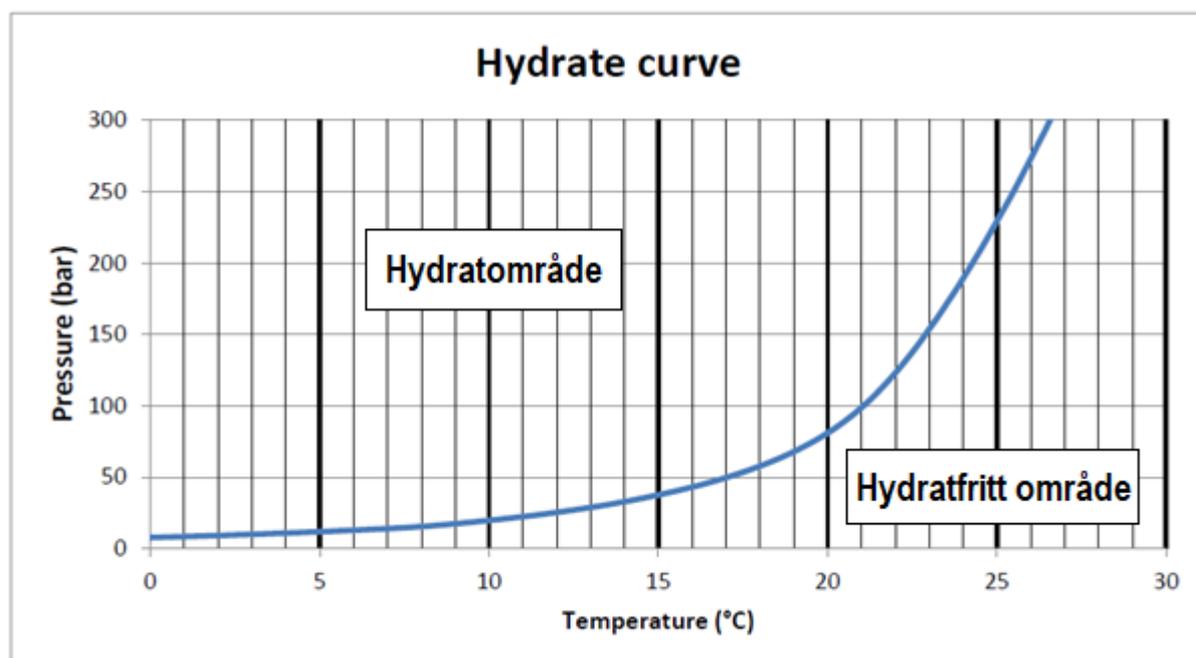
Hydrates are a form of ice which can occur in a hydrocarbon/water mix under high pressure and low temperature. The water molecules create a lattice structure which encases small hydrocarbon molecules. Hydrates primarily form with light hydrocarbons such as methane, ethane and propane. The gas crystallises in solid form as ice. At higher pressures, hydrates can form under warmer temperatures but not normally above 30°C. See Figure 1.

Figure 1: Hydrate curve. Source: Safety Critical Heat Conservation - Work Group Report 2013.

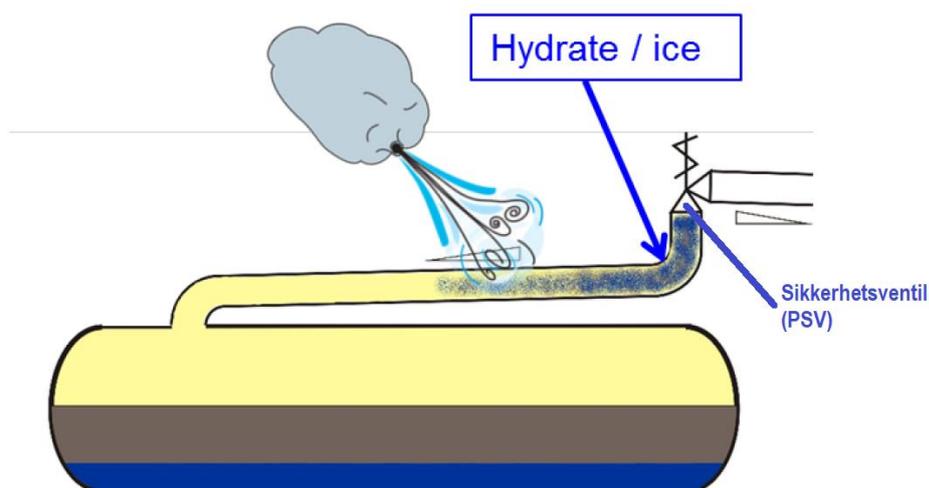
LNG primarily comprises methane and some ethane. Early in the process, the gas is also saturated with water and under varying pressures. Hydrates can form in deadlegs and parts of the process where the medium is normally stationary – such as pipes leading to PSVs and blowdown valves. If ambient temperatures fall and piping/valves lack heat conservation, these hydrates can grow and eventually cause blockages. A blocked pipe can prevent gas flow. In the event of a pressure blowdown, for example, gas will not flow past the hydrate plug to a safe area. The result could be overpressure in the process equipment which the PSV is intended to protect. Hydrates can also form in vertical piping.

Figure 2: Hydrate formation in a PSV. Source: Safety Critical Heat Conservation - Work Group Report 2013

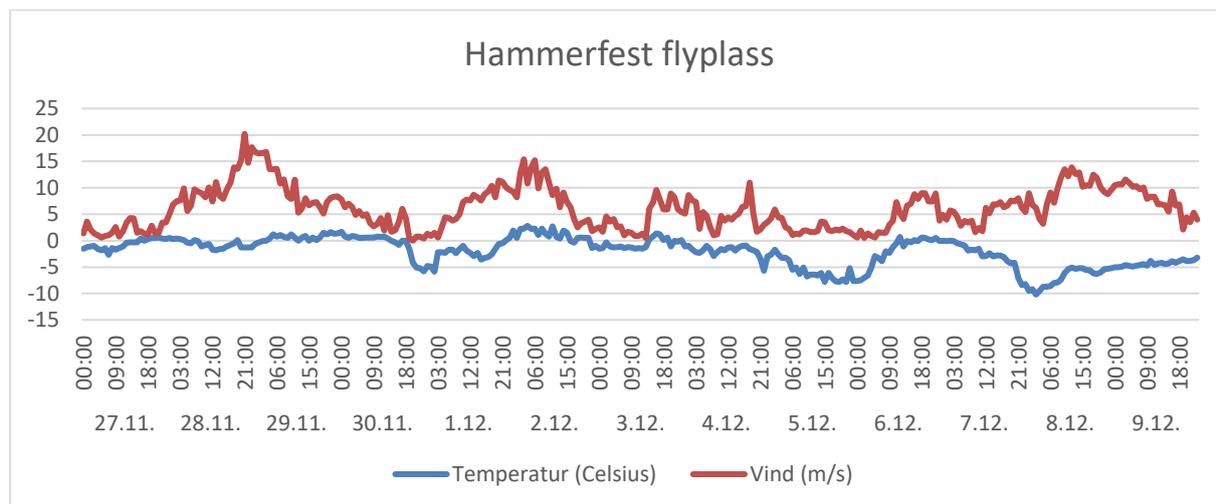
The direct cause of a potential for the PSVs to become blocked was that HT cables/insulation had not been installed to ensure that the temperature in the valves remained above the level for hydrate formation. The Melkøya plant is particularly exposed in this respect during the winter, when it faces a combination of low air temperature and wind. This combination had prevailed for a period when hydrate plugs were discovered in December 2018. See Figure 3 below.

Figure 3: Measured temperature and wind in Nov/Dec 2017 – Hammerfest airport observation station

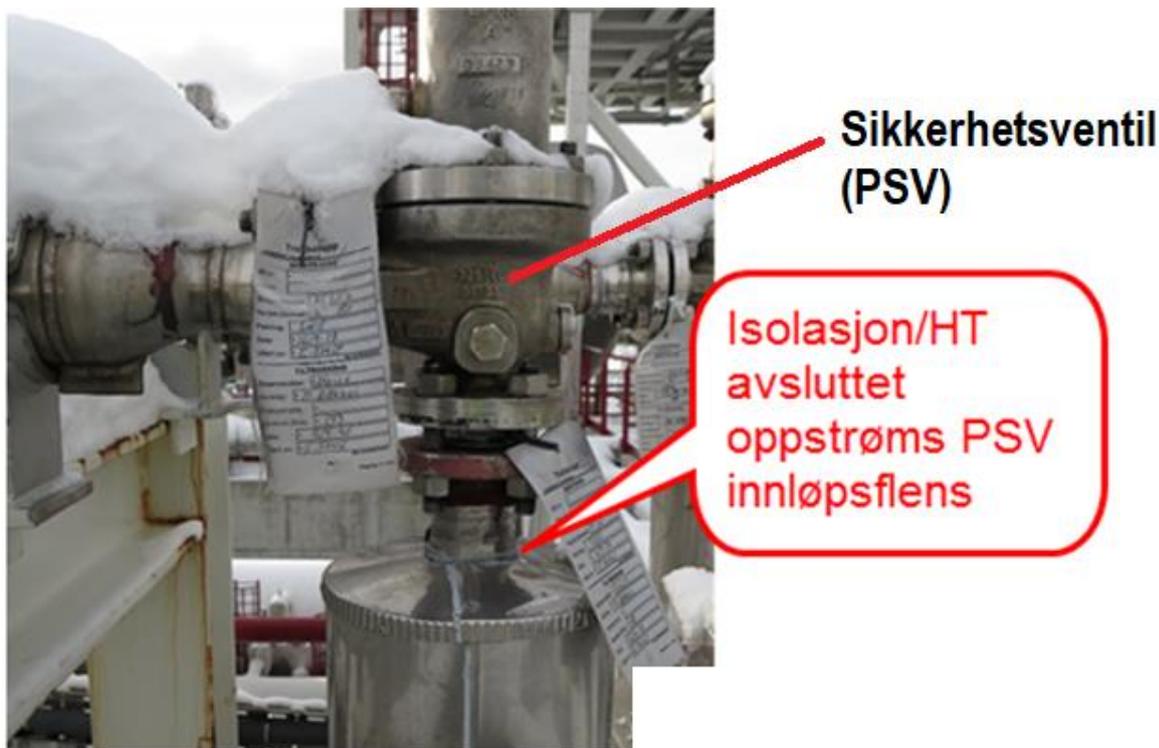
The plant was largely designed without insulation and HT cables on the PSVs. However, the piping leading to the PSVs does have this protection. See the photograph below.

Figure 4: PSV layout with insulation and HT cable. Source: Safety alert HLNG, 11 March 2019.  
 Key: Isolation/HT terminated upstream of the PSV inlet flange.

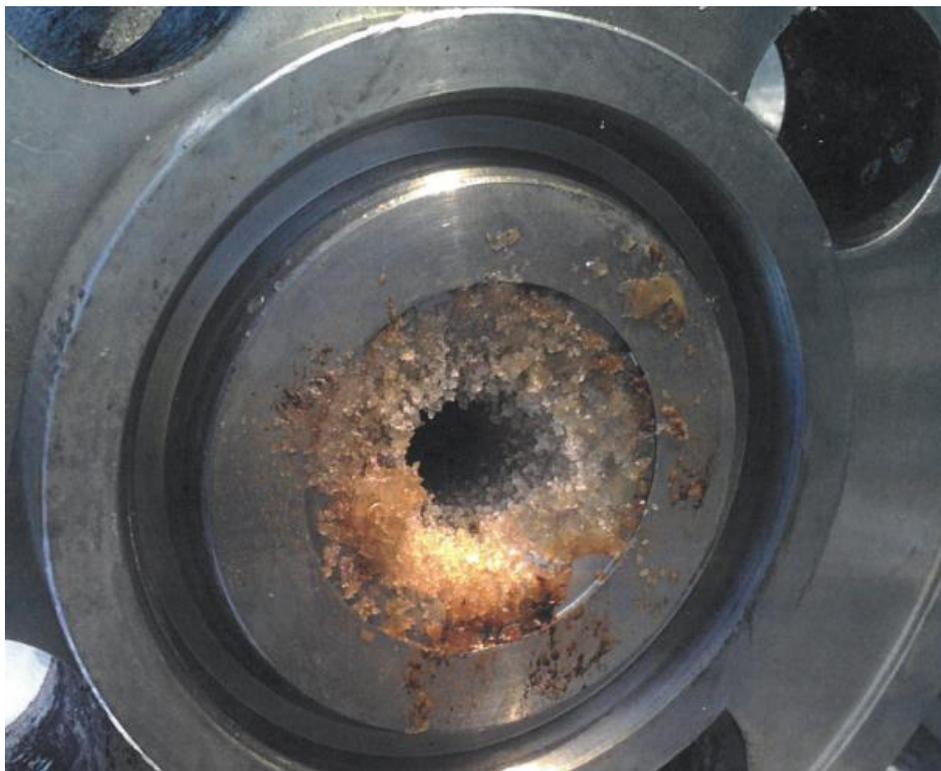
The PSVs are not normally used actively in a process plant. They must open to prevent overpressure if all other barriers have failed. As a result, hydrates in them will not be noticed in normal operation. The exception is when the valves are removed for recertification or testing. HLNG's practice has been that the PSV mechanic removes them after they have been isolated and blown down by the process operators. Since hydrates melt at low pressure, they could have been present in the PSVs without this being noticed because they melted before the PSV mechanics got around to removing the valves.

The photograph below shows hydrate/ice discovered in a PSV at HLNG.

*Figure 5: Example 1: Hydrate/ice in a PSV inlet. Source: HLNG*

HLNG has now changed its practice so that the process operators themselves remove PSVs weighing less than 25 kilograms. The time between isolation/blowdown of the valves and their removal will therefore generally be shorter. The team was informed that hydrates were twice discovered in PSVs by the process operators, on 9 March and 2 April 2018 respectively. In the first instance, the operators asked for a camera to be sent down to photograph the hydrates, but these melted quickly before it could arrive. With the second case, the hydrates were so extensive that they blocked the whole PSV inlet. Hydrates in PSVs can therefore have been an extensive problem at HLNG for a number of years without being identified. Those discovered in a PSV in December 2017 could have been more extensive and partly melted before the PSV was removed.
