# Investigation report

Report	
Report title Investigation report Visund - well-control incident in well 34/8-A-20 AH, 16.3.2016	Activity number 001120023

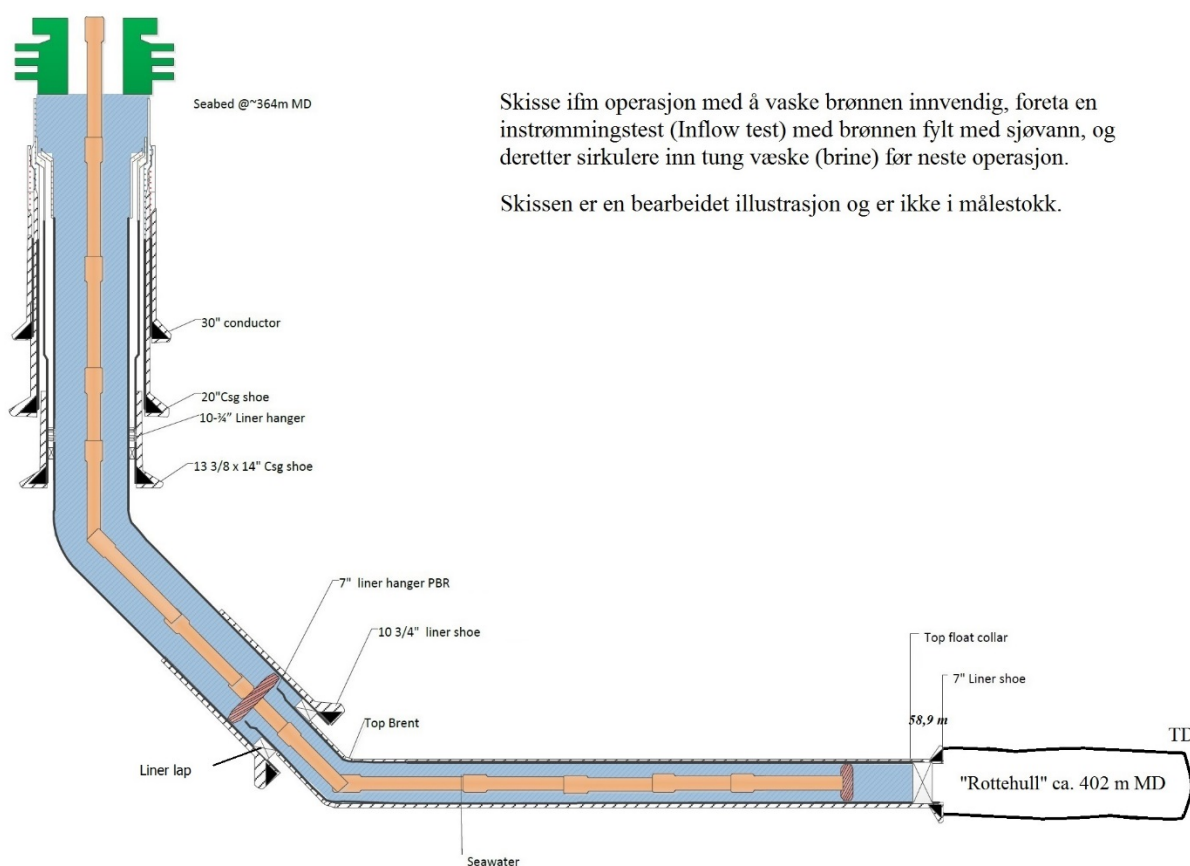
Figure 2 Statoil's diagram of the well as it was when the incident occurred on 16 March.

Figure 2 below shows a diagram (originally from Statoil) of the well with the wash string in it, as it was when the well-control incident occurred. The well was filled with sea water.

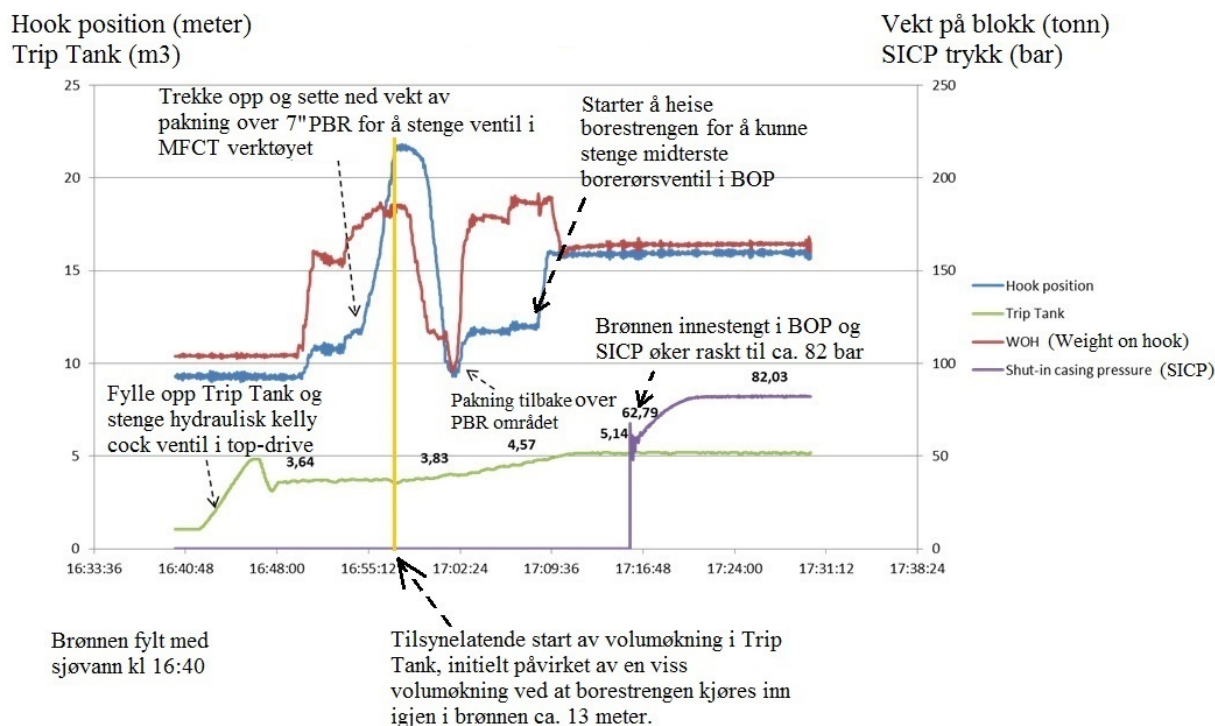
Figure 3 shows selected drill data from the time when the incident was discovered and the well shut in with a pipe ram in the BOP

During the last of these operations and immediately afterwards, the level gauge in the trip tank showed an increase in volume (green curve in the figure). This was detected at around the same time by a driller and assistant toolpusher on the drillfloor, while the drilling supervisor and toolpusher observed an increase on their screens showing realtime drilling data. The mud logger also observed the increase (from realtime drilling data onshore) and called up the driller on the facility. The driller and assistant toolpusher decided to move the drill string to the desired position and close the upper pipe ram in the BOP to shut the well. The hydraulic kelly cock valve below the top drive was already closed. The well was shut in at approx. 17:15 and a rising pressure was observed at the choke manifold, increasing from around 62 bar to 82 bar in the course of a few minutes, with a measured increase in volume (inflow) at the trip tank of 1.4 m<sup>3</sup>. SICP pressure subsequently stabilised at around 84 bar.

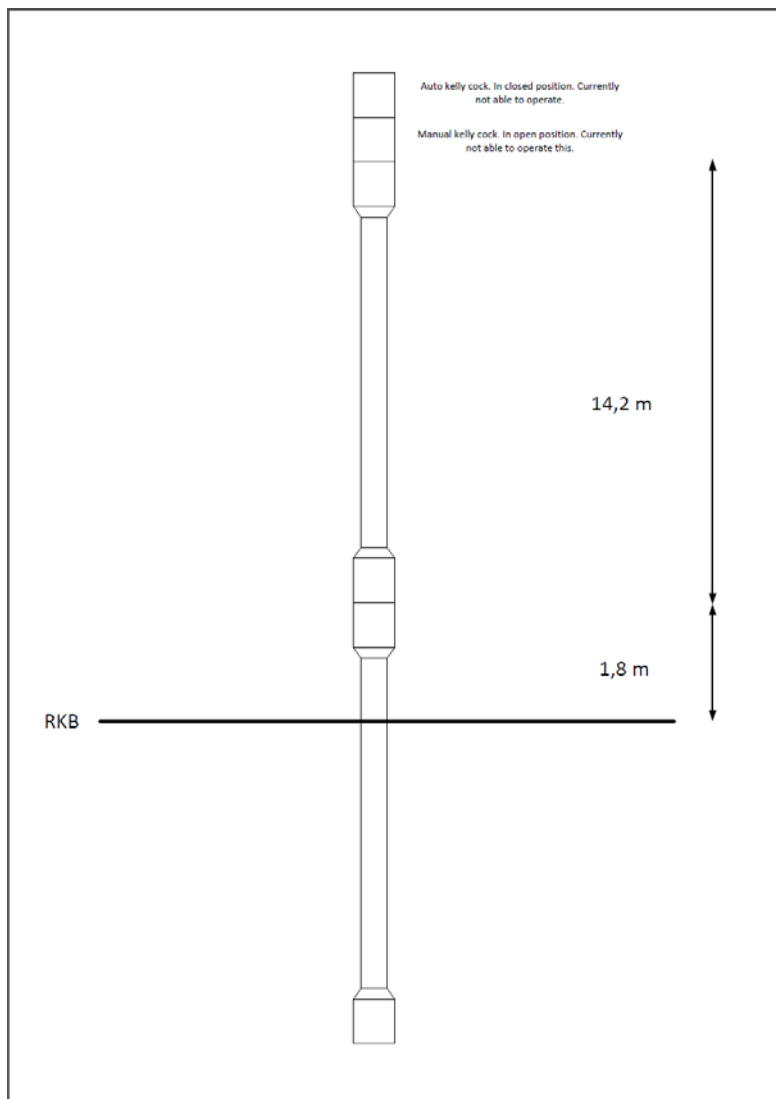
Figure 4 Diagram illustrating the height of the section of drill string above the drillfloor immediately after the incident

After the pressures and volumes were evaluated, an attempt was made to open the hydraulic (auto) kelly cock valves below the top drive in order to circulate out the inflow in accordance with standard well kill procedures, but the valve could not be opened. A person was hoisted up in a harness to close the manual kelly cock valve in the top drive using a long spanner, but it too was jammed.

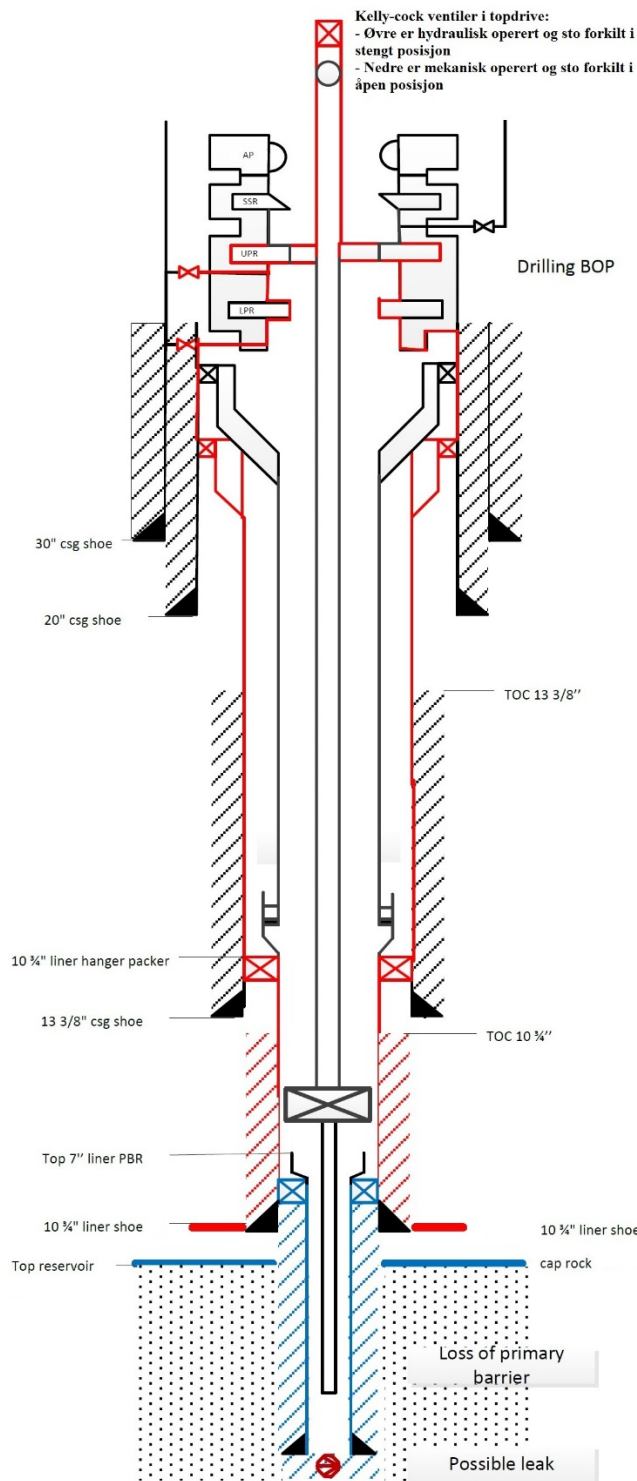
Figure 5 Barrier diagram once the incident has been ascertained and the well shut in with BOP and fixed/jammed kelly cock valve

Figure 5 below illustrates the barriers for the incident, where red secondary barriers have been activated because a breach has occurred in the blue primary barrier (failure in the inflow-tested liner). The failure in the primary barrier was assumed to be at bottom (inflow-tested cemented liner shoe).

The situation involving inflow into the well, which could not be handled by standard well-control procedures due to jammed kelly cock valves, was assessed as critical.

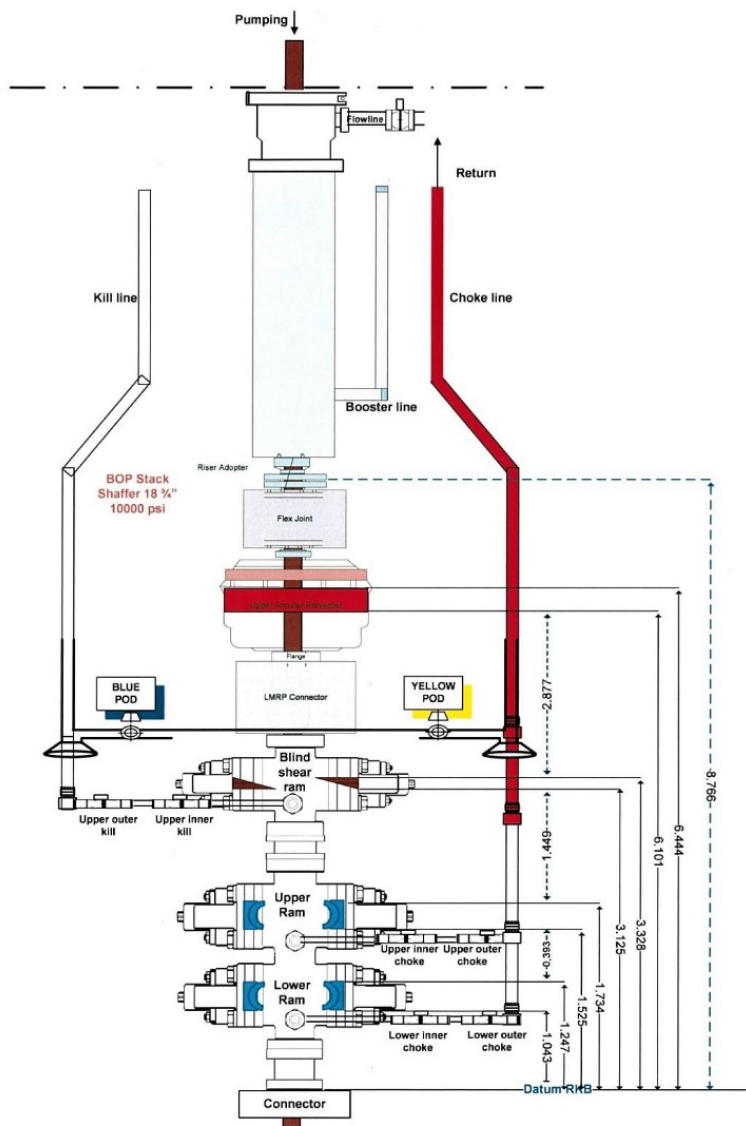
Figure 6 Diagram of Visund BOP on the sea bed, with kill & choke lines

No personal injuries, material damage or emissions to the external environment were recorded as a result of inflow into the well. The inflow was stopped by the BOP upper pipe ram being closed (see Figure 6) and the hydraulic kelly cock valve below the top drive being closed at the time of inflow.

In the event of a possible decoupling of the Lower Marine Riser Package (LMRP) while shut in (e.g. weather conditions), or the well being exposed to loads (pressures) it was not tested for, it would have been necessary to activate the shear valve in the BOP.

Before shutting in the well using the upper pipe ram, the drill string was positioned so that the tooljoint was 4-5 m above the BOP shear valve. It was not assessed whether to hang-off a tooljoint in the upper pipe ram after this was closed.
