Investigation report

Report	
Report title Report of the investigation into a hydrocarbon leak of 26 January 2014 on Statfjord C	Activity number 001037023

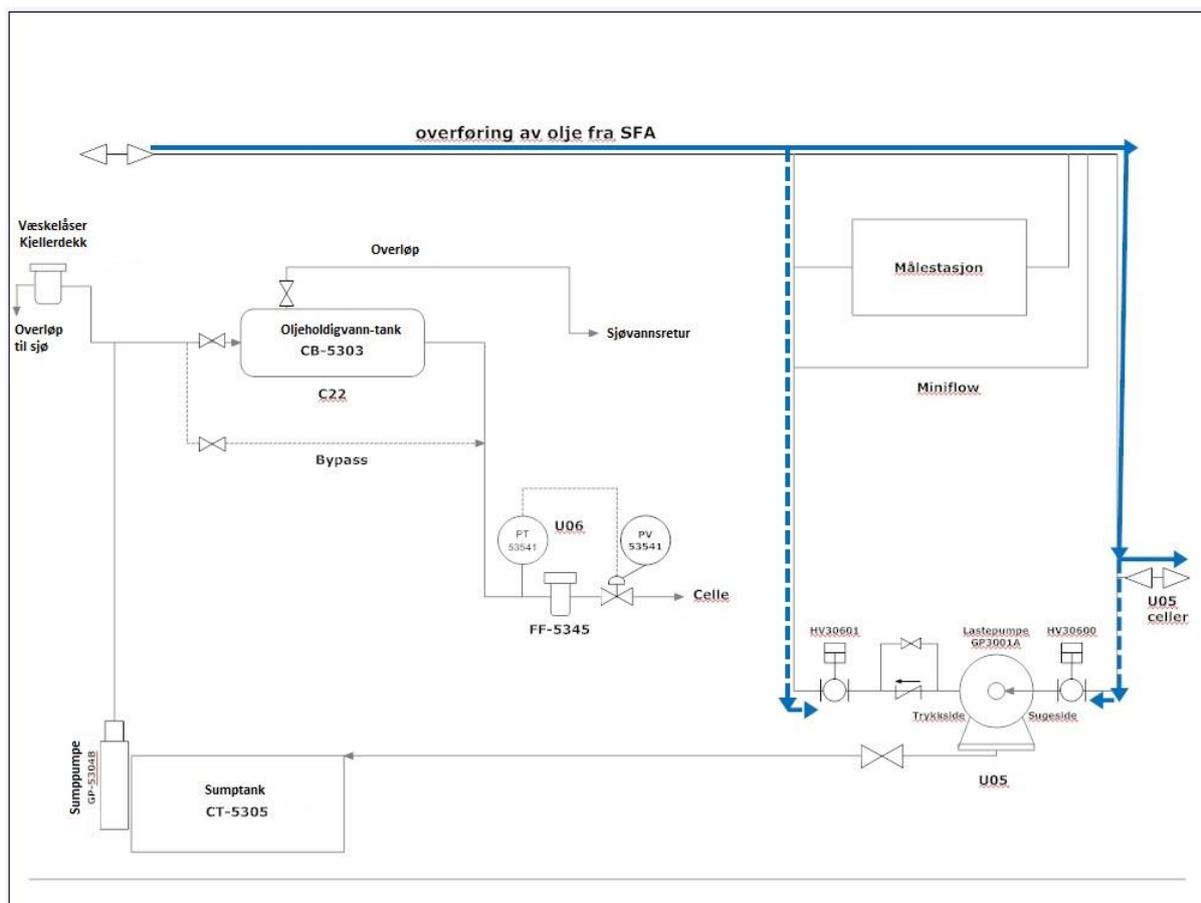
Loading pump A had been isolated about a day earlier for maintenance. An isolation valve (HV30601) for the loading pump sprang a leak, which caused oil to fill the pump house. This oil was drained to the sump tank in the shaft. When the level in the sump tank reached 70 per cent, the pump for transferring liquid in the sump tank to the oily water tank beneath the cellar deck started up automatically. The valve controlling the level in the oily water tank failed to open, and oil escaped via fire seals on the cellar deck. See the simplified diagram (figure 2) for an overview of the drainage system and loading pump components involved.

Figure 2. Simplified diagram.

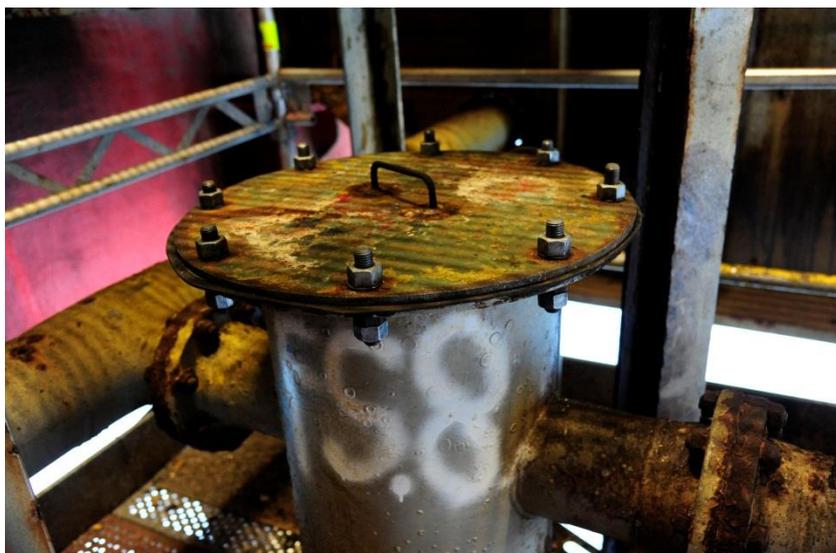
It has been established that the leak occurred through the overflows from several fire seals beneath the cellar deck. Fire seal FS8 sprang a leak through a defective gasket in its cover (see figure 3). The overflow on FS8 was blocked by a welding rag. A possible leak to the sea via the overflow in the open drainage system (seawater return line) cannot be excluded.

Figure 3. Photograph of fire seal FS8.

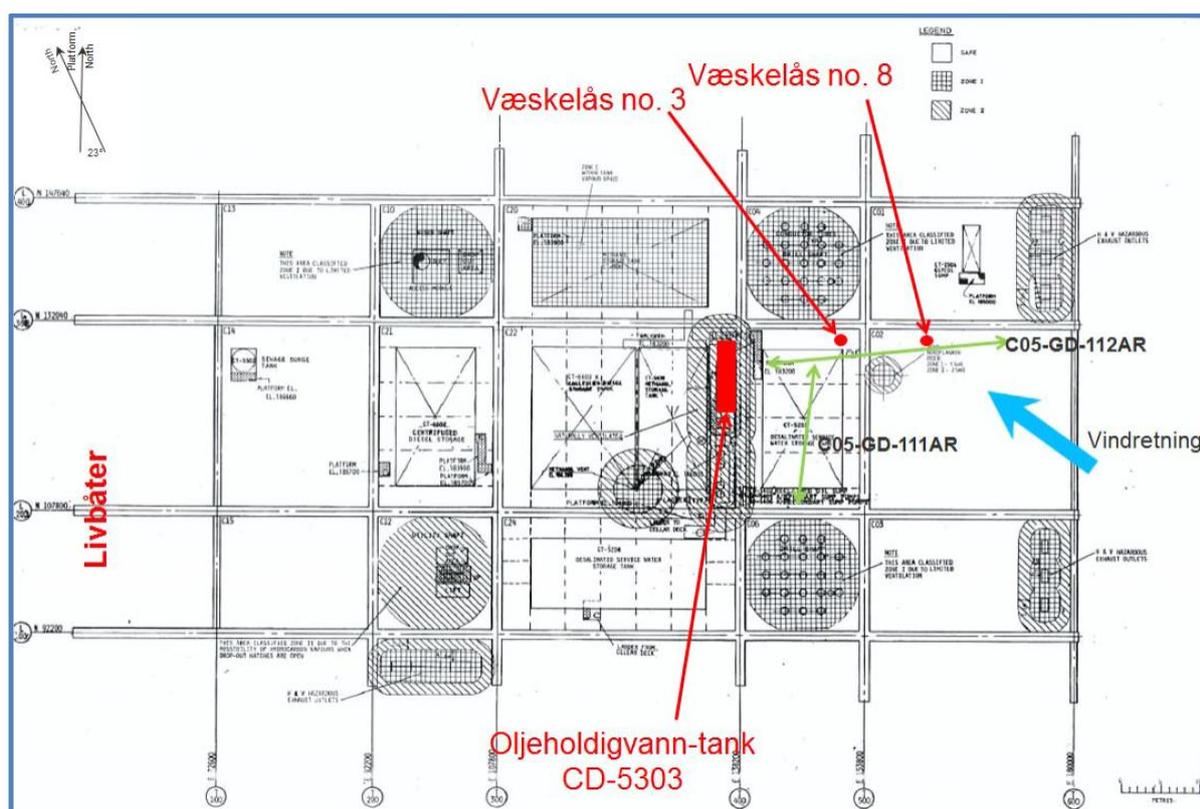
Figure 4. Layout diagram showing the position of line detector C05-GD-112AR. (Source: Statoil's investigation report /23/)

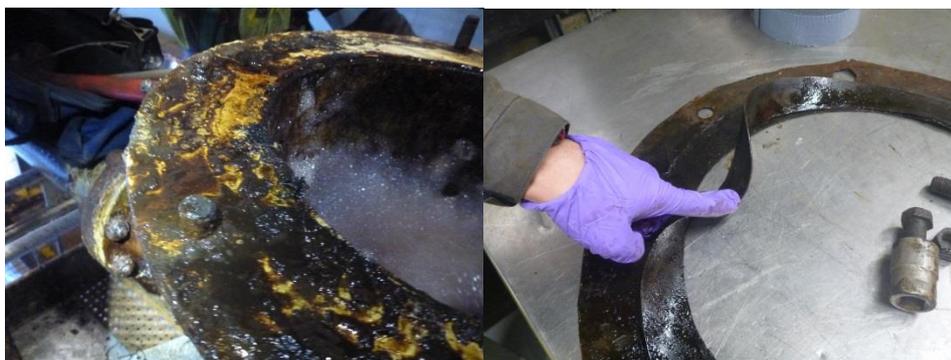
Inspection and interviews revealed that the contractor responsible for maintenance of fire seals had inadequate technical expertise. The cover of fire seal FS8 was installed with partly missing and defective bolts, a double set of gaskets, and strain washers between the gaskets. See figure 5. In the wake of the incident, Statoil's investigation team commissioned inspections of three fire seals and found that all had faulty gaskets and bolts /23/.

Figure 5. FS8 – inadequate and defective bolts and a double set of gaskets in the cover, in addition to strain washers between the gaskets.
