# Investigation report

Report	
Report title Nyhamna - Investigation following incidents involving falling objects	Activity number 005921020

Based on the many incidents of falling objects reported to the Petroleum Safety Authority Norway in 2015, it was decided to undertake an investigation of the follow-up of these by A/S Norske Shell and the contractors. Our investigation emphasised the companies' own follow-up of the incidents in relation to established governing documents in the project. The investigation at the facility was performed from 9 to 11 November 2015. In the main, the impression is that Shell and its contractors have performed good investigations of the individual incidents. No non-conformities with the regulations were identified in connection with our investigation. We did however detect some improvement points as shown in chapter 6. These relate primarily to deficient requirements in the governing documents.

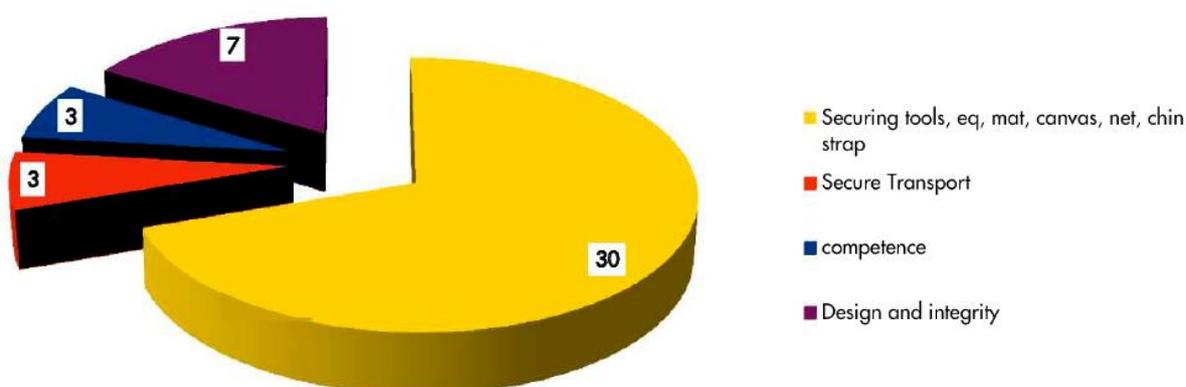
Figure 13 Barriers that could have prevented the 43 falling objects

This group was to clarify and strengthen the framework for working at heights at Nyhamna. The procedure for working at heights was to be revised as part of this activity. Part of the group's mandate was to review all recorded falling objects at Nyhamna, Stord and Verdal. The group decided to analyse 43 falling objects at Nyhamna since 2010 with a view to identifying common causes and possible measures for preventing similar incidents in the future.

The group has put forward several recommended measures for barriers in order to prevent falling objects and recommends that at least two barriers are established in order to prevent falling objects. A best practice document has also been prepared with a visualisation of what the **two barrier principle** means in practice. Examples of some of these measures are the use of hardhats with chinstraps, the securing of radios and loose tools, barrier covering to be used on gratings where many tools, parts and pieces of equipment are present. Blue cloth is to be used to ensure that objects do not fall through openings in railings.

At the time of our investigation at Nyhamna, the procedure for working at height had not been updated but these recommendations have now been implemented in Shell's procedure for working at height.

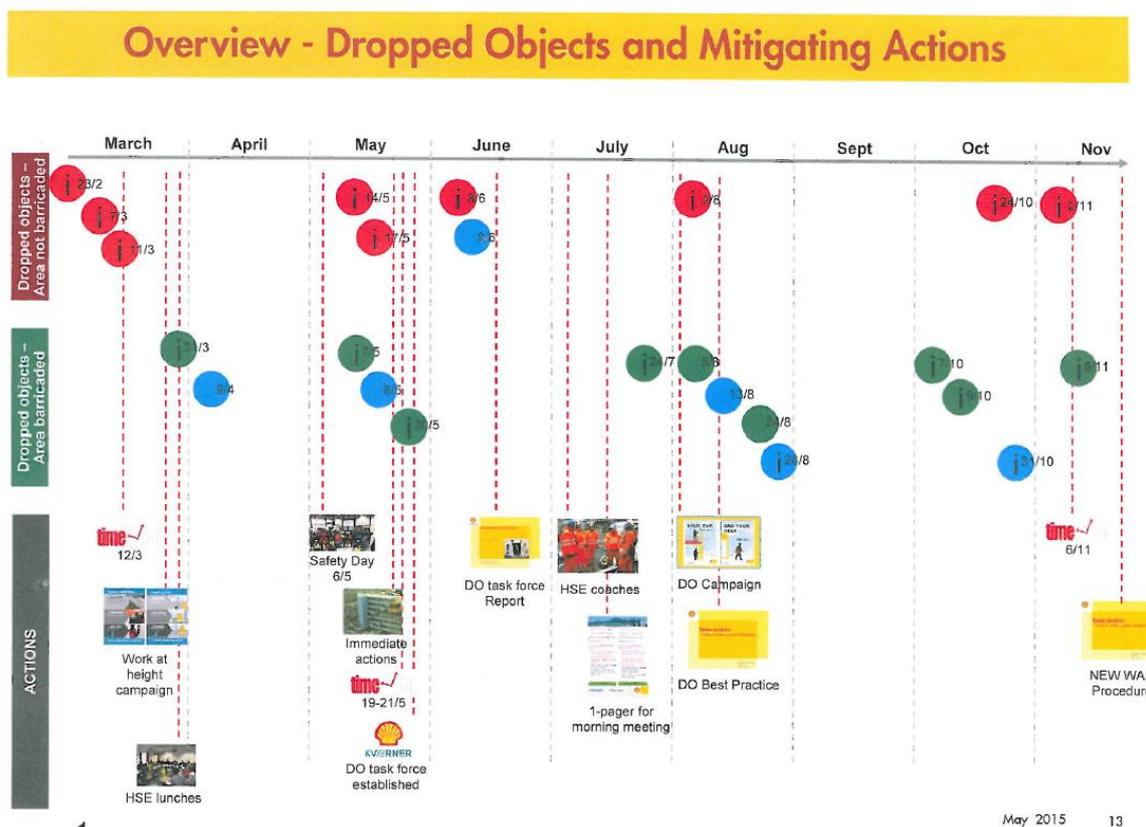
1  
Figure 14 Overview of falling objects and measures at Shell

Below is a figure that was presented by Shell. It shows the individual incidents in a time axis with Shell's colour coding for each incident. The risk potential of the incidents in the figure is represented by dark blue, green and red circle at the top of the figure. Implemented preventive actions are shown at the bottom of the figure.
