# Investigation report

Report title Investigation of an incident involving a dropped object on the Heidrun TLP, 22 September 2015	Activity number 001124022
---	------------------------------

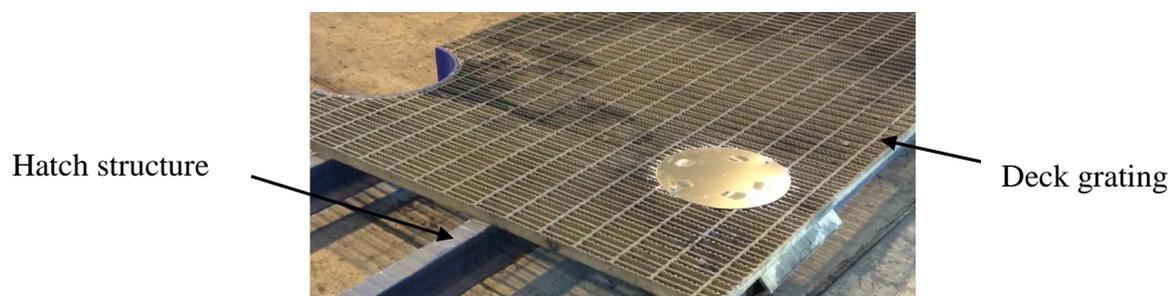
Photograph 4 Deck grating on hatch structure (source: user manual).

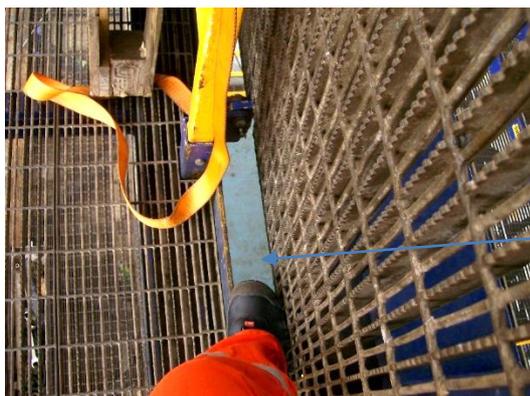
Gap between deck and hatch

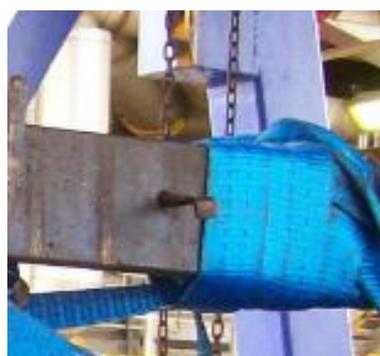
Photograph 9 *Deformed deck grating fastener where the grating came loose.*

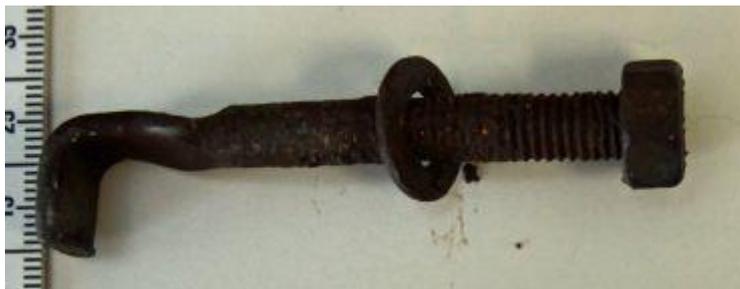
Photograph 10 *Deformed J hook for the deck grating, with bolt and spring washer disassembled from the hatch where the deck grating came loose.*

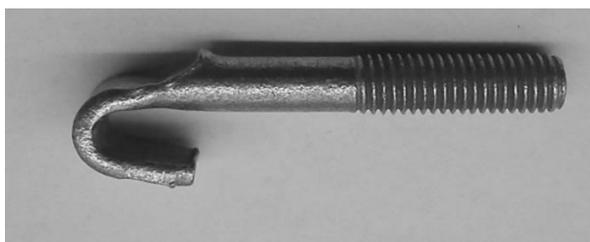
Photograph 11 *A new fastener of the J hook type for a deck grating, as it originally looked when the BIT was manufactured for the Heidrun TLP. (Source: Kongshavn Industri)*

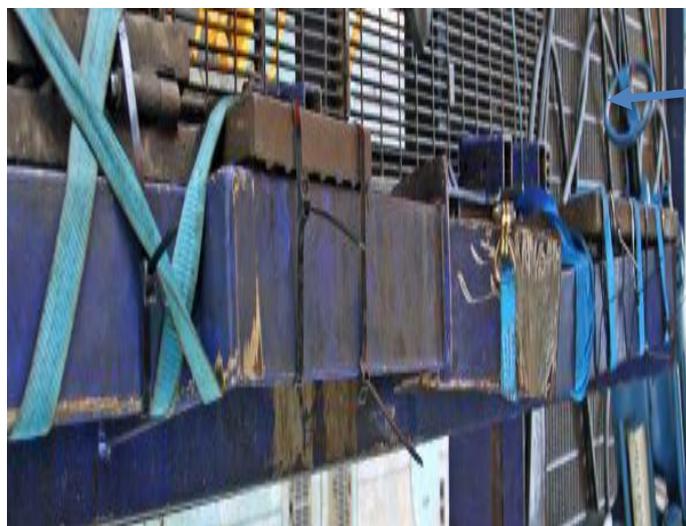
Damaged/deformed deck hatch structure

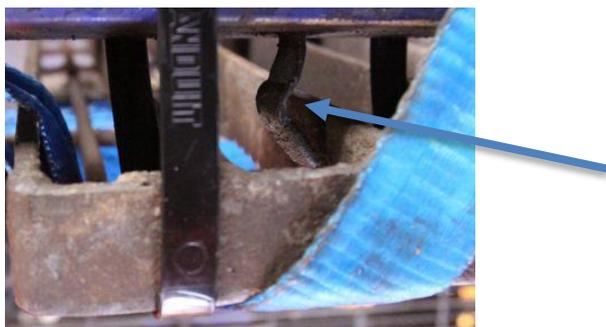
Deformed and loosened J hook fastener for remaining gratings on the hatch arm where the structural deformation was greatest

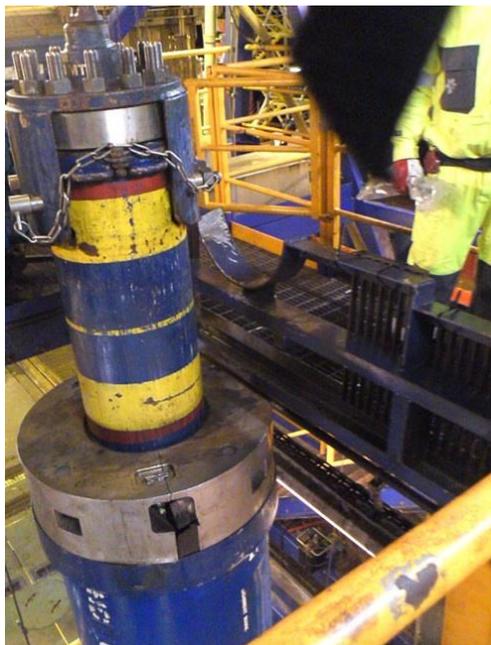
Photograph 14 Taken after the incident, this shows the position of the heave compensator in relation to the relevant hatch arm on the BIT BOP deck where the grating came loose. (Source: Statoil)

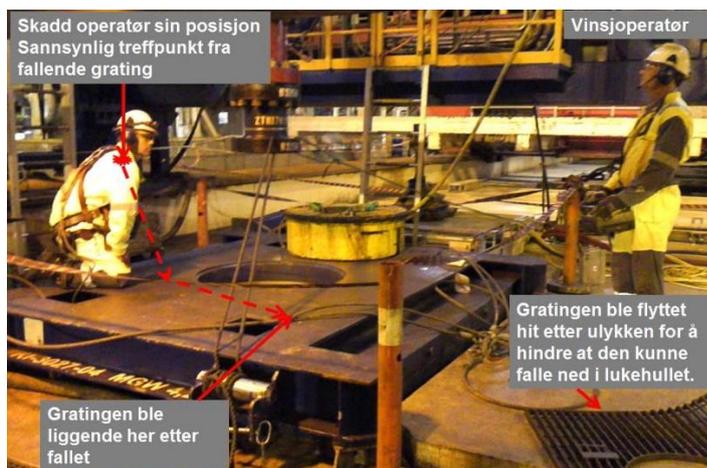
Photograph 15 A reconstruction showing where the people on the hatch deck were placed when the grating landed. (Source: Statoil)

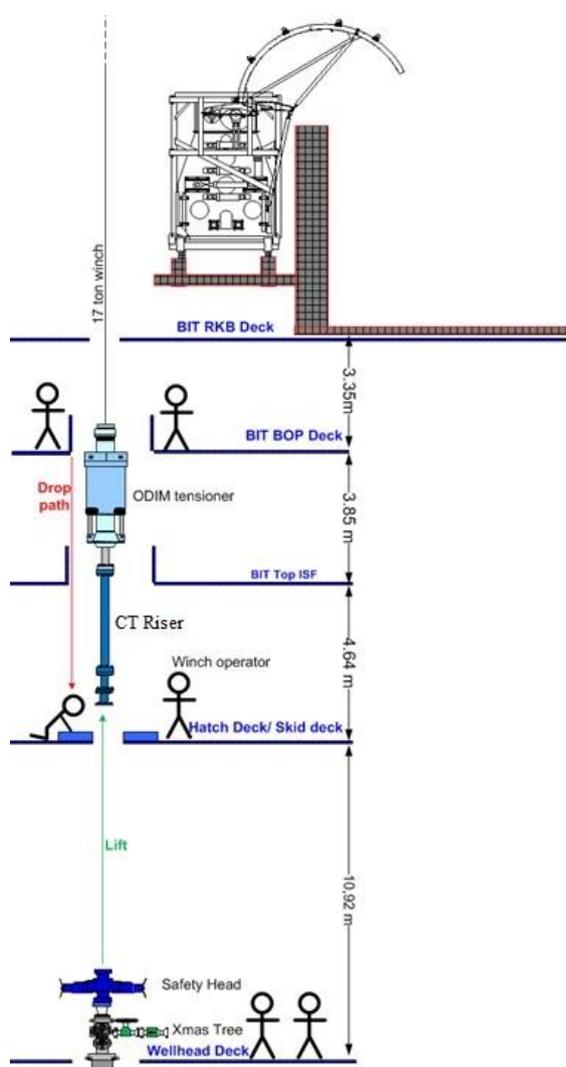
Figure 1 Agreed and actual location for lifting the Odim heave compensator with riser section suspended beneath – indicated in the figure as “CT Riser”. (Source: Statoil)

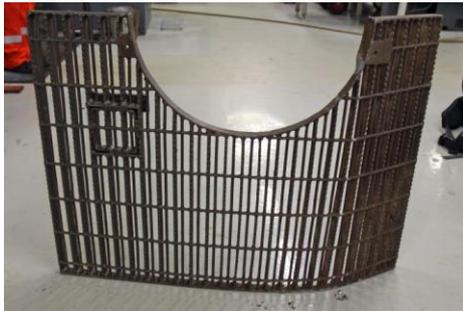
Photograph 16 *Damaged deck grating plate.*

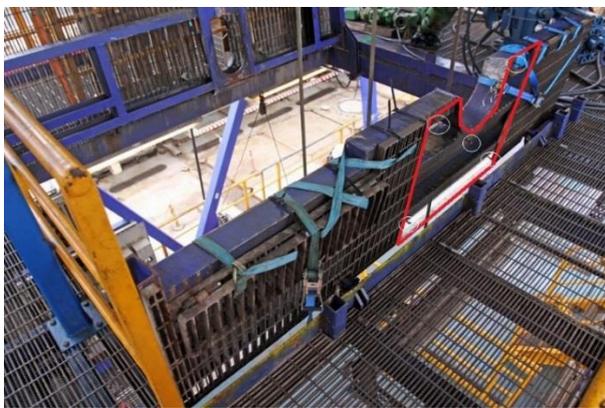
Photograph 17 *Position of the grating which fell.*
