ODA FLEXIBLE WATER INJECTION PIPELINE EXPERIENCE

Ullandhaug

4/12 - 2019

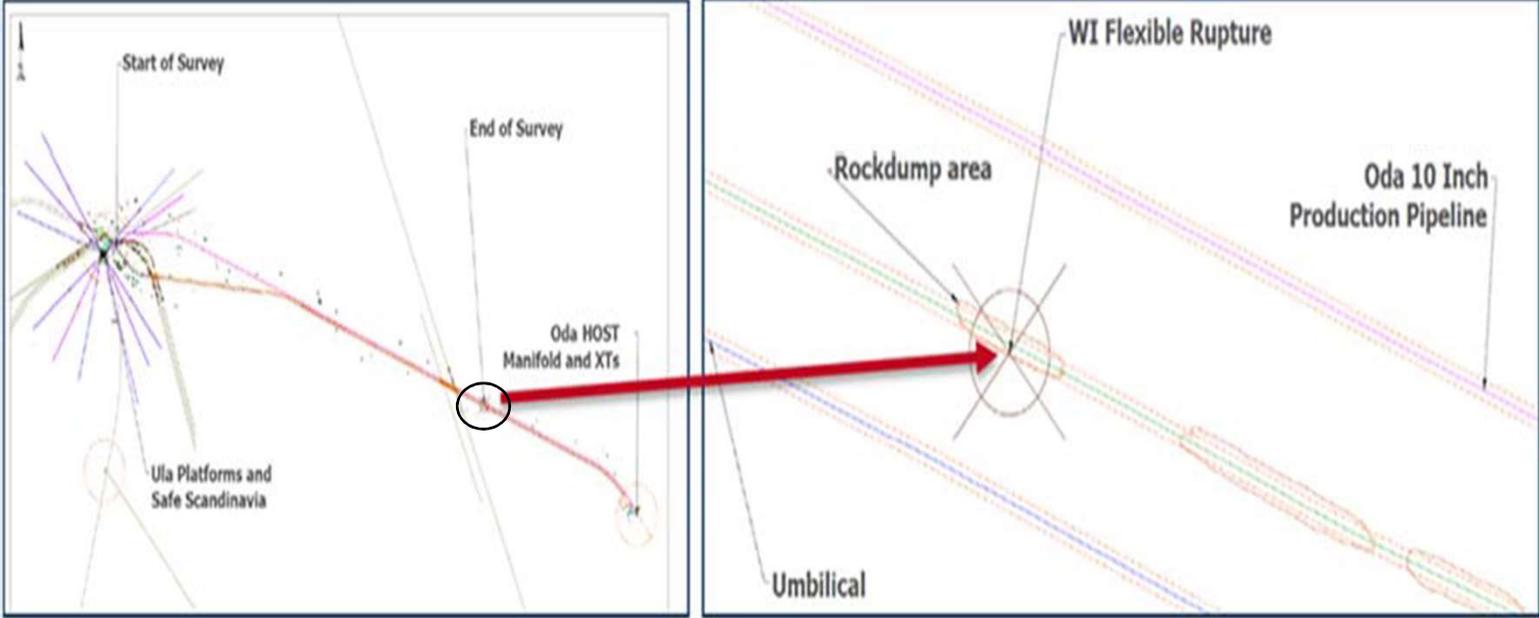
22.01.2019 @20:40 Visual inspection WI pipeline KP 9.811

- During system strength testing of the water injection flexible pipeline from Ula platform to the Oda manifold 21.01.19, an abrupt drop in pressure was noted from 312 barg to 0.5 barg in a few seconds
- At this point 16.8m³ of water had been pumped into the pipeline in addition to the pre-flooded volume. Pressure loss occurred at ~85% of design pressure.
- For reference and clarity:
 - Design Pressure – 365 Bar G
 - Strength Test Pressure – 474 Bar G (1.3 x design - completed successfully during FAT at factory)
 - Target System Strength Test Pressure – 401 Bar G (1.1 x design)

- Impossible to repair failed flexible pipeline -> installation of new WI pipeline found to be the preferred option.
- Delayed pressure support into Oda reservoir resulted in curtailment of oil production

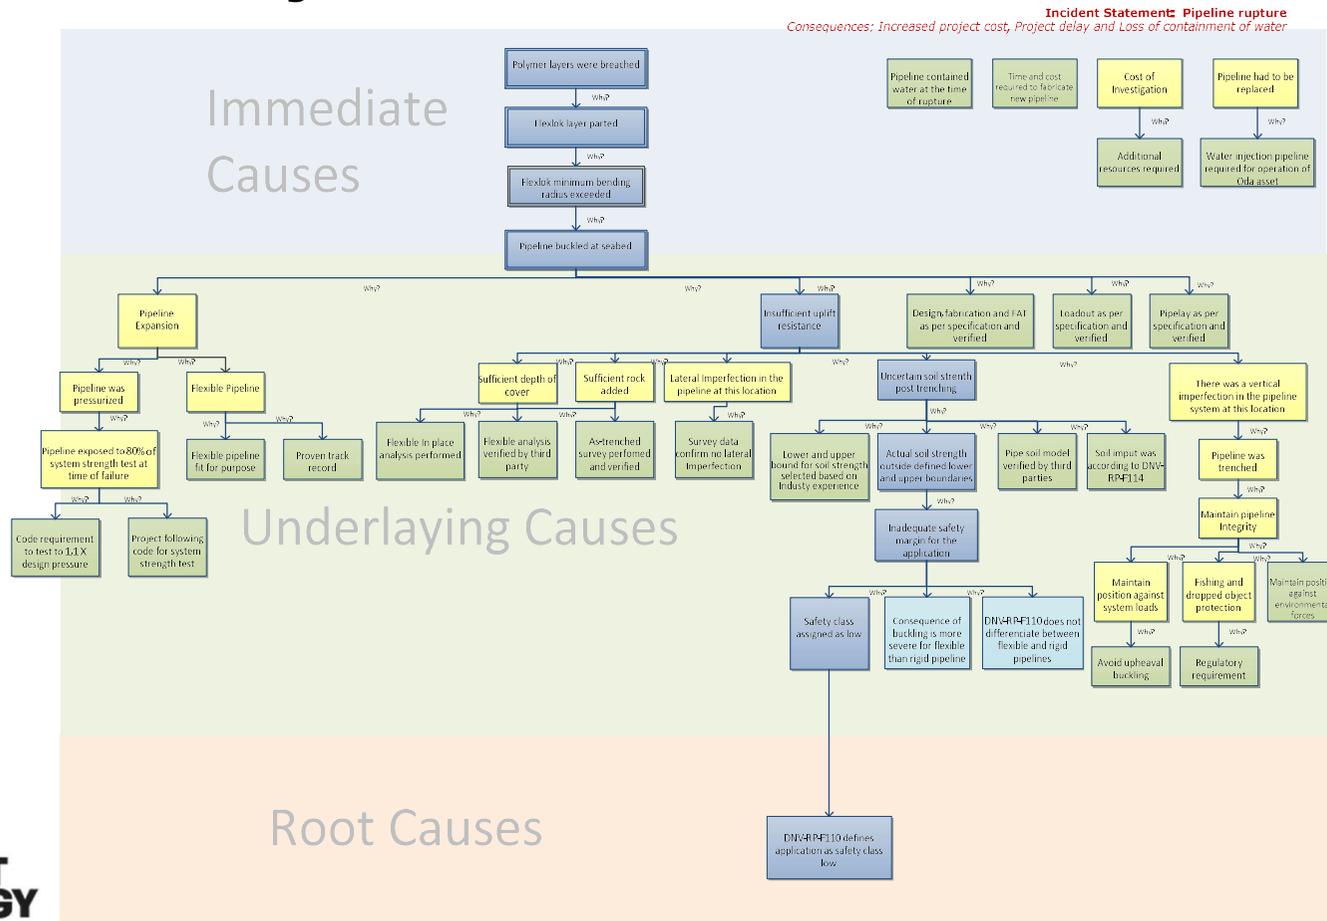
Root Cause Analysis

- The investigation found no evidence of a manufacturing defect or pre-existing damage from installation
- The rupture and loss of containment was caused entirely by the buckling of the pipeline
- The investigation found that the pipeline (including trenching, backfill and SRI parameters) was designed in accordance with accepted industry practice and relevant Codes and that the parameters associated with those standards were met offshore

- Insufficient uplift resistance
- Insufficient soil cover strength and an inadequate safety margin
- The safety factors applied to the parameters (set within the Code) are marginal for this particular case (a WI pipeline during system strength testing)

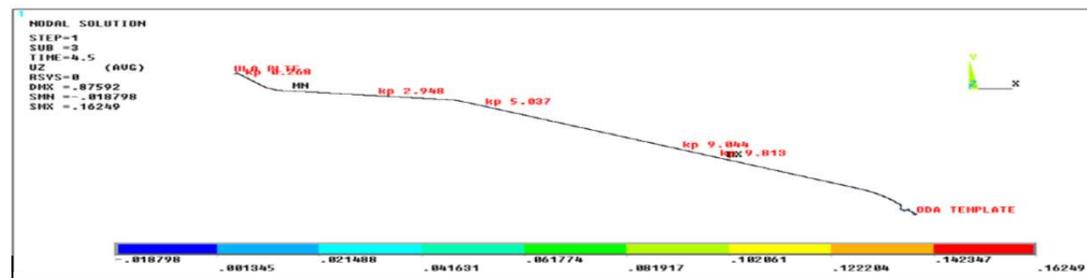
UHB sensitivity analysis – post incident

- As part of the investigation Spirit Energy has verified through independent models that there is no reason not to trust the FE models used for UHB.
- Sensitivity analysis with substantially weakened soil, the Oda WI flexible will fail first at the kp 9.814 which corresponds to the actual failure location

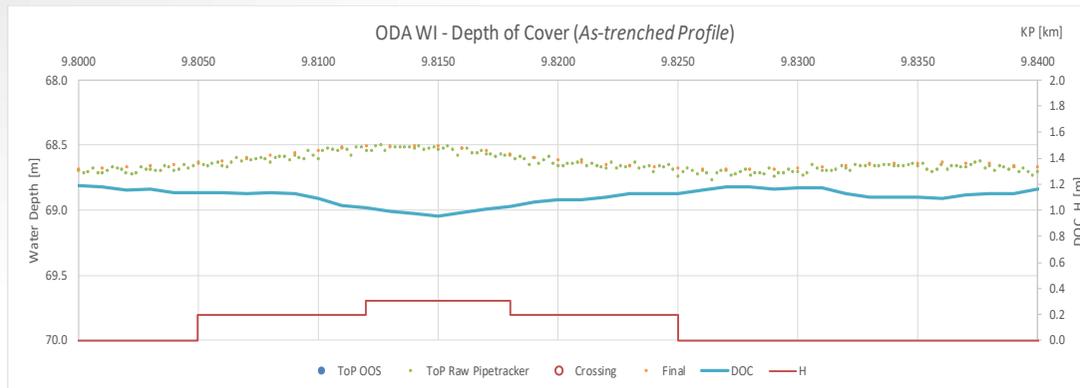
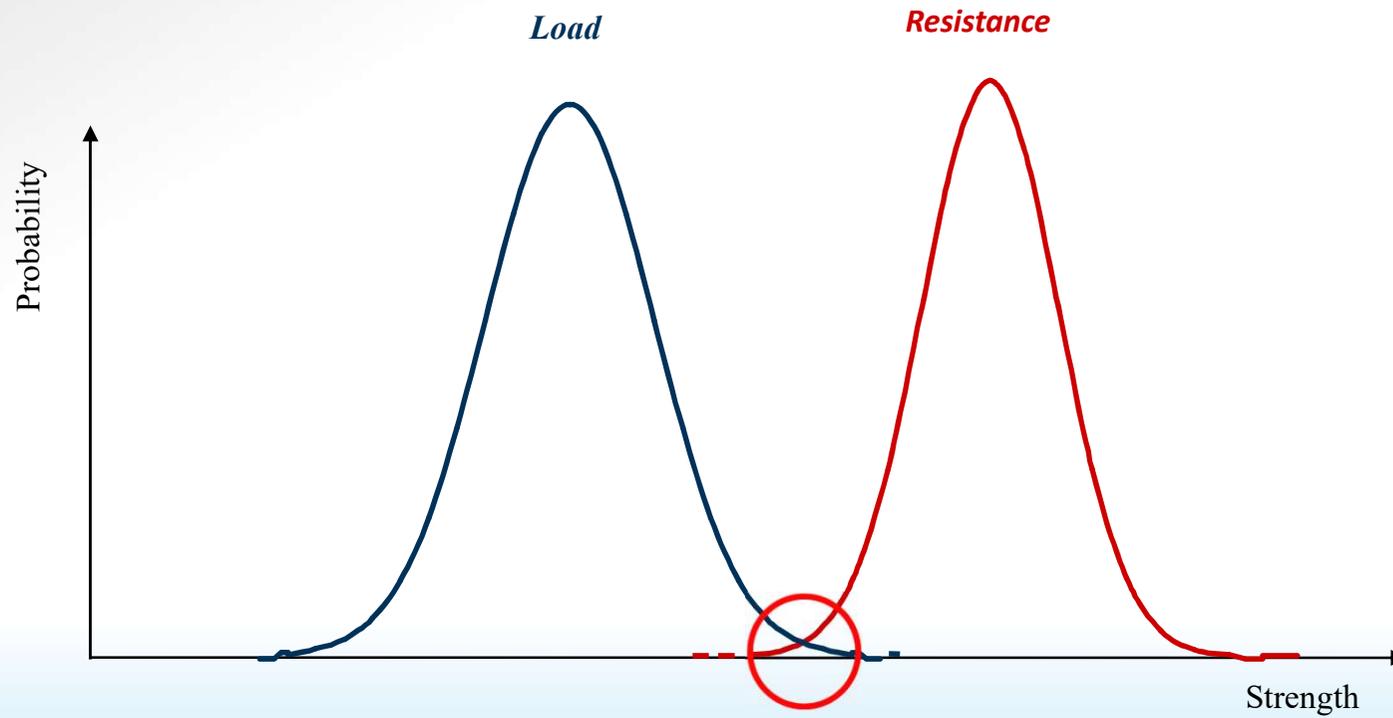
- Pipe profile, depth of backfill cover and SRI

- As per design, the cover requirement was 1.2m ToP (0.9m soil backfill + 0.3m Spot Rock Dump) – Design according to DNVGL RP-F110
- The actual soil backfill cover was 1.08m (average) with an additional ~0.4-0.5m of spot rock dump
- *But the pipeline still failed – why?*
- *The failure was detrimental !*

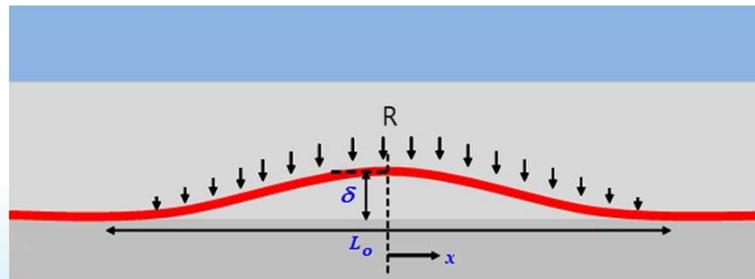
- Pipe axial stiffness and associated axial force
- Pipe bending stiffness
- For a flexible pipe, a larger portion of the resistance is from the soil, compared to a rigid pipe, where the bending stiffness provides a significant contribution. As the soil uplift resistance is one of the main uncertainties (see above), there is a larger uncertainty in the overall resistance for a flexible pipeline than a rigid pipeline.

Pipe type	Required Uplift Resistance (N/m)		Ratio
	<i>B-stiffness 100%</i>	<i>B-stiffness 60%</i>	
Rigid pipe	3160	7150	1,26
Flexible pipe	2680	5010	0,87

- A comprehensive review of the UHB design requirements applicable to flexible flowlines should be performed (specifically relating to the differences when compared to a rigid pipe applications). In the meantime, there are two main recommendations that should be noted:
 - Since the **consequence of upheaval buckling** evidently can be detrimental to a flexible flowline, a higher safety class (i.e. lower failure probability) should be evaluated for future installations.
 - The design against UHB for a flexible pipe has additional uncertainties compared to the rigid pipe. In addition, as the UHB resistance for a flexible flowline is more dependent on the soil than for a rigid flowline (less contribution from the pipe bending stiffness), the total uncertainty increases. An increased safety margin should be considered for future designs.
