Investigation report

Report	
Report title	Activity number
Report of the investigation of an incident with a ram door blown off a BOP during a connection test on <i>Rowan Stavanger</i> 14 September 2020	Equinor (001025023) Valaris (414002011)

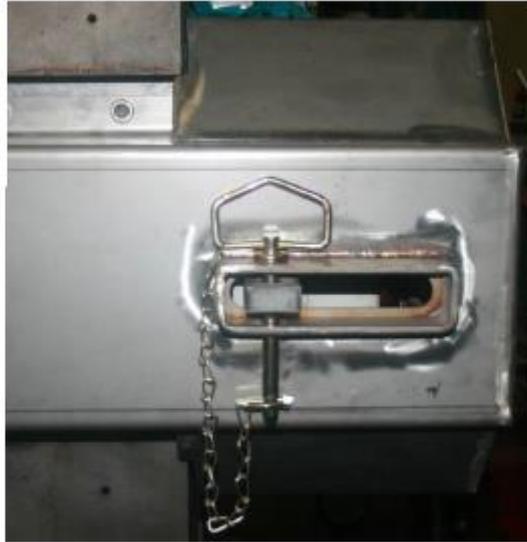
Figure 9: Photos from the NOV safety report show the correct installation of the safety pin.

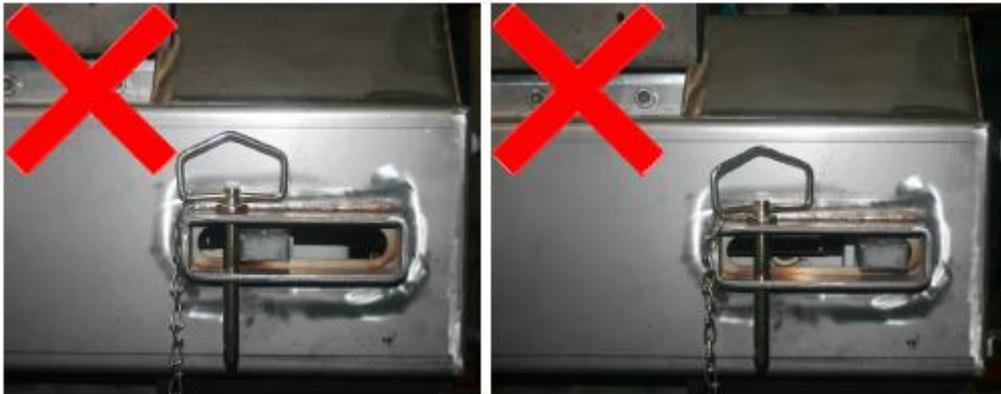
Figure 10: Incorrect installation.

The direct cause of the incident was that the anti-rotation bar was in the wrong position after closing the BOP doors. The incident occurred when the BSR test was to be carried out in combination with the BOP pressure test.

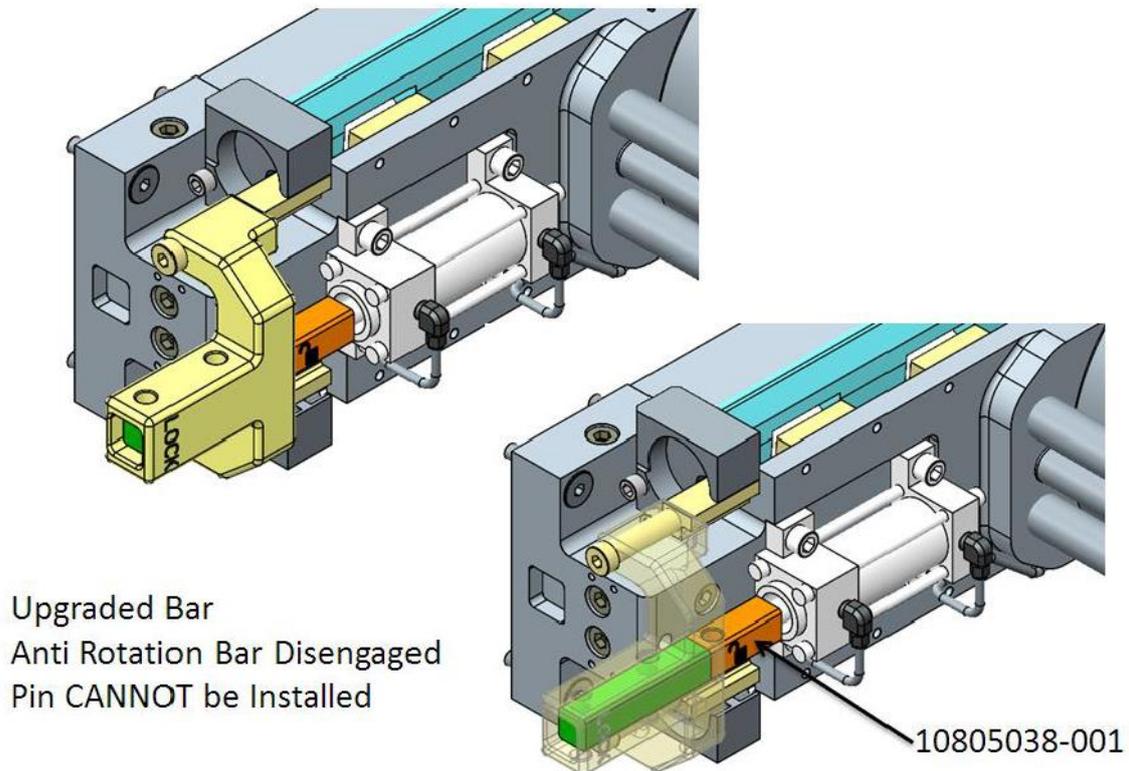
After an incident involving incorrect use of the locking system, NOV issued a product bulletin on 22 September 2014 to provide information on a new upgrade of the anti-rotation locking bar. Part of the 2012 change, this bar (P/N 20089153) needed to be replaced with a longer version (P/N 10805038-001).

Figure 13 Illustration from safety report D4511043808-PIB-001 Rev 01 showing changes to the design which involved a lengthened component with product number 10805038-001.

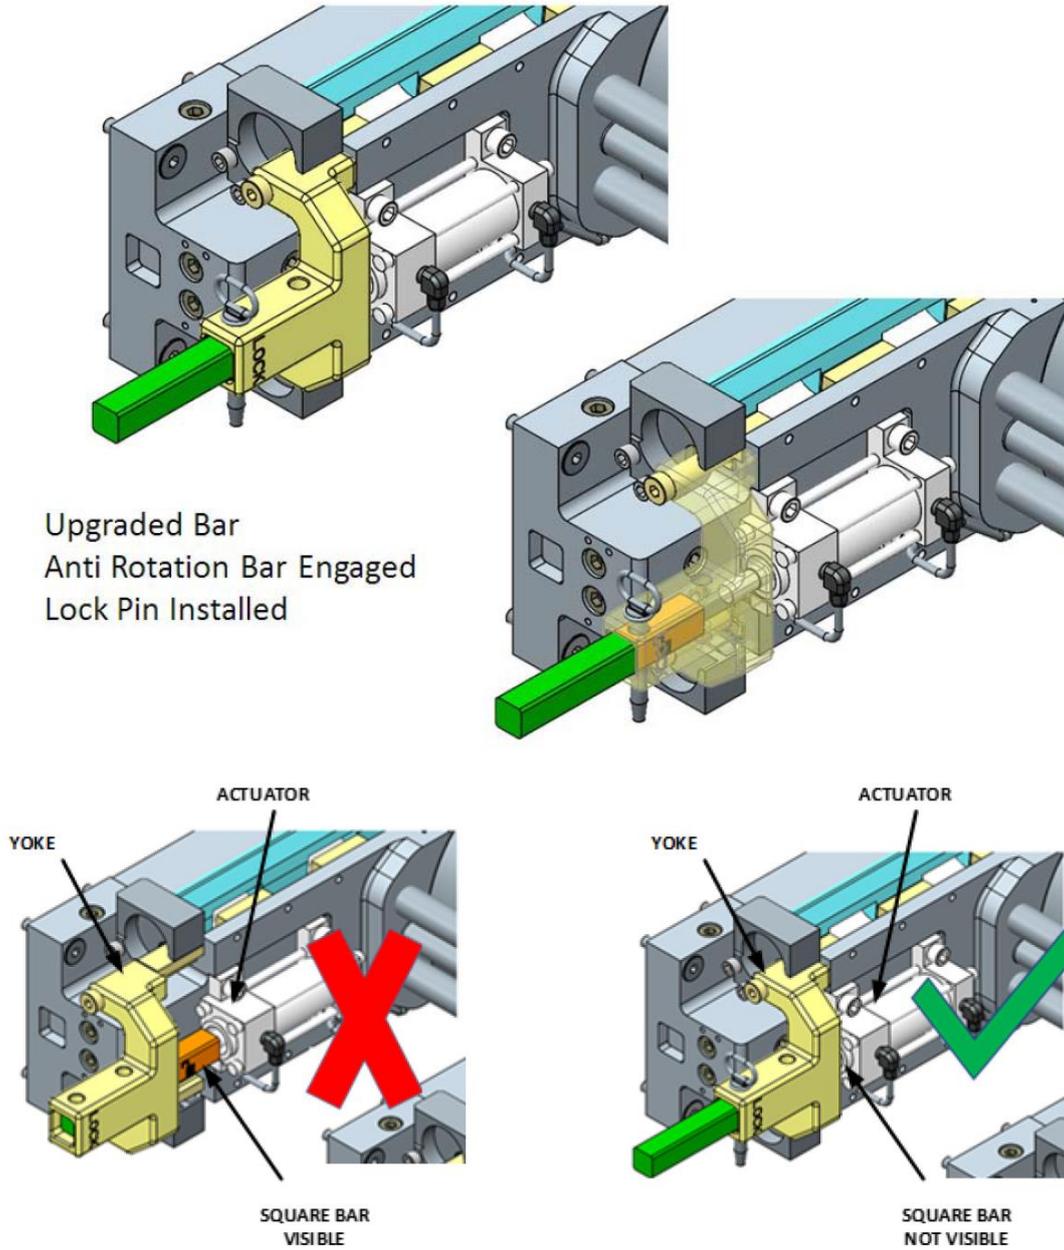
After yet another incident of incorrect use of the door-locking mechanism on the NXT BOP, a safety bulletin (no 1000012002-SA) was issued by NOV on 30 March 2017 with a reminder of the correct way to operate the anti-rotation bar.

Figure 14: Images from safety bulletin 1000012002-SA issued by NOV showing the secured door with the anti-rotation bar activated and the lock pin in the correct position.

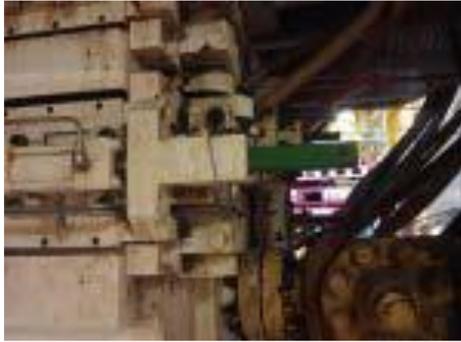
Figure 17 Anti-rotation bar in the correct position. The colours were part of the 2014 upgrade.

- The lock system failed to give a clear indication that the anti-rotation bar was in the right position. The ram-door locking system on the NXT BOP had no fail-safe mode, which meant the bar was placed in the wrong position and the lock pin was inserted in the wrong hole.
- A lack of transparency meant the system contributed little to the actions needed to install the lock correctly. The pin used to secure the anti-rotation mechanism, for example, could be inserted even though the bar was in the wrong position.
- The system failed to present the information needed to take good decisions. The colours used to show the bar's position in the locking system were easy to misunderstand. Interviews revealed that this was case with the meaning of the colours green and orange. Personnel involved assumed that orange meant the bar was in the locked position, but this was incorrect.
