Investigation report

Report	
Report title Investigation of an incident with personal injury on <i>Askeladden</i> , 10 February 2021	Activity number 419001006

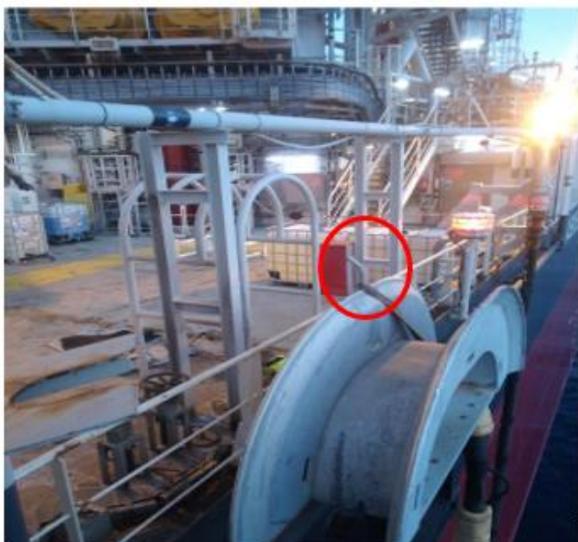
Figure 4.4 Port saddle and protector. The bracket with safety strap is illustrated by a red circle (photo: police).

The protector is offset in relation to the centre of the saddle. See figure 4.5. On the port side, it is positioned further to on the deck because of a cable tray along the base of the railing and a drain in the deck. A pipe track running along the upper part of the hull on the port side means the saddle is positioned further out from the hull. See figure 4.4.

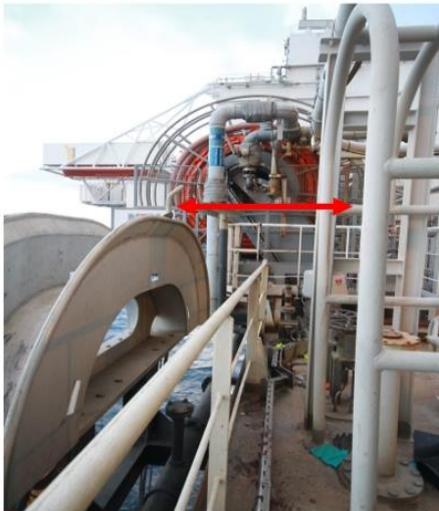
Figures 4.6 and 4.7 show how the protectors and saddles are positioned in relation to the railing. Measurements by the police give a gap of about 90 cm from port protector to the saddle bracket.

Figure 4.6 Port protector and saddle (photo: police).

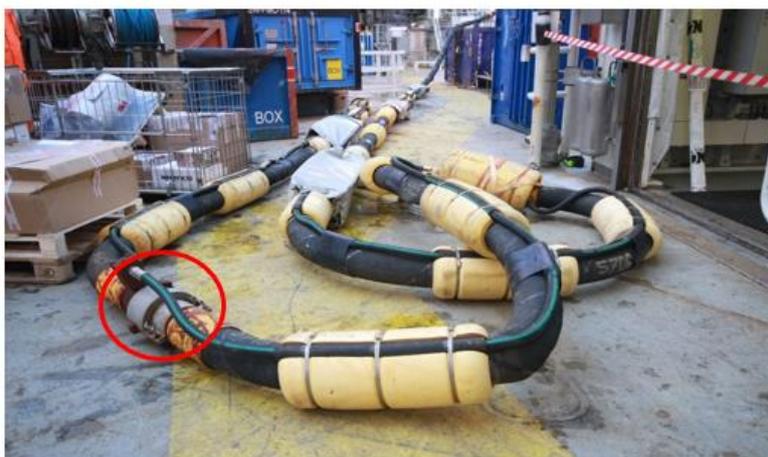
Valve blocks and flanges are lagged with tarpaulin and buoyancy elements, in part to protect the block and prevent damage to the hull. However, one valve block and a flange were not lagged, as shown by the red circle in figure 4.9.

Figure 4.9 Starboard cuttings hose (photo: police).

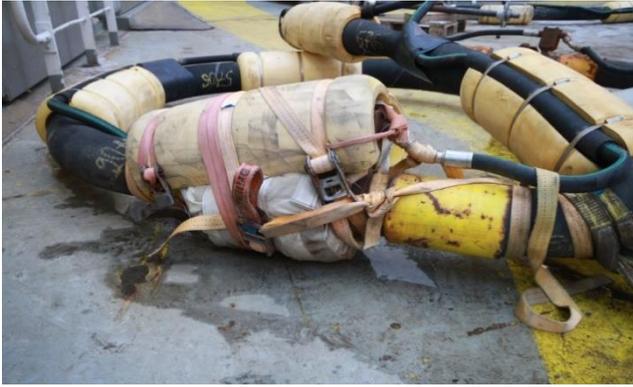
Additional lagging with buoyancy elements and ratchet tie-down straps was used on one valve block and a flange as shown in figure 4.10

Figure 4.10 Valve block and flange with extra protection (photo: police)

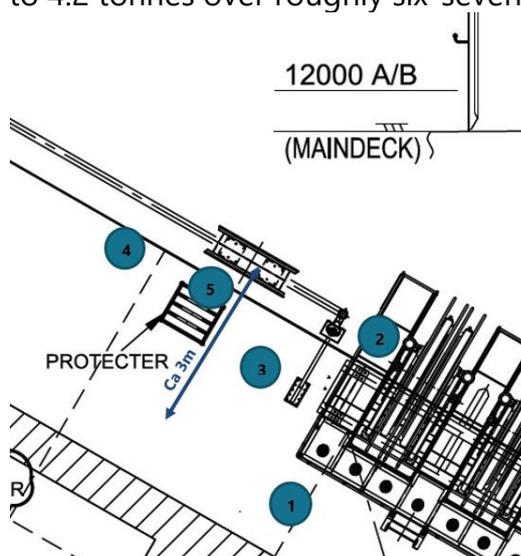
- The IP moved along the railing towards the saddle and stood between the railing and the protector – position 5. While they were standing there, the sling between pennant and hose broke. The hose dropped and hit the IP.

Figure 5.1 The numbers indicate where the IP was positioned in the minutes before the incident.

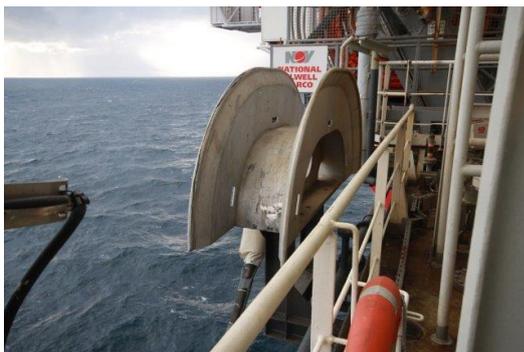
The saddle is positioned on a base about 0.5 metres out from the railing, as shown in figure 7.1. The design of the areas around the saddle and the hang-off bracket, and the complex structure of the hose with buoyancy elements, offer a number of opportunities for the hose to snag.

Figure 7.1 Distance to the saddle.

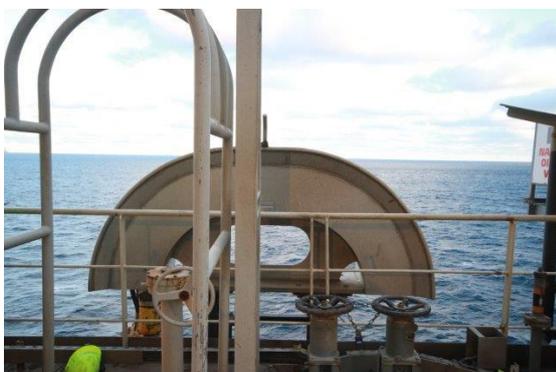
The protector intended to safeguard personnel is positioned at a distance from the railing. See figure 7.2. It is possible to stand exposed between the protector and the railing, where personnel must be to reach the saddle when installing/removing the safety strap. The IP was in this position when the hose dropped.

Figure 7.2 Positioning of the protector and snag points on the saddle

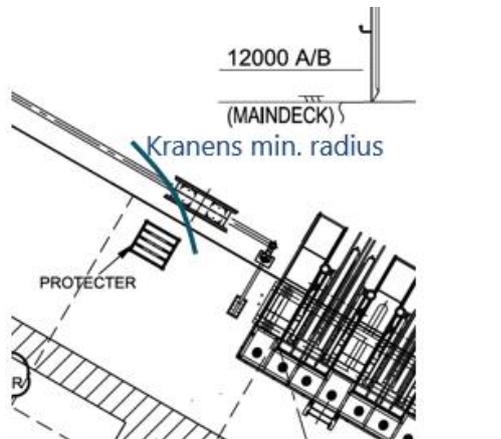
On the port side, the saddle is positioned within the minimum radius for crane's main lift. The cuttings hose is normally handled using the auxiliary lift, which provides some visibility inwards towards the saddle. This limits the crane operator's ability to guide the hose in and out of the saddle without the assistance of a slinger.

Figure 7.3 The crane's minimum radius (= Kranens min. radius).

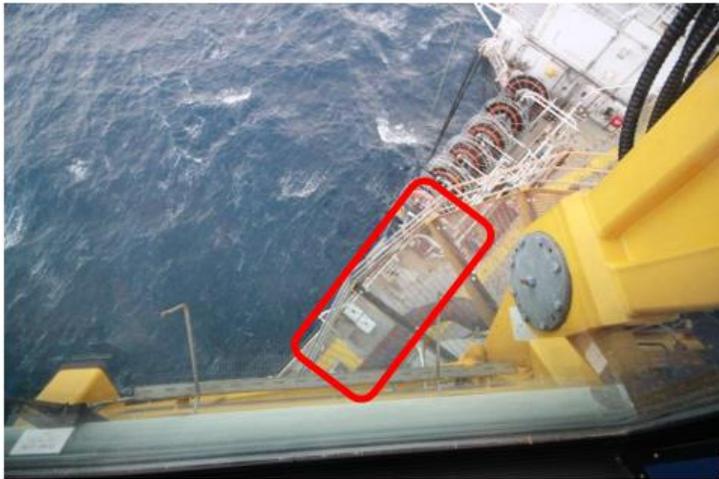
The cuttings hose is placed at the crane's minimum radius. When a lifting operation occurs close to the pedestal, the crane operator must bend forward to look down at the deck. The lift began with a free view, but became a blind lift when the hose was hoisted over the vessel side. Figure 7.4 shows that the view of the area around the hose station is restricted by a grating deck and associated railing which forms part of the access to the crane. The area by the hose station therefore lies partially in a blind zone where the crane operator is unable to see the slinger on deck. When the operator is leaning forward to follow developments, it is also difficult to keep an eye on the load indicator and the camera monitor. The crane is equipped with a camera, but the image on the cabin monitor comes across as unclear. Interviewees reported that an activity was under way with the crane manufacturer get this improved.

None of the supervisors involved or personnel on deck have identified the lifting operation as a blind lift or the challenges involved in executing this operation, which involves activity under a suspended load.

Figure 7.4 View from the crane with the hook suspended over the saddle (source: police).

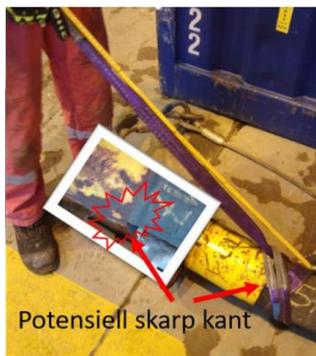
Figure 7.6 Reconstruction of webbing sling attached to the hose. Text in figure: potential sharp edge (source: KCAD).

According to the user guide for the sling, choking will reduce capacity by 20 per cent. The sling was choked around the hose and very probably pulled against a sharp edge on the sleeve, which has contributed to a further reduction in capacity. As shown in figure 7.7, the user guide for the sling warns against laying it over sharp edges.
