# Investigation report

Report	
Report title Report of the investigation into the fire in the mud laboratory on <i>West Phoenix</i> on 5 November 2018.	Activity number 404004006

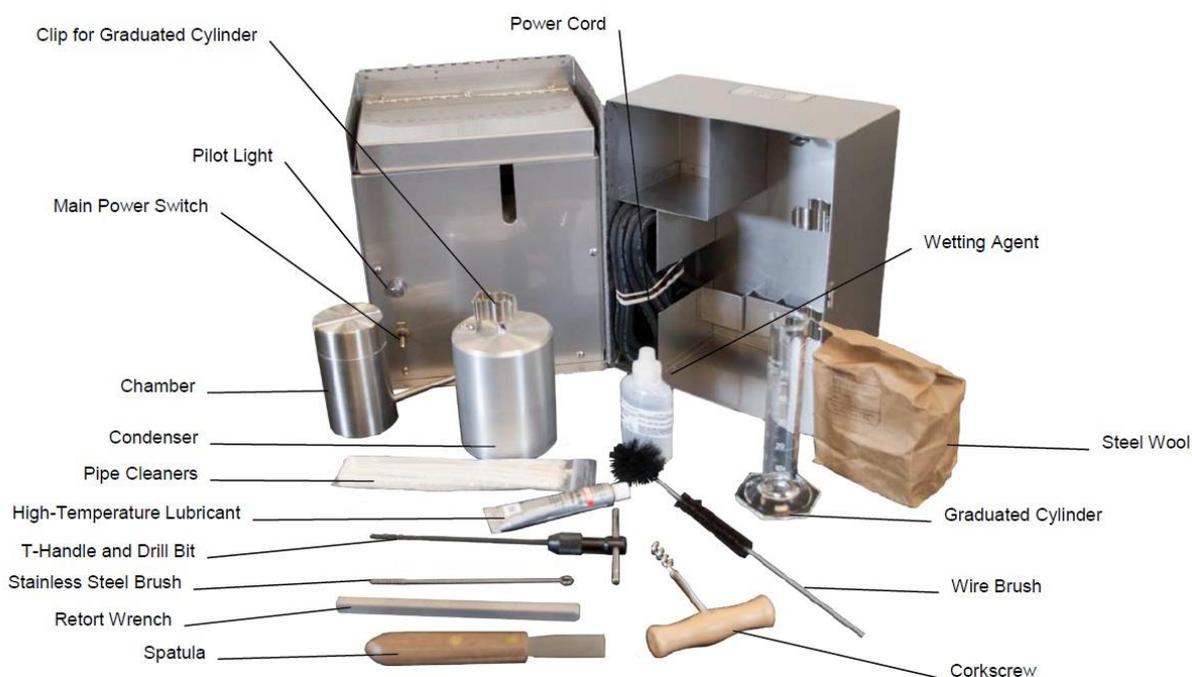
A retort (figure 1) was used several times a day in the facility's mud lab during drilling in order to monitor the quantities of water, oil and solids in the drilling fluid. This is normal practice during such operations, and is done to check the density and content of solids and water in the fluid. Equinor had a contract with Halliburton to provide this drilling fluid service on the facility.

Figure 1 Retort with parts (from the Fann user guide).

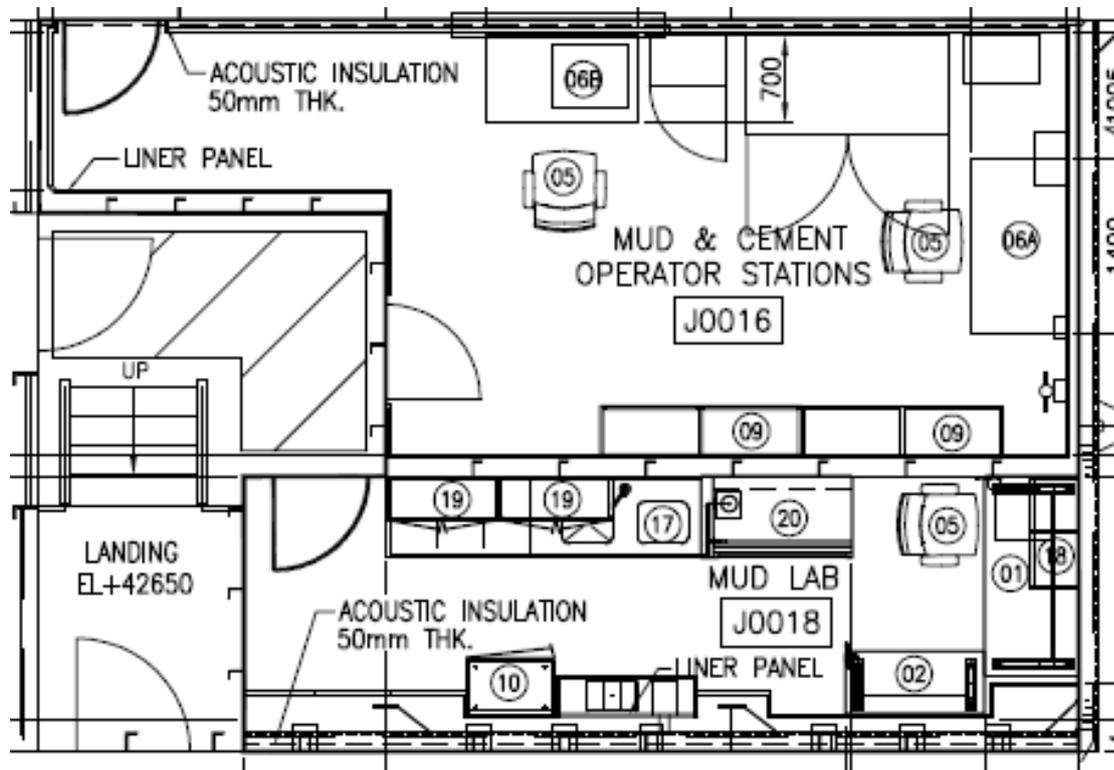
Figure 2 shows the placement and arrangement of equipment in the mud lab. It is located on the tween deck near the pump room and operator stations for mud and cement.

Figure 2 Positioning of the mud lab and the room layout.

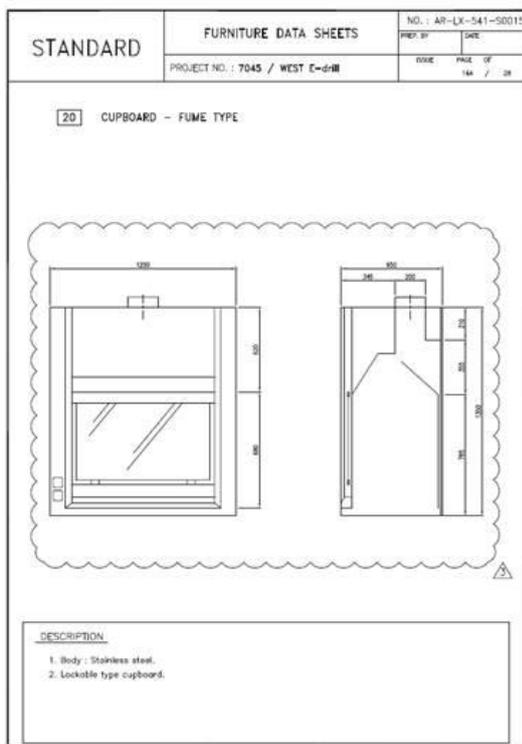
Chemicals used for mud testing were stored in the fume cabinet. Design drawings indicate that this cabinet should be made of stainless steel, but the fire damage shows that it was clad internally with flammable sheets. The chemicals and the flammable sheets inside the cabinet contributed to the rapid escalation of the fire.

Figure 3 The fume cabinet in the mud lab (see figure 2, unit 20).

The fume cabinet drawings showed that it should be made from stainless steel sheets. These were not used in its construction. The cabinet was clad internally with flammable fibre sheets.

No separate power socket was installed in the cabinet to avoid having to run an extension cord through the opening under the hatch.

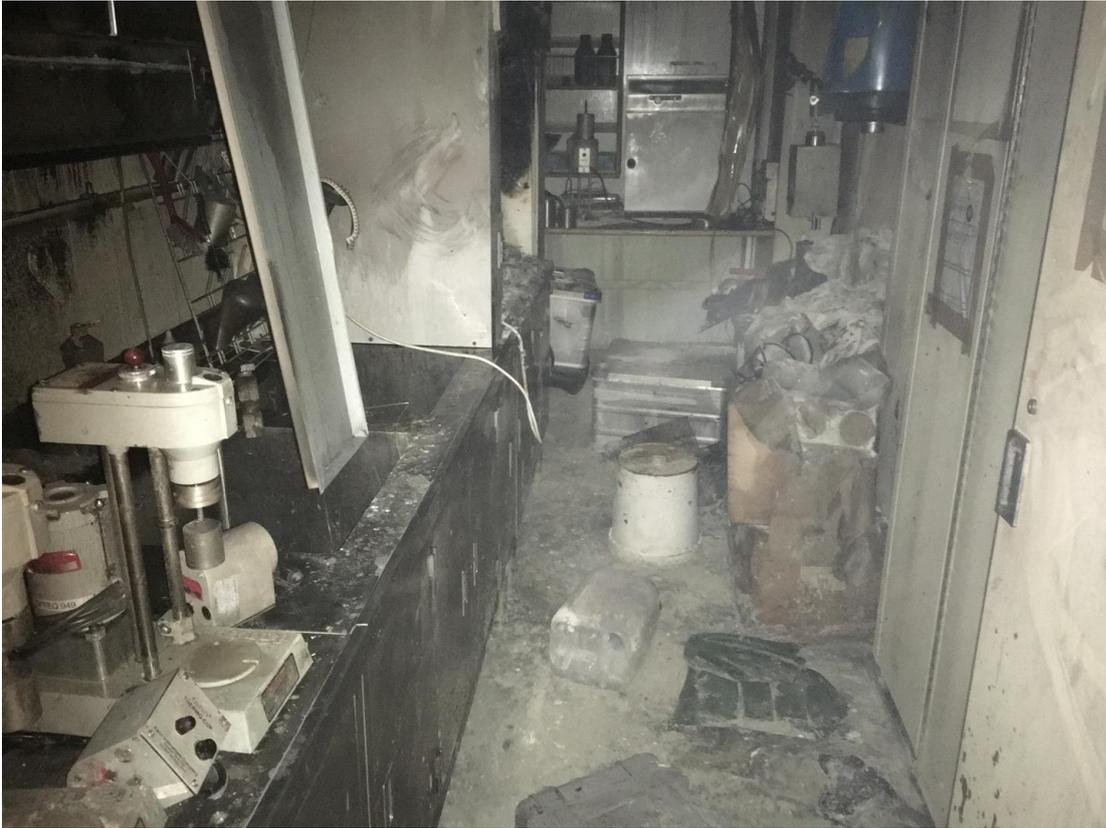
The consequence of the incident was material damage and a five-day halt to drilling. Seadrill has specified 75.25 hours of downtime as a result. Material damage was confined to the mud lab. See figures 4 and 5. Checks of bulkheads, cable conduits and equipment in adjacent rooms after the fire registered no visible damage. Before drilling could resume, a new mud lab had to be requisitioned from land, sent to the facility and made ready.

*Figure 4 Overview of the mud lab after the fire (from Seadrill).*

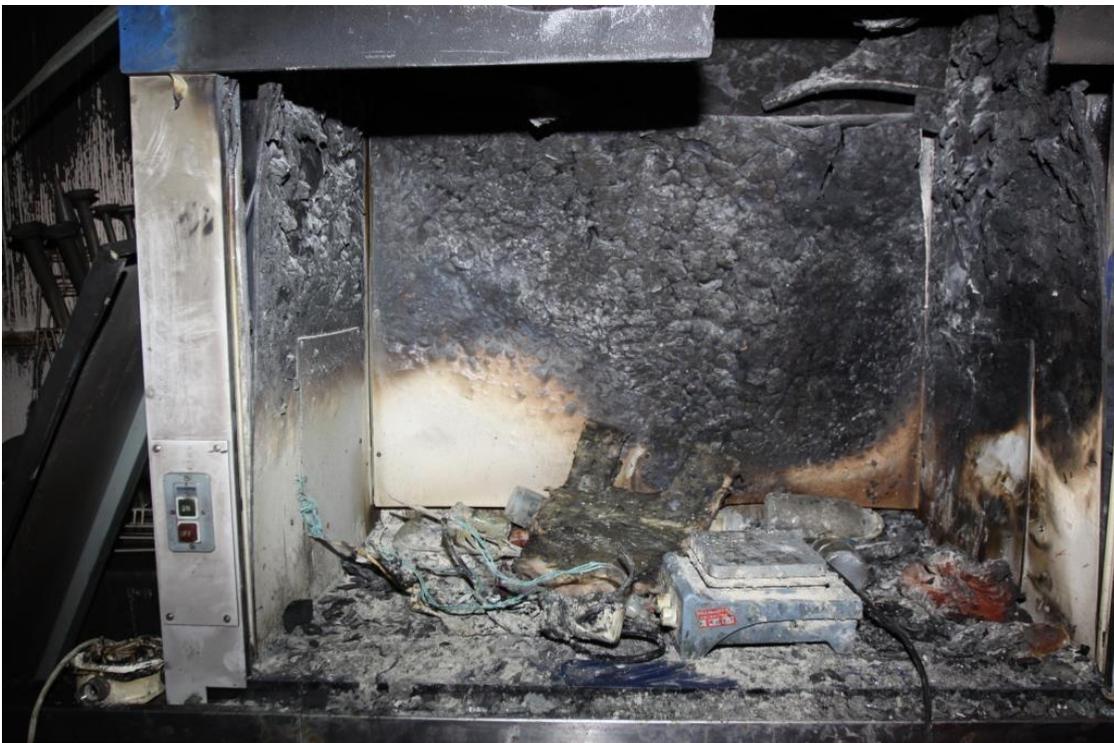
The site showed that the fire began in the fume cabinet where the retort was placed. The retort and the extension power cord used in the cabinet were taken ashore by the police for more detailed forensic examination.

*Figure 5 The fume cabinet in the mud lab (from the police).*

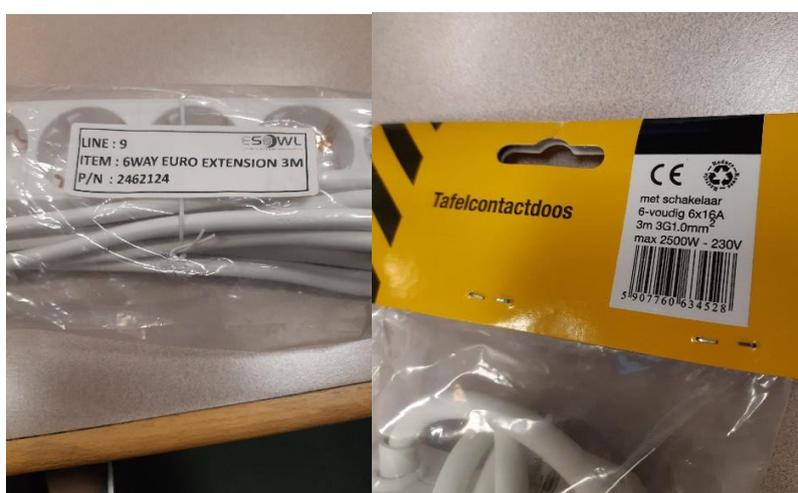
Investigations by the criminal investigation service found traces of serial arcing in the cord, which was very probably the cause of the fire. The arcing has almost certainly occurred as the result of insulation failure owing to mechanical damage.

Figure 6 Extension cord corresponding to the one used in the mud laboratory.

The extension cord used in the mud lab was not dimensioned and sufficiently robust to avoid a high temperature or arcing.

The cord used was three metres long and had a cross-section area of one square millimetre. The standard requires at least 1.5 square millimetres Cu (copper) for such cords.
