Investigation report

Report	
Report title Report of the investigation into a gas leak on Aasta Hansteen, 8 April 2019	Activity number 001218029

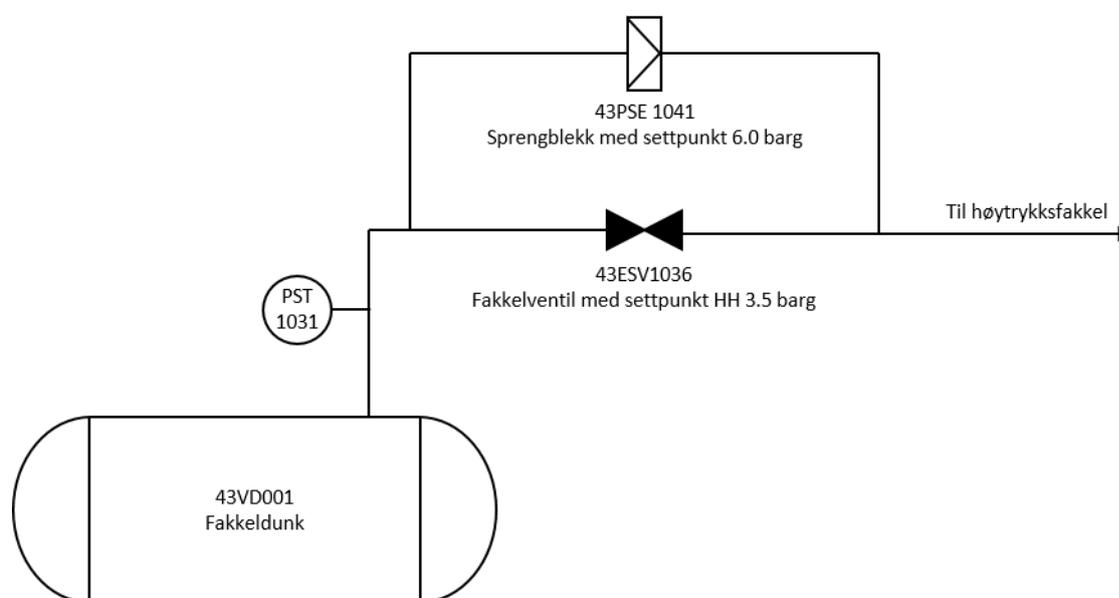
Figure 1 Simplified diagram of the high-pressure flare knockout drum and flare valve configuration.

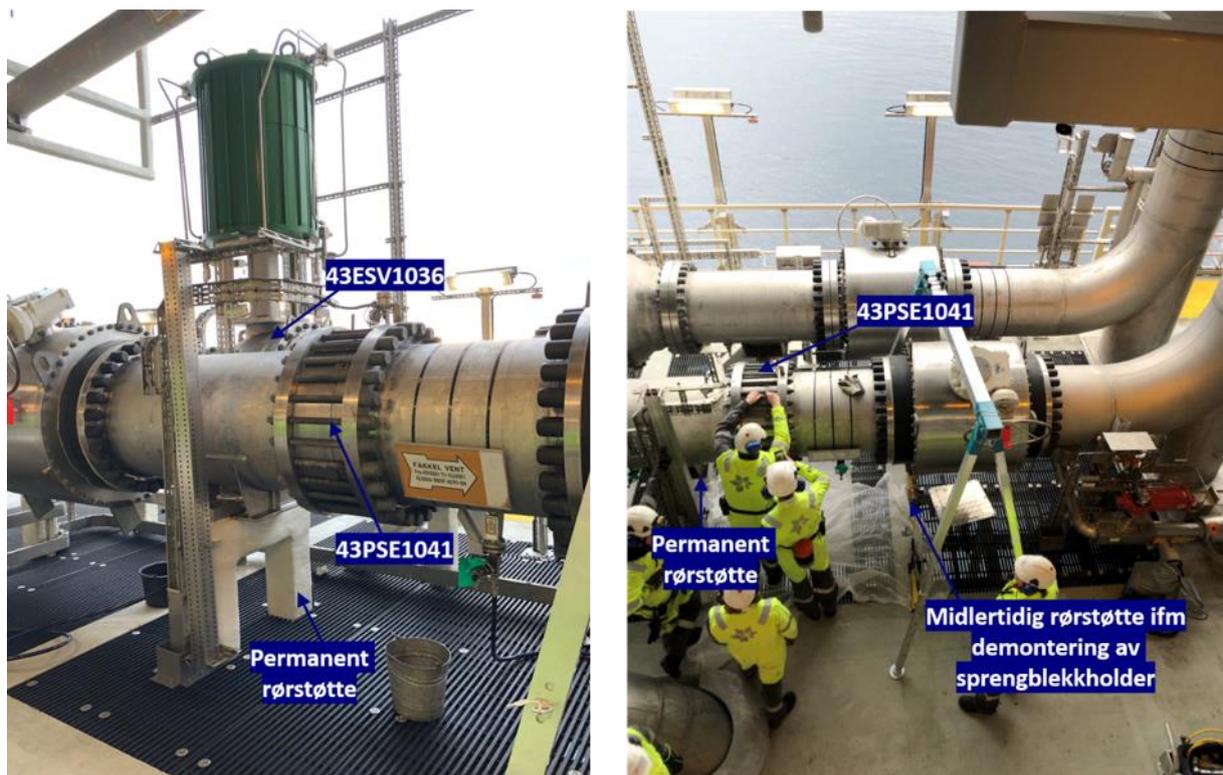
Photos 1 and 2: Taken at the incident site while disassembling the rupture disc on 11 April 2019 (PSA).

The direct cause of the gas leak was that the rupture disc burst in such a way that its edge was drawn into the flare line in two places. That led in turn to the loss of the seal at these points, permitting a gas leak.

Witness observations during the incident back the team's conclusions, while Equinor's analysis contains an inconsistency between the calculated gas cloud and the gas detector responses in the area. Furthermore, descriptions of the damage to the disc in Equinor's material technology investigation support the team's observation. These describe plastic deformations compatible with the disc being drawn into the line at two points, one at three o'clock and the other at six o'clock.

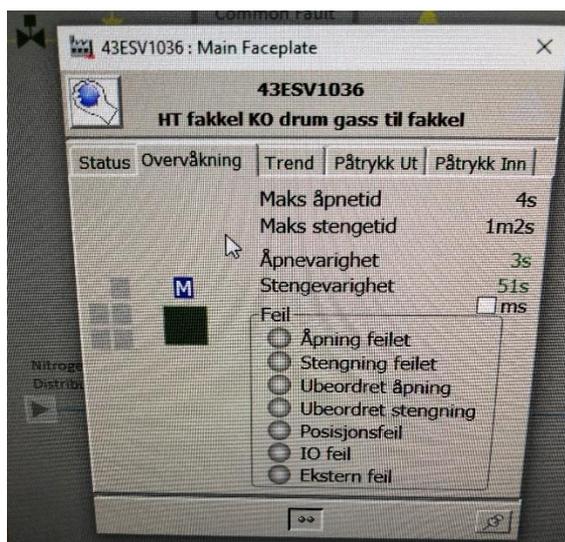
Flare valve 43ESV1036 has been tested with three seconds as the requirement for total opening time. That does not meet the specification in the process safety report.

The maximum opening time for flare valve 43ESV1036 is set to four seconds in SAS. That does not correspond with the requirements in the other documents.

Photo 3: Screen capture from the central control room, 12 April 2019 (PSA).
