OMAE2020-19287

## IN SERVICE EXPERIENCES WITH SHIP-SHAPED FLOATING PRODUCTION UNITS

Marita Halsne<sup>1</sup>, Narve Oma, Gerhard Ersdal, Arne Kvitrud, Roger L. Leonhardsen,  
Morten Langøy, Terje Andersen, Lars G. Bjørheim  
Petroleum Safety Authority Norway (PSA)  
Stavanger, Norway

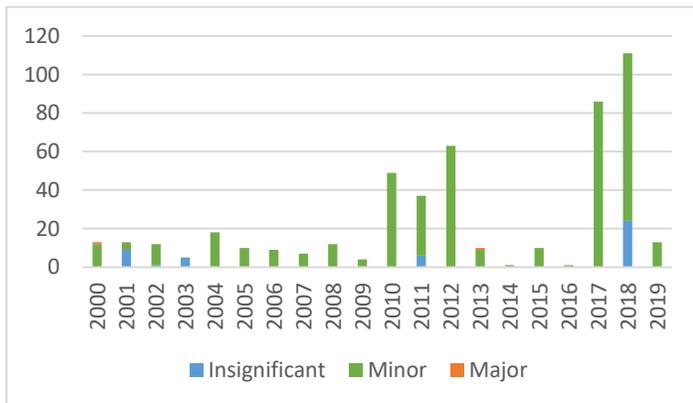
**FIGURE 2:** THE CRACK AS CLASSIFIED INTO CLASSES OF SEVERITY PER ANNUM ON ALL 17 PRODUCTION UNITS ON THE NCS IN THE PERIOD 2000-2019. NOT NORMALIZED.

As can be seen from Figure 2, a total of 494 cracks are reported for the 17 units between 2000 and 2019. 466 are classified by the operator as cracks of minor severity while 26 are classified as cracks of insignificant severity. Only two cracks are reported to be of major severity, in 2000 and 2013

respectively. These classifications are based on the operator's subjective evaluation and have not been quality controlled by the authors.

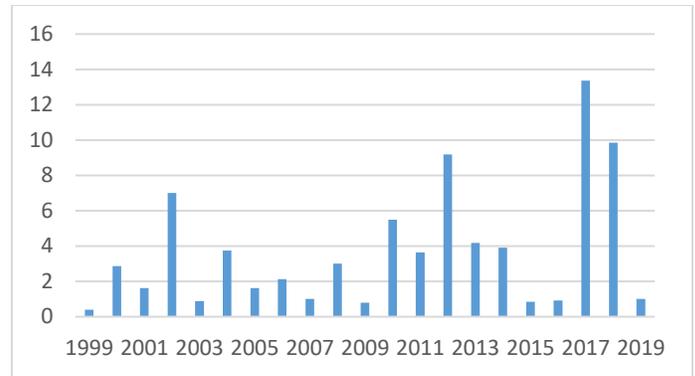
**FIGURE 3:** THE ANNUAL NUMBERS OF CRACKS\*) ON ALL 17 PRODUCTION UNITS NORMALIZED BY NUMBERS OF UNITS IN ACTIVE OPERATION THE ACTUAL YEAR.

Figure 3 identifies reported cracks on FPSOs / FSOs in the period 2000 to 2019 which are normalized by yearly numbers of units in active operation indicating an average of approximately four cracks yearly per unit. Some peaks can be identified and this may be caused by inspection campaigns or winter seasons with harsh weather. Several of these FPSOs have been life extended causing enhanced inspection campaigns and some correlation with these life extension projects has been identified.

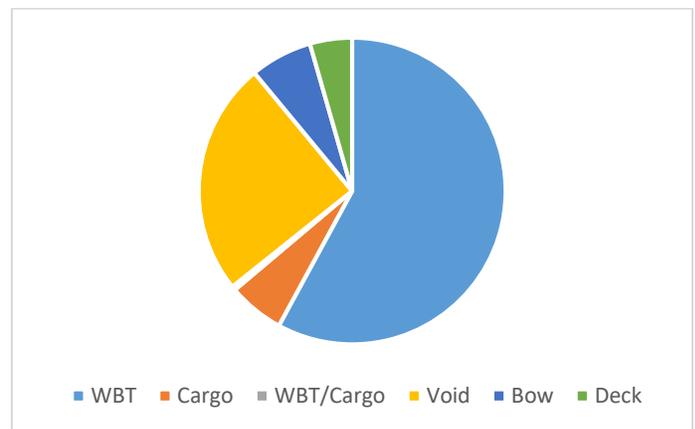
**FIGURE 4:** CRACKS ON ALL 17 PRODUCTION UNITS GIVEN BY LOCATIONS OF THE CRACKS. NOT NORMALIZED.

Figure 4 identifies cracks on all units given by location in the hull. Most of the cracks are in

The same also applies to cracks reported in the bow area. Many cracks are also reported in void spaces in the fore and aft ship, such as cofferdams, engine rooms and pump rooms. Many of these cracks are located in the corner of door openings and are normally caused by a small radius in the corners of the cut-outs and often in combination with a reduced effective shear area in the bulkheads of the hull girder.

Few cracks are reported in the main deck, in the cargo area and the bulkheads between cargo and ballast tanks. However, cracks have been reported in the knuckle lines of the inner side longitudinal bulkhead causing extensive repair work for an FPSO in 2004.

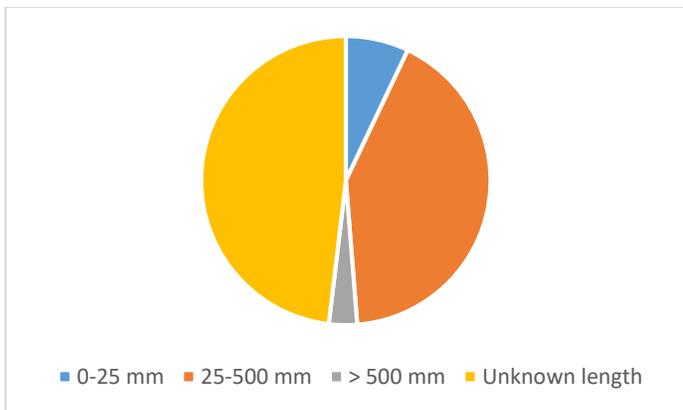
**FIGURE 5:** MEASURED CRACK LENGTH\*) ON SIX UNITS.

As can be seen on Figure 5 many of the operators have failed to report the crack length or other vital information. However, most of the reported cracks have a length between 25 and 500 mm, while a few are reported to have a length less than 25 mm. In 2004, 2007 and 2018 several cracks have been reported to have a length more than 500 mm. These cracks have been reported to be in the main deck (2 cracks), water ballast tanks (WBT) (10 cracks), between the WBT and cargo tanks (2 cracks), bow (1 crack) and the void spaces (10 cracks).

Most of the cracks are reported to be caused by fatigue, but in recent years the operators have also specified design or a combination of design and fabrication as the primary causes of the cracks.

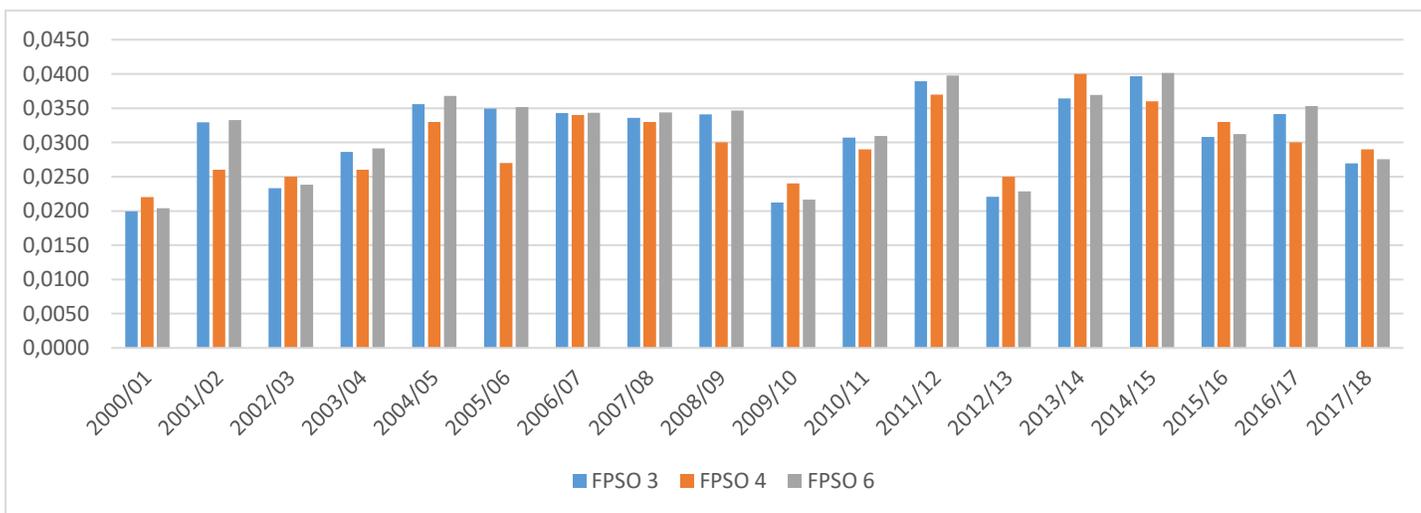
**FIGURE 6:** RELATIVE ACCUMULATED FATIGUE DAMAGE OF THREE FPSOS BASED ON SEASONAL HINDCAST DATA (JULY TO JUNE) FROM 2000-2001 TO 2017-2018.

detected can also be caused by inspection campaigns and the tail of the “bath tube” curve can be caused by harsh weather in the winter 2013/14 and 2014/15 as shown in Figure 6.

FPSO 4 has been in service on the NCS in the entire period since 2000. A total of 150 cracks have been reported for this unit. Most of the cracks were reported in 2017 and 2018. There is a weak trend towards an increase with age, but the number of cracks detected can also be a result of inspection campaigns or harsh weather in the winter 2013/14 and partly 2014/15 as shown in Figure 6.

FPSO 6 has been in service on the NCS since 2011. A total of 26 cracks have been reported for this unit. Most of the cracks were reported in 2017. These cracks are related mostly to sharp corners of door openings and cut-outs and often in combination with a reduced effective shear area in the longitudinal bulkheads of the hull girder. This peak in the number of cracks in 2017 can be caused by a combination of a possible inspection campaign, unfavourable structural details and the harsh weather in the winter seasons 2013/14 and 2014/15 as shown in Figure 6.

Fatigue damage will vary in different years depending on the severity of the annual wave conditions. This can be calculated in a simplified form by summing the damage from each sea-state. The damage is set as a function of the significant wave height and associated period (the method is further described in Erstad (2005)). Figure 6 gives the relative generic accumulated fatigue damage for a structural detail in an FPSO based on the NORA 10 hindcast data (Reistad et al., 2011). As can be seen from Figure 6 the fatigue damage in the worst years is a factor of 2 greater than the mildest years which may have a significant effect on the number of cracks found.

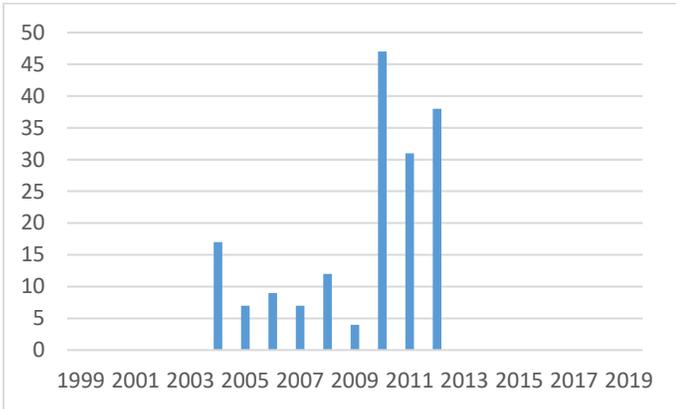
**FIGURE 7:** ANNUAL NUMBER OF CRACKS FOR FPSO 1. THIS FPSO WAS IN SERVICE FROM 2001 TO 2013.

FPSO 1 was in service from 2001 to 2013. She was refurbished in 2000-2001 and many outer hull plates and details were changed. The vessel was 27 years old when it left NCS. A total of 173 cracks were reported, most of which in the last three years of operation. They are probably caused by an old and unsatisfactory design, unfavourable details and fabrication errors, combined with the age of the unit.

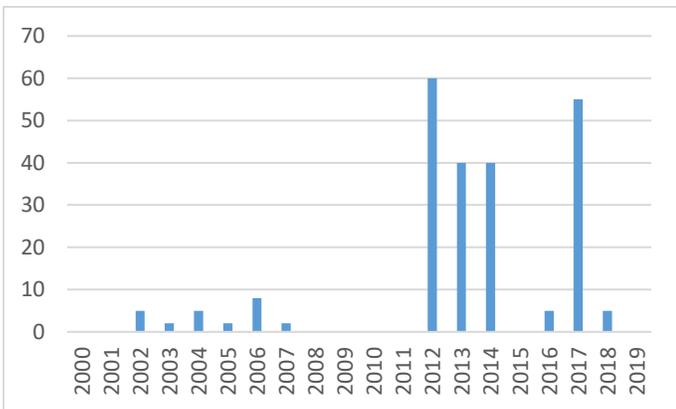
**FIGURE 8:** ANNUAL NUMBER OF CRACKS\*) FOR FPSO 2. THIS FPSO HAS BEEN IN SERVICE SINCE 1999.

FPSO 2 has been in service on the NCS since 2001. A total of 229 cracks have been reported for this unit. Most of the cracks were reported in the last seven years of operation. There is a weak trend towards increase with age, but the number of cracks detected can also be caused by inspection campaigns or harsh weather in the winter season 2013/14 and 2014/15.

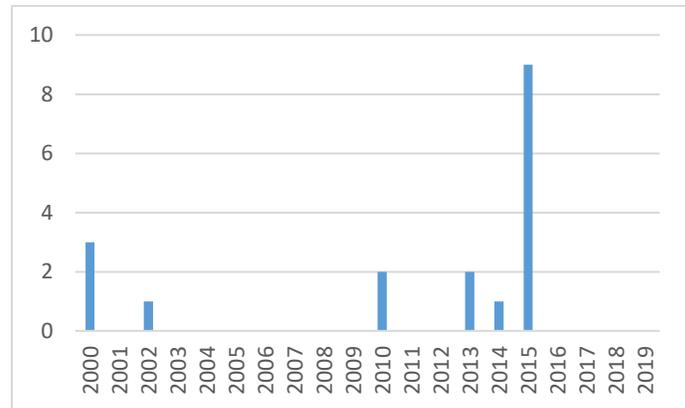
**FIGURE 11:** ANNUAL NUMBER OF CRACKS FOR FPSO 5. THIS FPSO HAS BEEN IN SERVICE FROM 1999 TO 2016.

FPSO 5 has been in service on the NCS in the period from 2000 to 2016. A total of 18 cracks are reported for this unit. Most of the cracks were reported in 2015. No trend is observed indicating that ageing effects are present.

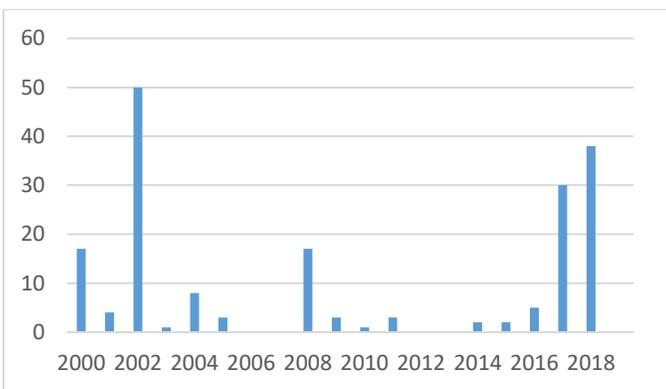
**FIGURE 9:** ANNUAL NUMBER OF CRACKS \*) FOR FPSO 3. THIS FPSO HAS BEEN IN SERVICE SINCE 1997.

FPSO 3 has been in service on the NCS since 2000. A total of 184 cracks have been reported for this unit. Most of the cracks were reported in 2003 and in the last two years. There is a weak trend towards a “bath tube” curve, but the number of cracks
