Investigation report

Report	
Report title Investigation of unintentional disconnection of the gangway on <i>Floatel Endurance</i> on 29 February 2020	Activity number 420002008

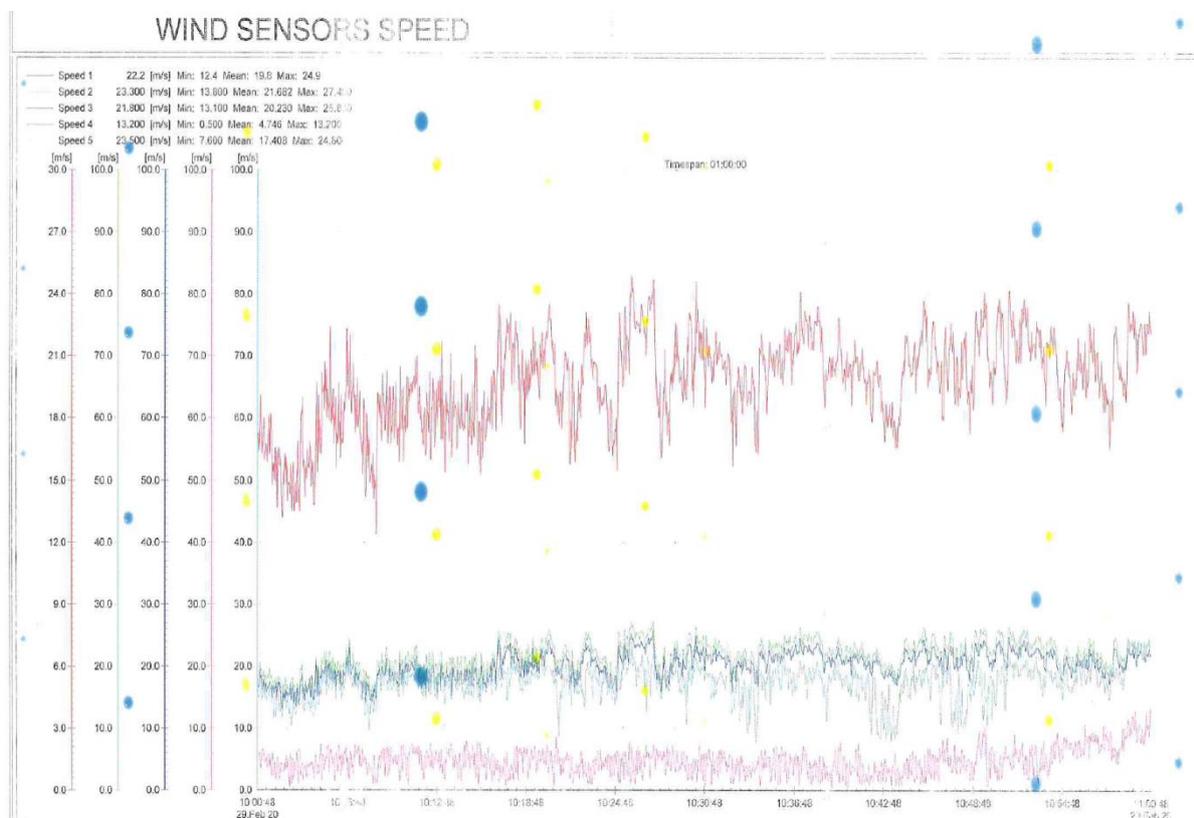
Figure 2. Registered wind speeds.

Weather observations between 10.00 and the incident time of 10.45 largely showed wind from east-south-east at strengths in the 19-22 metres per second interval. See Figure 2 below.

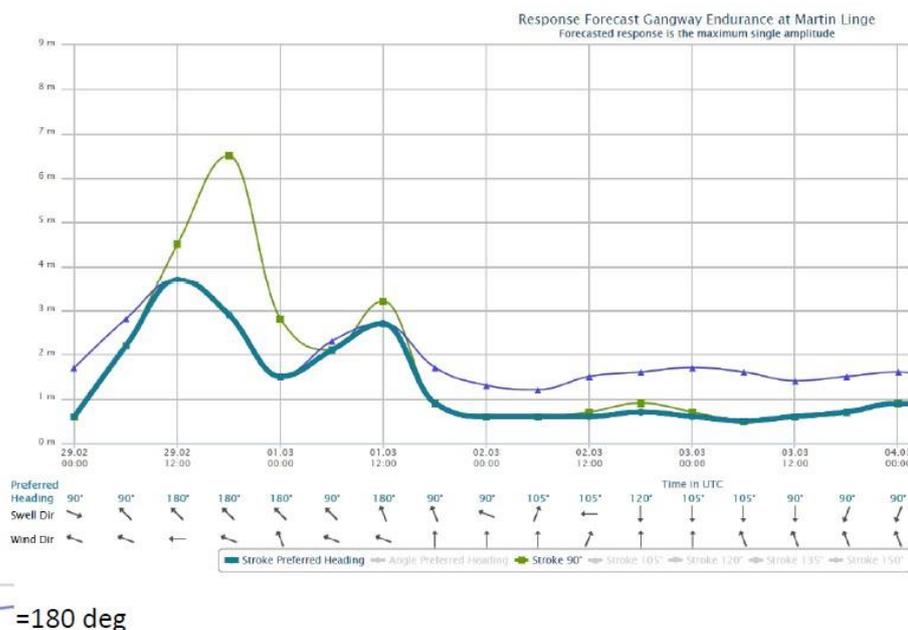
Figure 5. Estimated gangway motion.

The weather forecast for 29 February reported that wind strength and wave height would continue to increase through the day. Estimated gangway motion also showed an expected increase during the morning. See Figures 4 and 5 for the weather forecast and estimated gangway motion respectively.

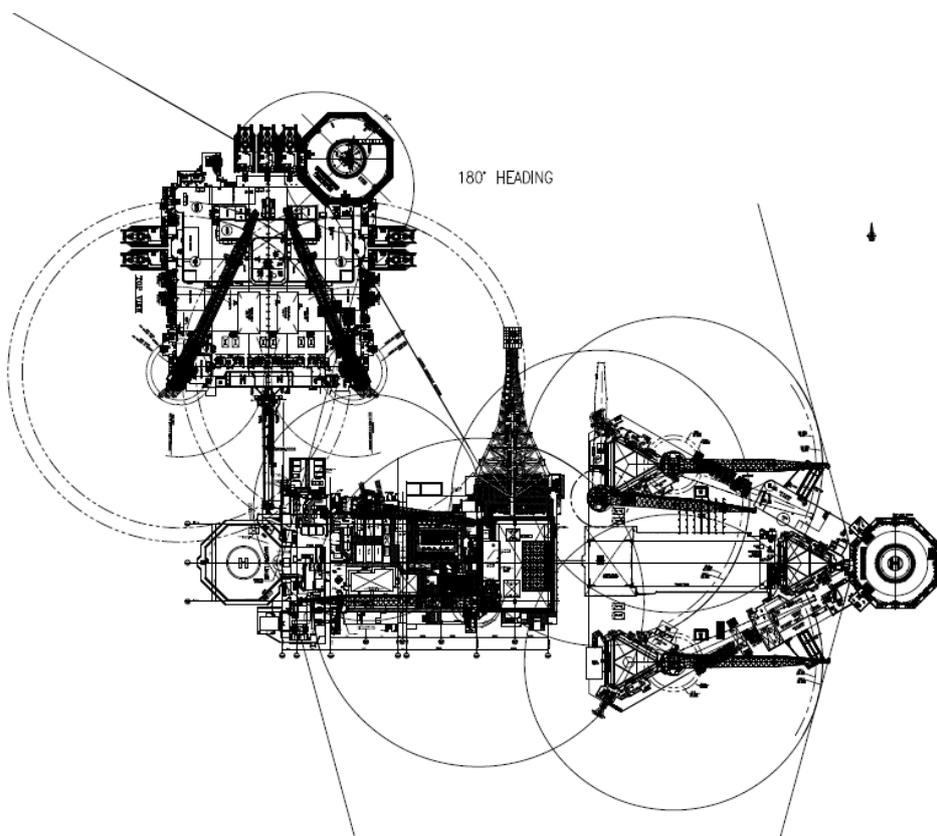
Figure 7. FED with heading of 180 degrees.

The gangway was swung away from MLA, owing to concerns that it might hit the platform and cause damage because of the 170-degree heading (see Figure 7). Neither MLA nor the gangway suffered material damage.

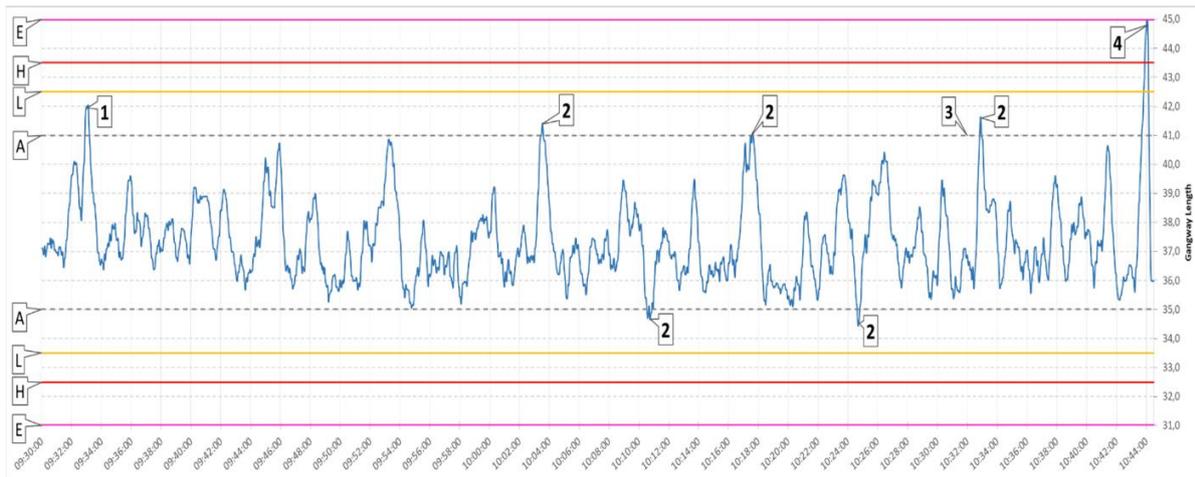
Figure 8. Overview of changes in gangway stroke.

The advisory limit specified in the LSOG was registered six times between 09.30 and 10.30 before the emergency-lift incident (see Figure 8).

1. Advisory limit exceeded. Advisory meeting called.

2. Advisory limit exceeded.

3. Decision to recall personnel to *FED*

4. Emergency lift

Before the incident, gangway stroke was observed to exceed the three-metre limit six times in the space of an hour, with the operational condition changing from normal to advisory. See Figure 8. No values were above the limit for yellow condition, when plans were supposed to be made to abandon operation.

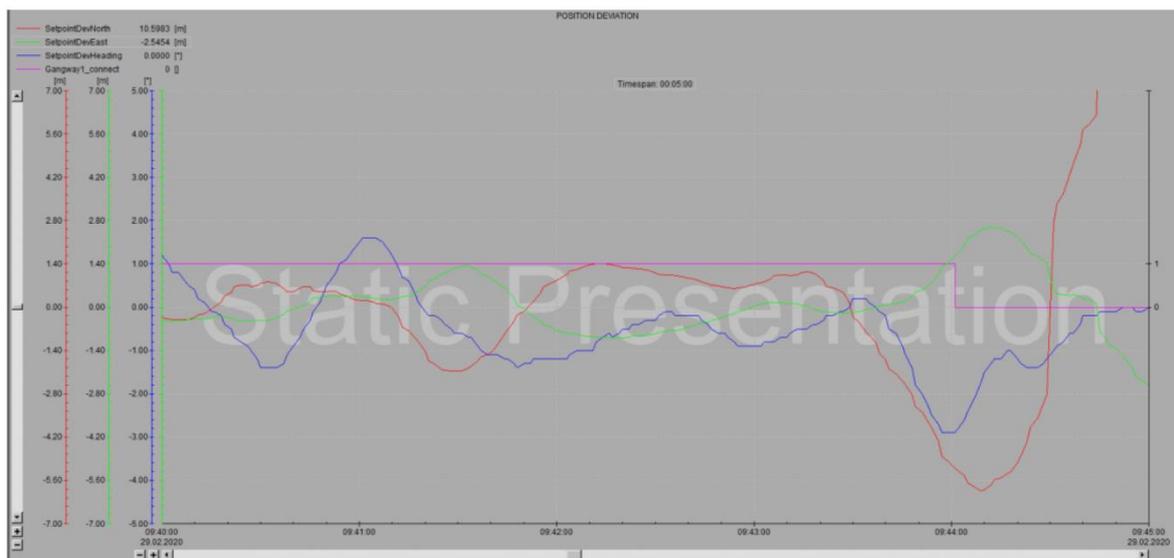
Figure 9. Position and heading for Floatel Endurance during the emergency lift (from the Kongsberg Maritime report: Investigation report – Floatel Endurance – emergency lift, 29 February 2020).

Figure 9 indicates that *FED* was subject to a high load of short duration (impulse load) which gave the facility a virtually constant speed of about 0.15 metres per second in a northerly direction and an increasing speed in a westerly direction. The response from the DP system did not halt the motion until after the emergency lift of the gangway had been activated.
