1 Summary

Two gas leaks occurred on 23 May 2022 on the Statfjord B (SFB) facility while running up after a turnaround. They derived from holes in blowdown lines in the M10T area of the upper north-eastern corner of the Equinor-operated facility. The Petroleum Safety Authority Norway (PSA) decided to investigate this incident on 24 May 2022.

The direct cause of the hydrocarbon (HC) leaks was external corrosion and consequent loss of integrity in two carbon-steel (CS) blowdown lines. These were used during startup after the turnaround on the facility, and had probably corroded through before the incident.

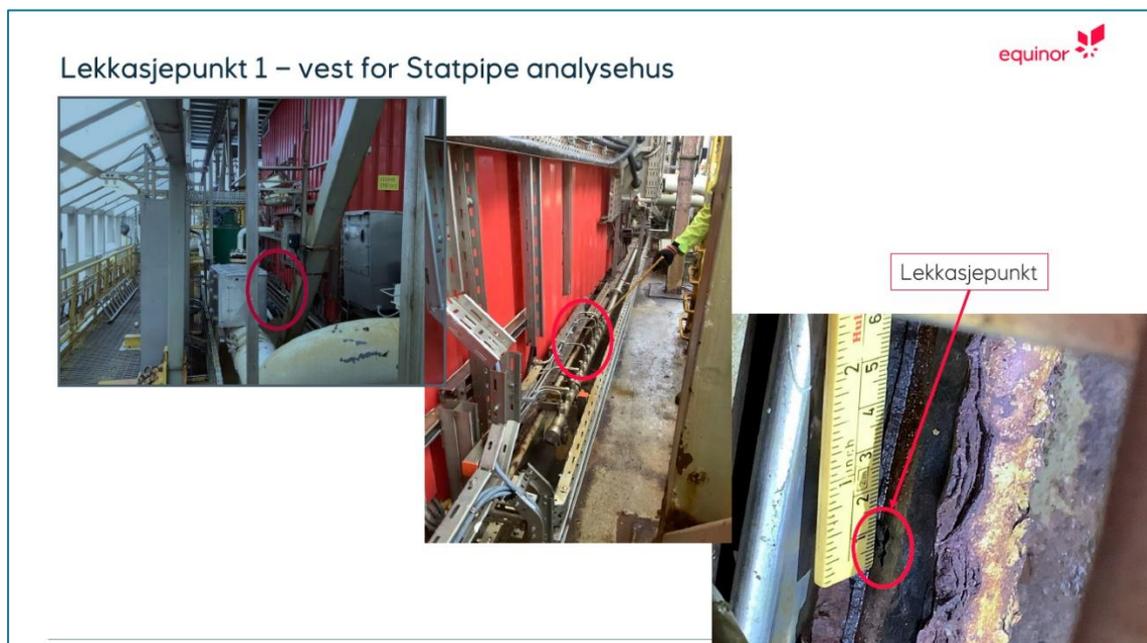
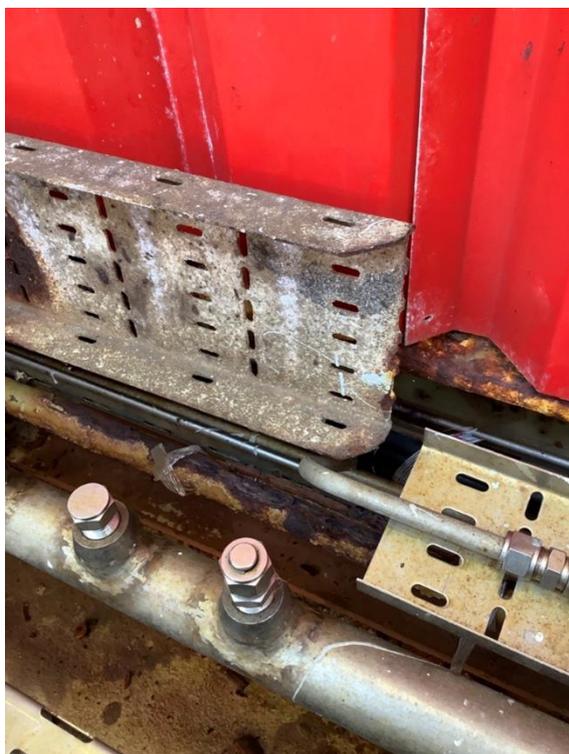
Image 2 Leak point 1, Statpipe metering station. SFB. (Source: Equinor)

Image 2 Leak point 1, Statpipe metering station. SFB. (Source: taken during PSA investigation)

The direct cause of the two HC leaks in the M10T area was heavy external corrosion of piping in CS.

The surface coating had degraded, and corrosion had been allowed to develop to a serious extent without technical or operational measures being initiated. Rust holes had probably already developed in the pipes when they were pressurised as part of running up.

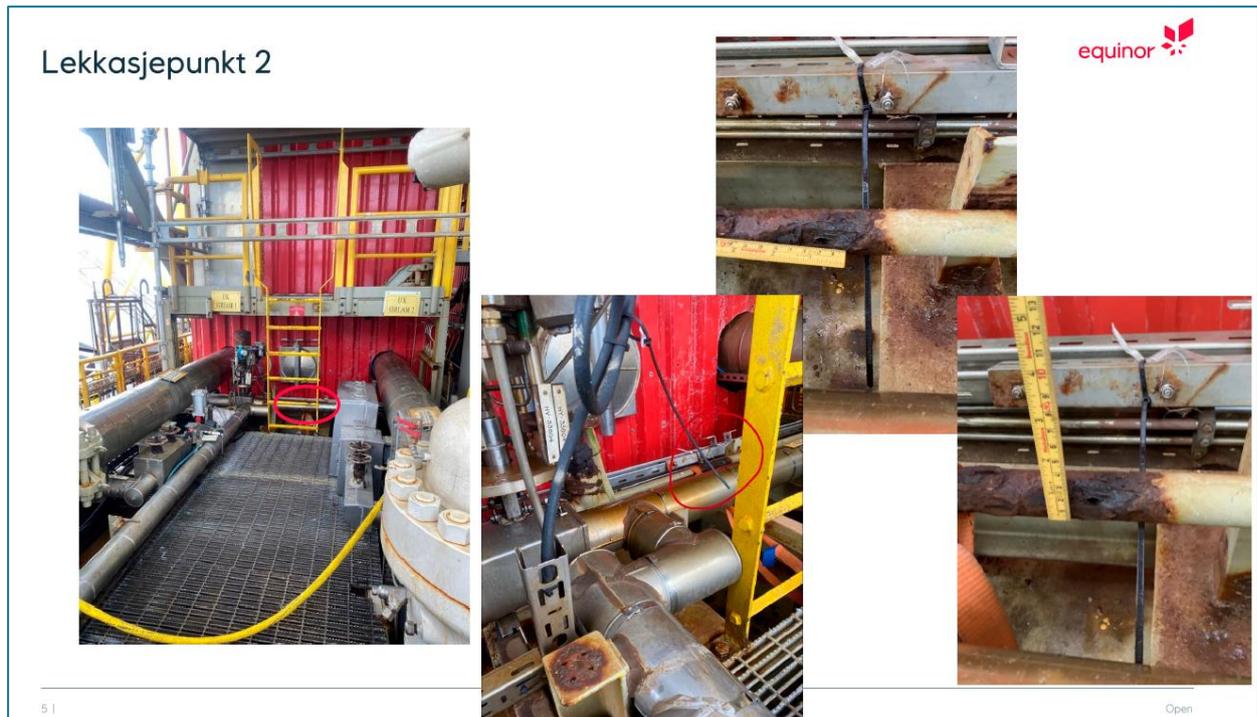
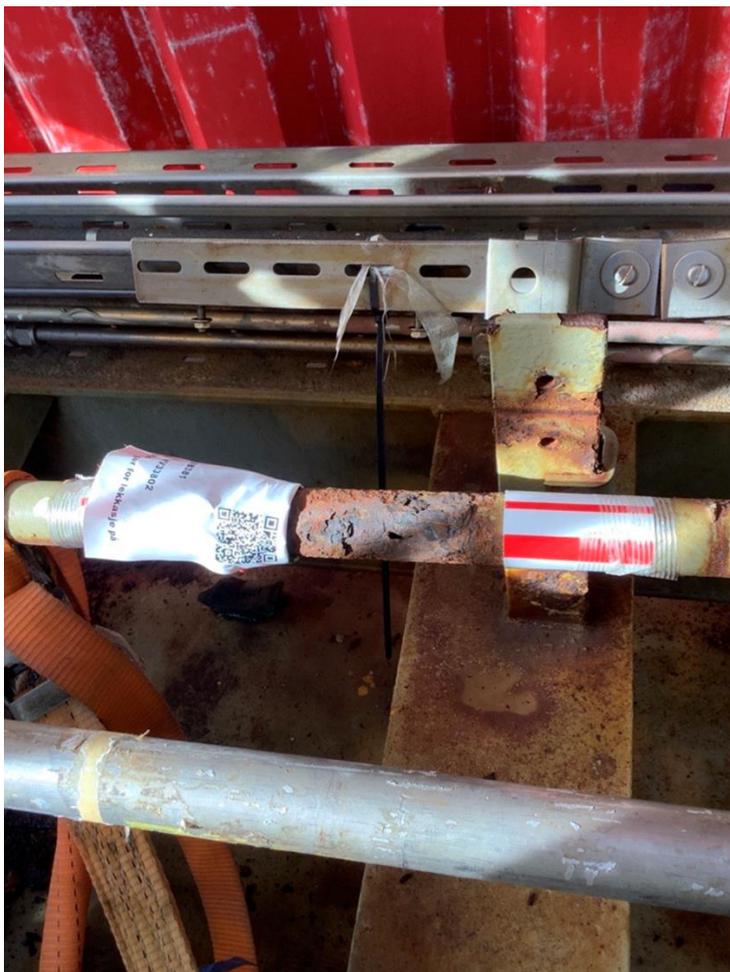
Image 3 Leak point 2, UK metering station. SFB. (Source: Equinor))

Image 4 Leak point 2, UK metering station. SFB. (Source: taken during PSA investigation)

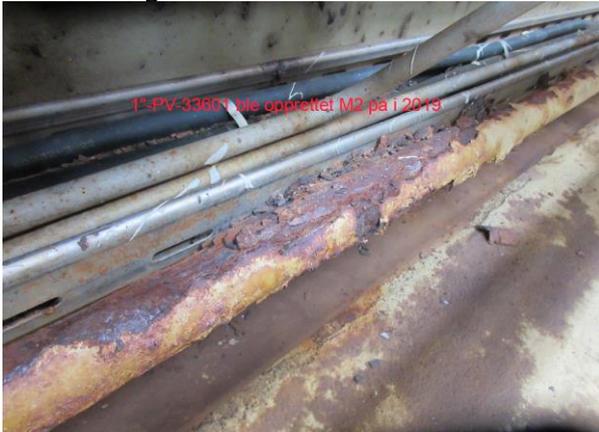
<p><i>Image 5 Appendix to M3 notification 46745491. (Source: Equinor)</i></p> <p>Comment from the PSA team: Interviews revealed that this was a misunderstanding and that the images depict line 01"-VF-33001-MF3. This corrosion finding was thereby not reported.</p>

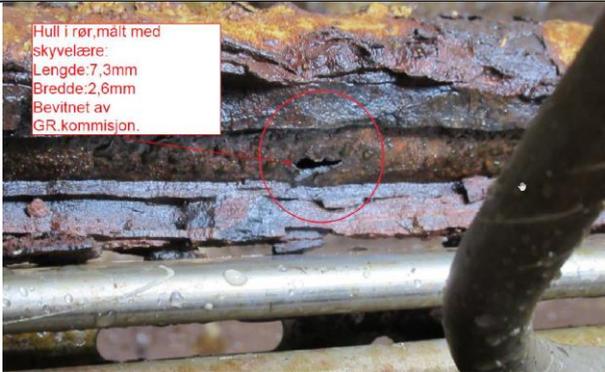
<p>Hull i rør, målt med skyvelære: Lengde: 7,3mm Bredd: 2,6mm Bevitnet av GR.kommisjon.</p> <p>Image 6 Appendix M2 notification 47074220. (Source: Equinor)</p>
24 May 2022	Leak point 2 (01"-VF-33601-MF3)	<p>M2 notification 47074214 Hole measured using callipers with the following dimensions: length 6.3mm and breadth 2.0mm.</p>

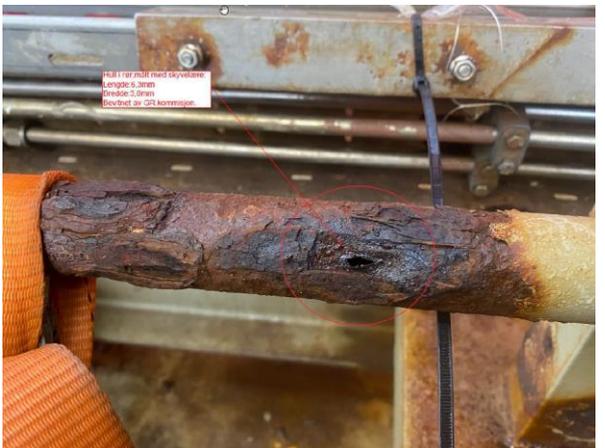
<p>Hull i rør, målt med skyvelære: Lengde: 6,3mm Bredd: 2,0mm Bevitnet av GR.kommisjon.</p> <p>Image 7 Appendix M2 notification 47074214. (Source: Equinor)</p>

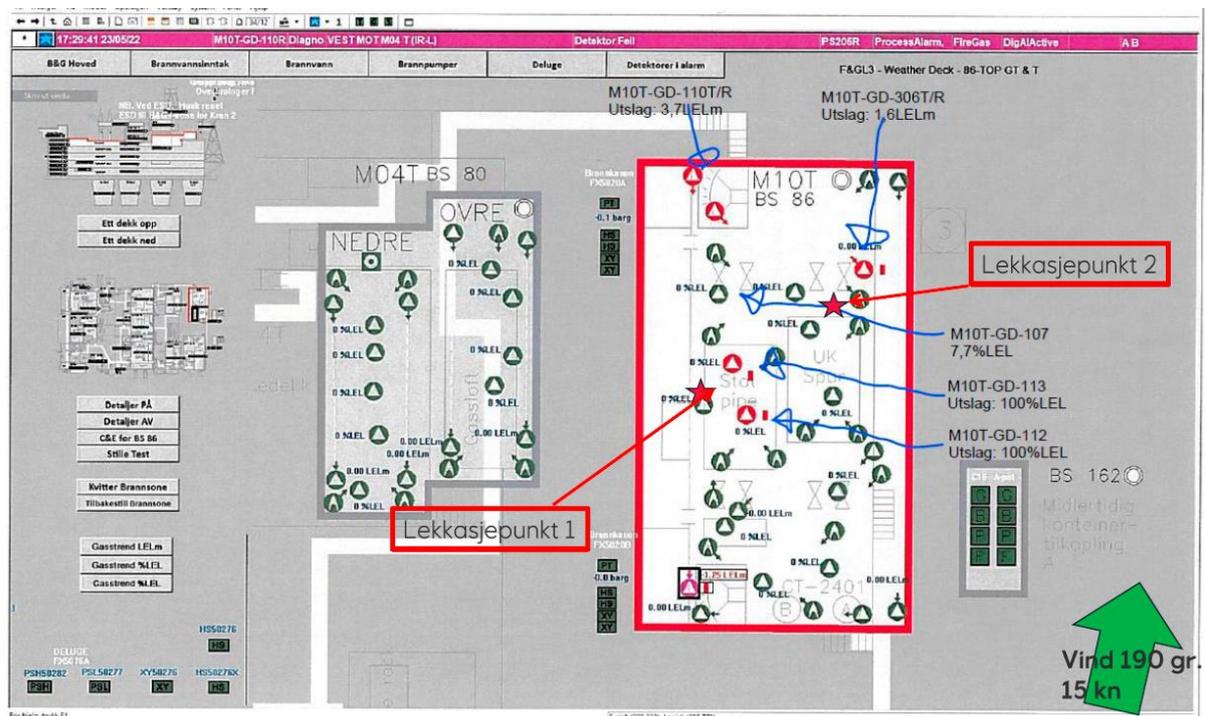
The gas leaks occurred in the open M10T process area at the upper north-eastern corner of SFB, where the gas-export metering stations are positioned. M10T is the top of the M10 injection compressor module. This houses gas turbines and injection compressor trains, which had been taken out of operation before the incident. Wind speed was 15 knots from the south-east (information subsequently received from Equinor corrects the wind direction from 190 degrees in the figure below to 170). The figure shows the activated gas detectors. The two point gas detectors registering 100 per cent LEL were installed inside the Statpipe analysis compartment, while the line-of-sight gas detectors were out in the module.

Figure 4 Overview of fire detection on M10T. (Source: Equinor)
Key: Lekkasjepunkt = Leak point; Vind = Wind 190 degrees.

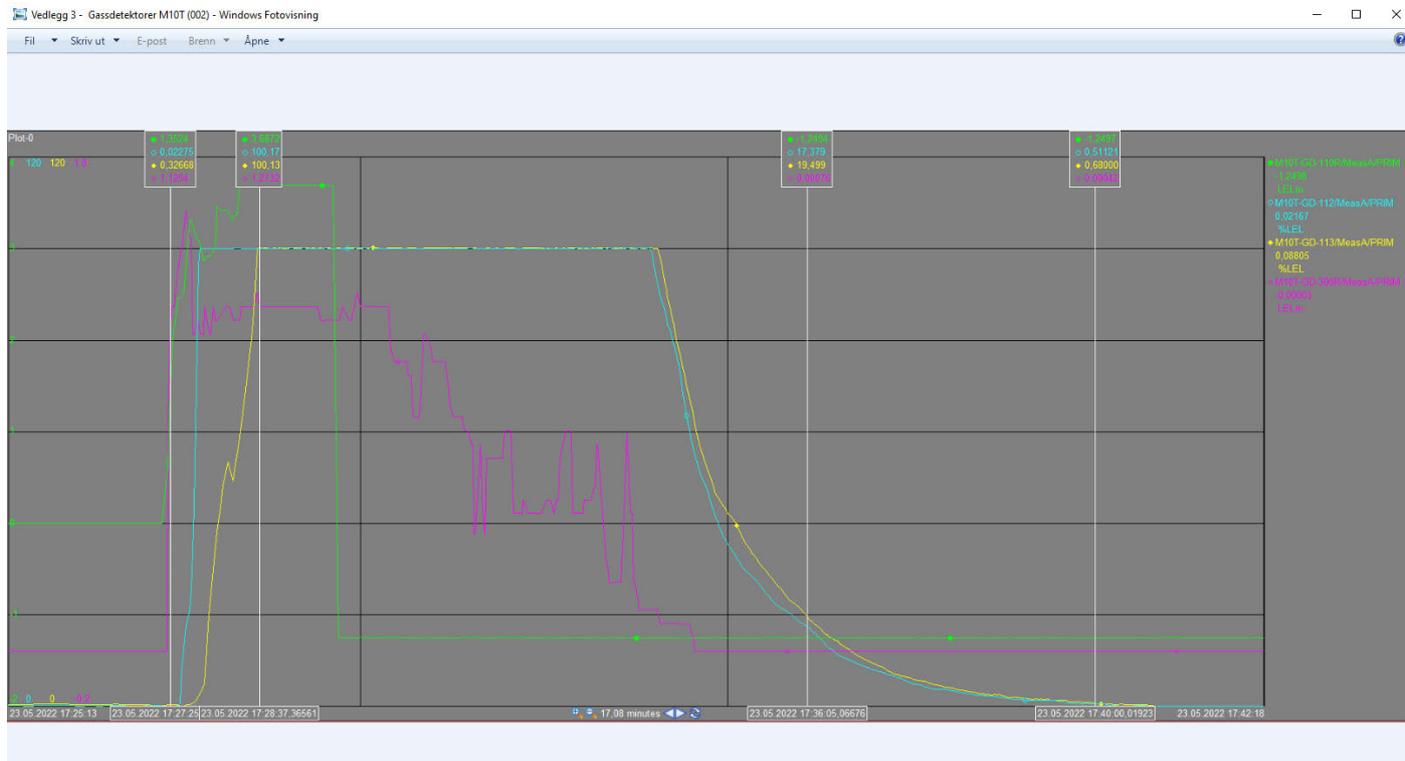
Figure 5 Activation of gas detectors on M10T. (Source: Equinor)

- The first marker shows when the first gas detectors activated. These are line-of-sight gas detectors and measure in LEL metres, with one designated as H and other as HH.
- The second marker shows when four gas detectors were activated – two line-of-site and two point.
- The third marker shows when all the detectors were below 20 per cent LEL.
- The fourth marker shows when all the detectors were down to zero per cent (at 17.40).

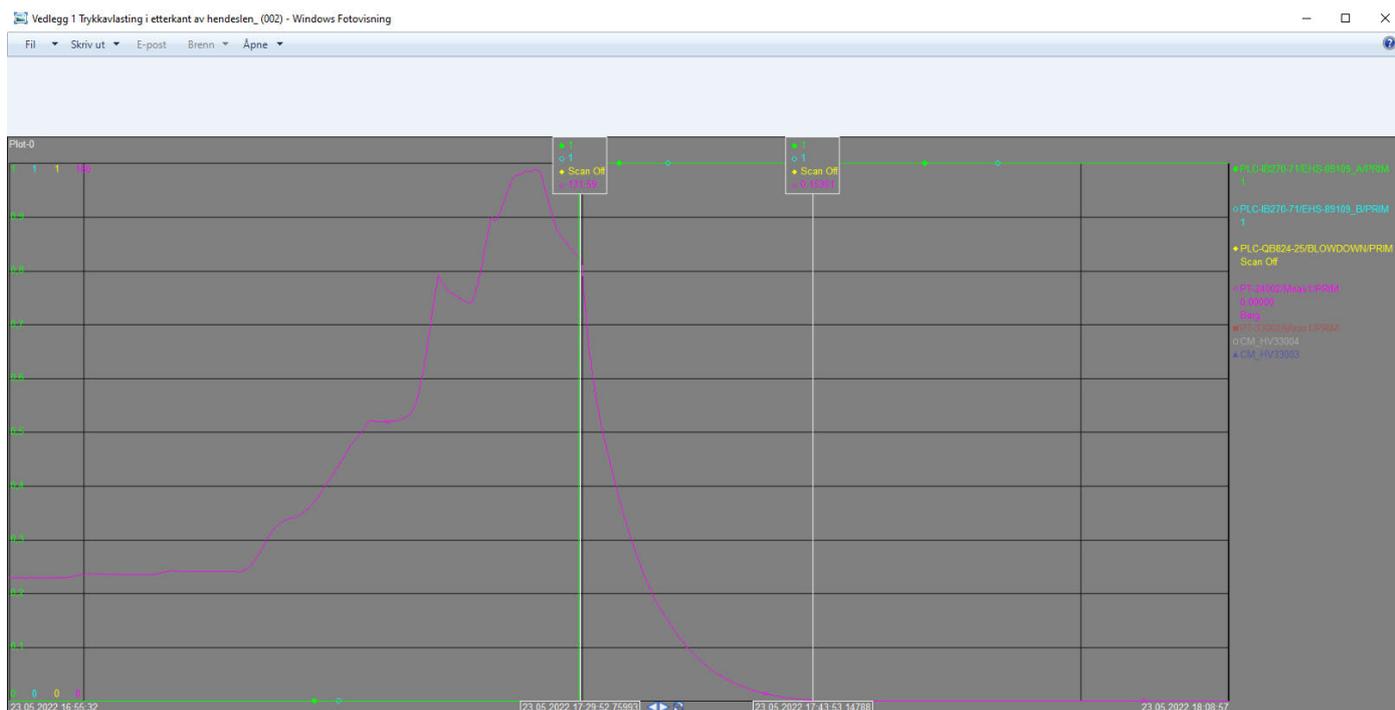
Initial pressure at the leak point was about 160 bar. Manual pressure relief was activated at 17.29.52, roughly 2.5 minutes after the GA and ESD2. The curves below show when the gas detectors activated and the course of pressure relief respectively.

Figure 6 Pressure relief in the wake of the incident. (Source: Equinor)

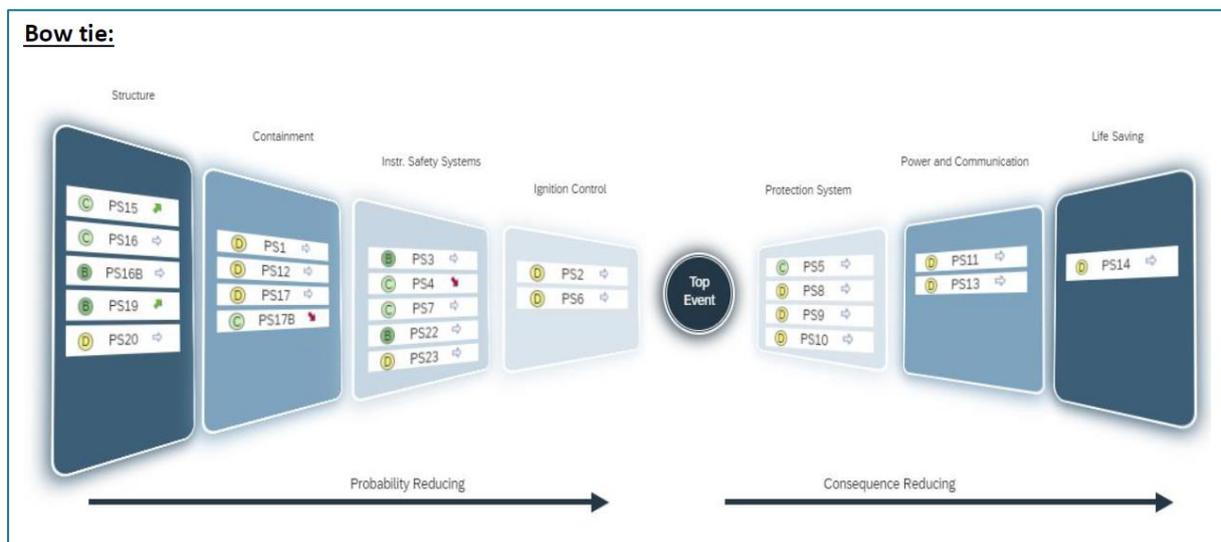
The TRA assumes that the integrity of the facility and the safety barriers is maintained. PS6 ignition source control receives a D grading (substantial deficiencies) in the Timp overview because of the risk related to the condition of heating cables, and the company has established an extended-life measure to install ignition source disconnection, with an investment decision (DG3) due in 2023. Uncertainty has also been identified over non-electric ignition sources, where the company has established a survey activity with a deadline of 31 December 2022. This indicates that ignition sources represent a vulnerability for SFB.

Figure 7 Timp picture SFB. (Source: Equinor)
