Investigation report

Report title Investigation of an incident involving a dropped object on <i>West Venture</i> on 23 March 2015	Activity number 404005004
---	------------------------------

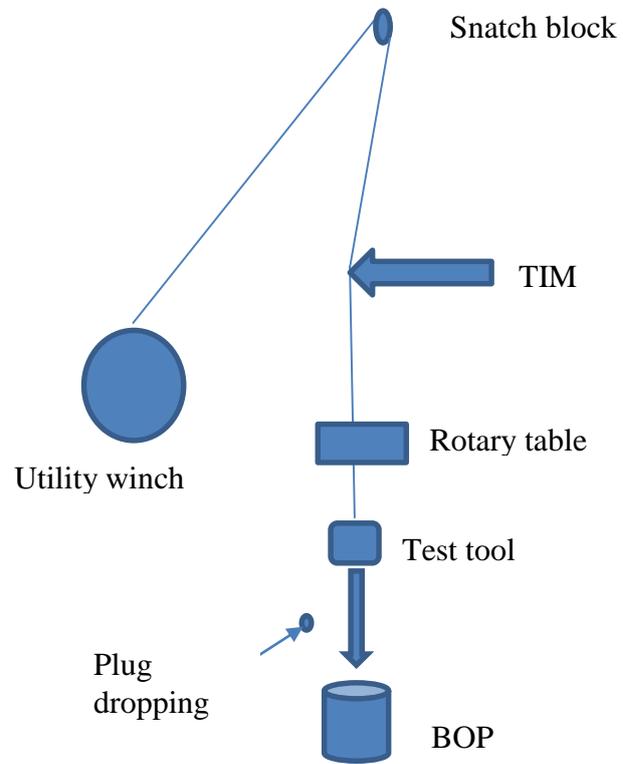
Figure 1: Diagram of the lowering operation.

A utility winch was used to hoist the test tool up and down through the rotary table to the BOP. The tool was held by three one-tonne fibre straps attached to eyebolts and assembled in a shackle in the winch hook. Roustabout 1, who was operating the winch, began the operation in cooperation with roustabout 2, who was operating the tail-in machine (TIM). The gripper claws in the latter were crossed over and the lifting chain/steel rope laid in the crossover in order to centre the lift through the spider/rotary table. Roustabout 2 functioned both as operator of the TIM and as signaller. The passage through the rotary table was a blind lift.

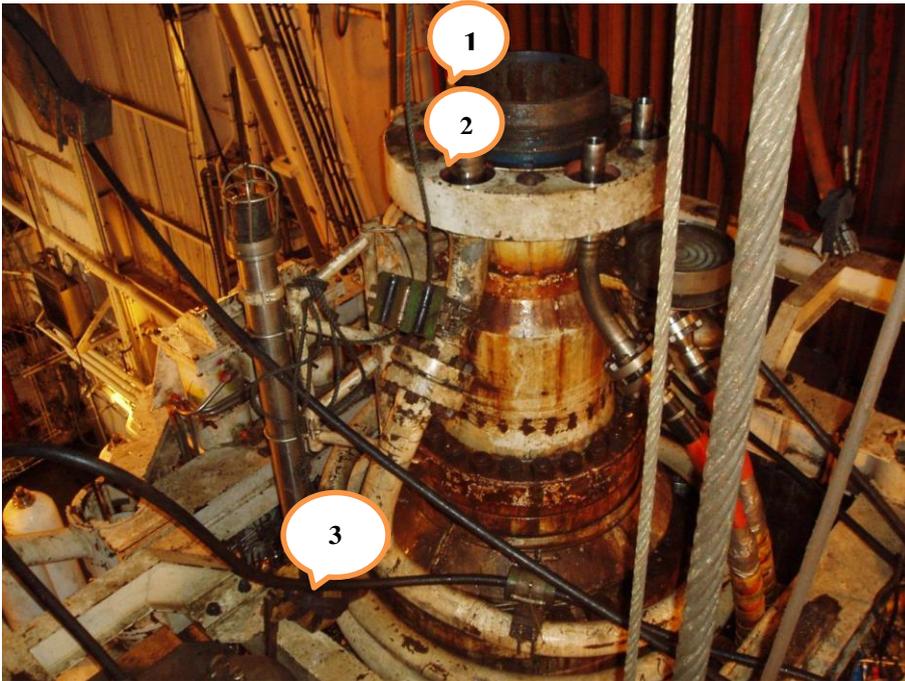
Illustration 2: Point of impact in the incident.

The test tool had five test plugs (marked in different colours) which were installed in slots in the flange on top of the BOP. These were unsecured in the released position to avoid getting stuck during installation. A released position meant that each of the five plugs protruded a little above the edge of the test tool. One plug (yellow) was pushed out of the hole in the test tool when it snagged on or struck structure(s) while descending through the rotary table or spider because the tool was not properly centred. The plug then fell some six metres and hit the flange of the mud-seal hub, where it lost much of its energy, before falling another two metres and becoming wedged between the BOP frame and the kill-line hub.

The incident occurred around 23.25 on 23 March 2015. The dropped object weighed about 90kg. Its kinetic energy just before impact over six metres was calculated as 5 297 Joules.

1. First point of impact on top of the mud-seal hub
2. Second point of impact on the kill-line hub
3. Third and final point of impact, where the dropped object came to rest.

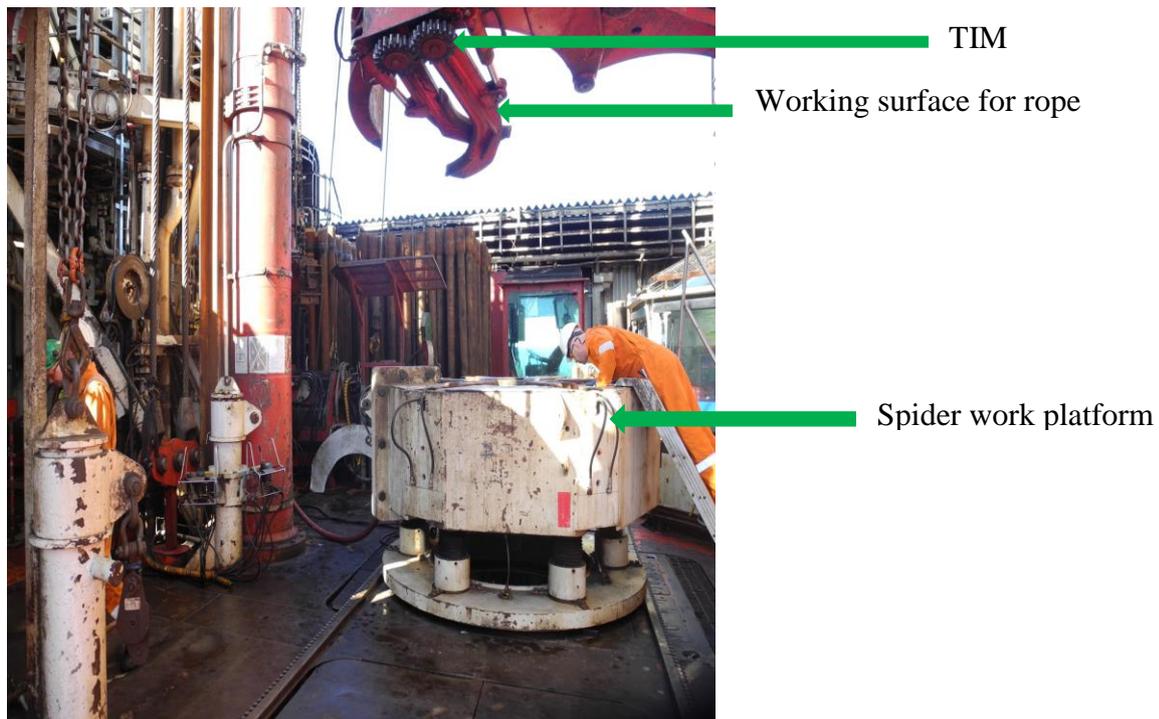
Illustration 4: Spider.

The direct cause of the incident was the entanglement of the test tool during lowering with one of several structures protruding into the opening in the work platform or the rotary table. This caused one of the unsecured test plugs to be pushed out of its slot, fall off the test tool and hit the BOP.

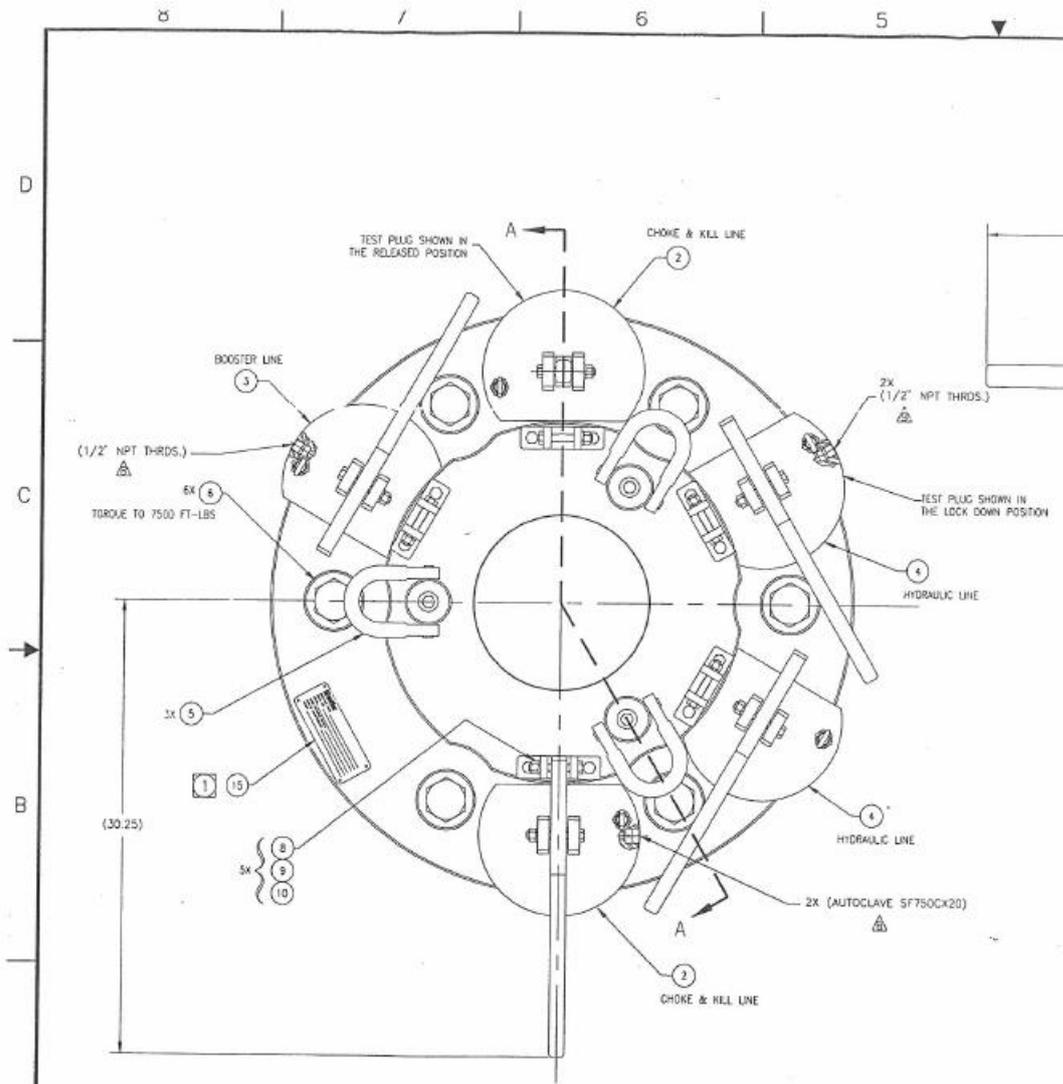
Illustration 6: Diagram of test tool.

- Nor were user instructions available, and these probably did not exist either. It transpired that only a diagram of the test tool was available, and that this was in a file held by the toolpusher.
