Investigation report

Report	
Report title Report following the investigation of a turbine breakdown with subsequent fire at Tjeldbergodden on 2 December 2020	Activity number 001904026

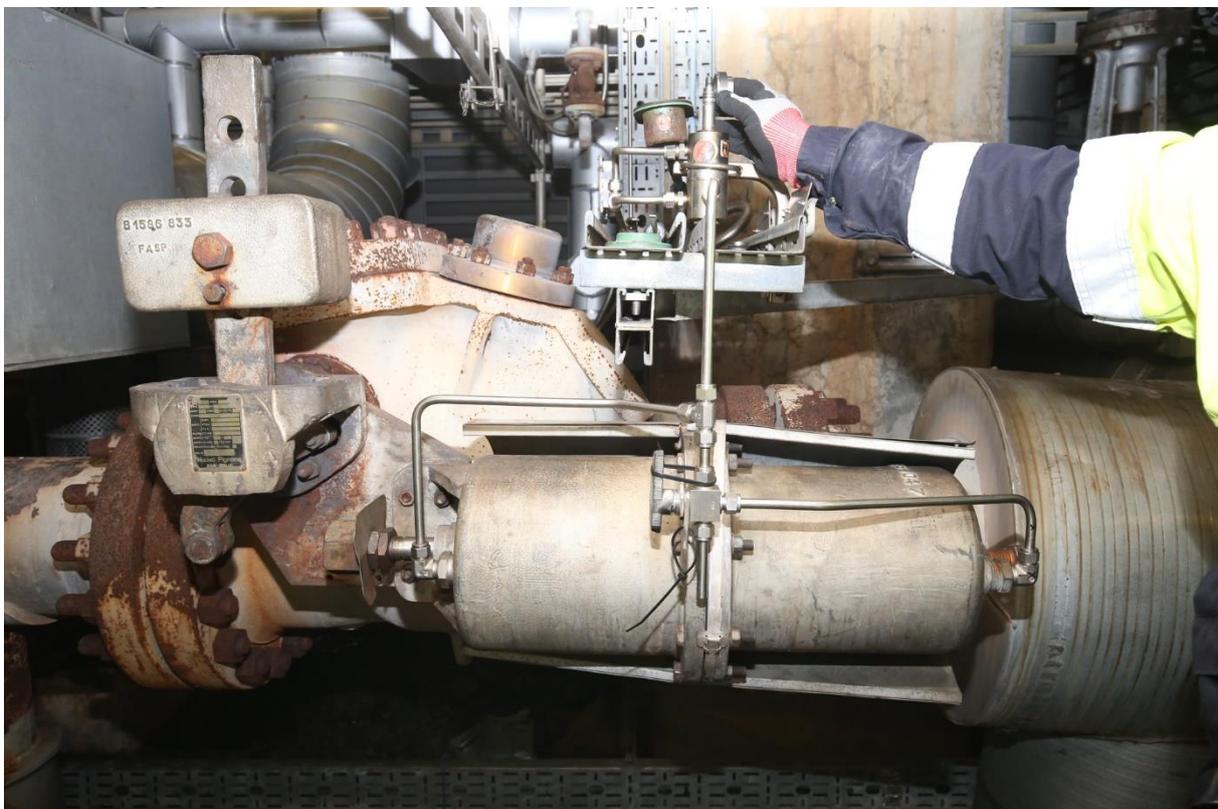
Figure 6 The Flintstone valve after the incident (source: Kripas).

Actuator movement was noticed in October during a logging tour of the plant. The Flintstone valve's solenoid had probably been damaged by a sandblasting job in the vicinity. A temporary repair was made with a non-original piston seal and some new O rings while the plant was in operation.

The valve was entered in SAP as "serious ill". It was assumed that the impairment could cause unintentional closure but not that it could fail in the event of a closure signal. The Flintstone valve functioned as intended in connection with a shut-down in November, when a repair (tightening) was made to the pack box to avoid external steam leaks.

A couple of months before the incident, actuator movement was observed on the Flintstone valve during a logging tour of the plant. Owing to uncertainty over the choice of solenoid type, it was decided to make a temporary repair while the plant was operational. This was expected to prevent unintentional closure of the valve, and the safety function was considered to remain intact. A notification was established for final repair. During a system shutdown a couple of weeks later, a new temporary repair was carried out with the same valve. This involved tightening the pack box to avoid external steam leaks.

The Flintstone valve was categorised in SAP as "serious ill". As described above, the valve has two independent closure functions. Temporary repairs were made to both of these in October and November 2020. Section 4.1.2 describes the machine's overspeed protection. The mechanical protection closes the quick closing and the HP/LP control valves by bleeding off the oil pressure keeping them open. Calculations have shown that the volume of flow through the holes in the LP control valves is sufficient to speed up turbine rotation if the generator is disconnected.
