# Investigation report

Report	
Report title Hydrocarbon leak in the process plant at Hammerfest LNG	Activity number 001901027

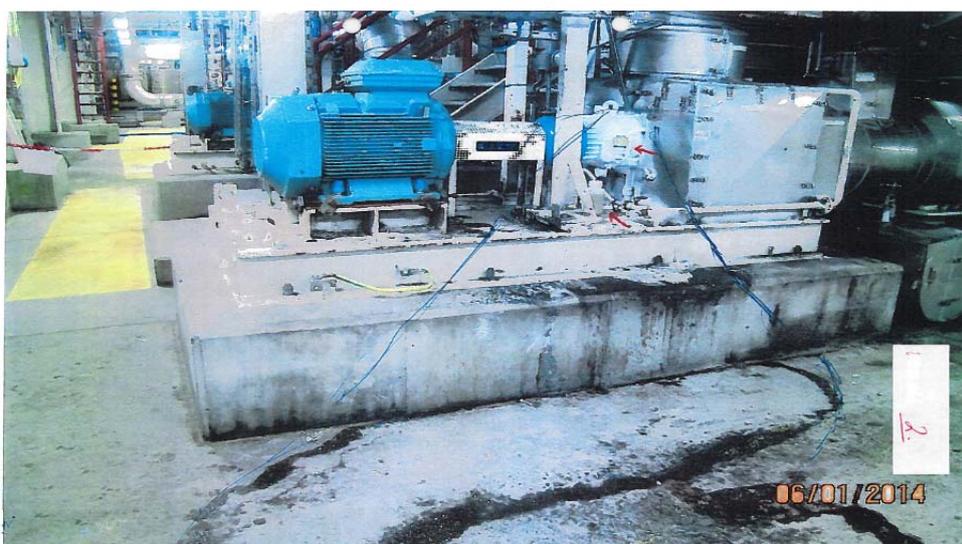
Illustration 2. Sketch of the location of the observed ice build-up.

The incident manager inspected the area around the pump and noted ice build-up fanning out from the stuffing box. See his sketch on illustration 2. The ice build-up could not be seen on the other side of the pump. Noted that the plastic flask and not-return valve were ice-covered.

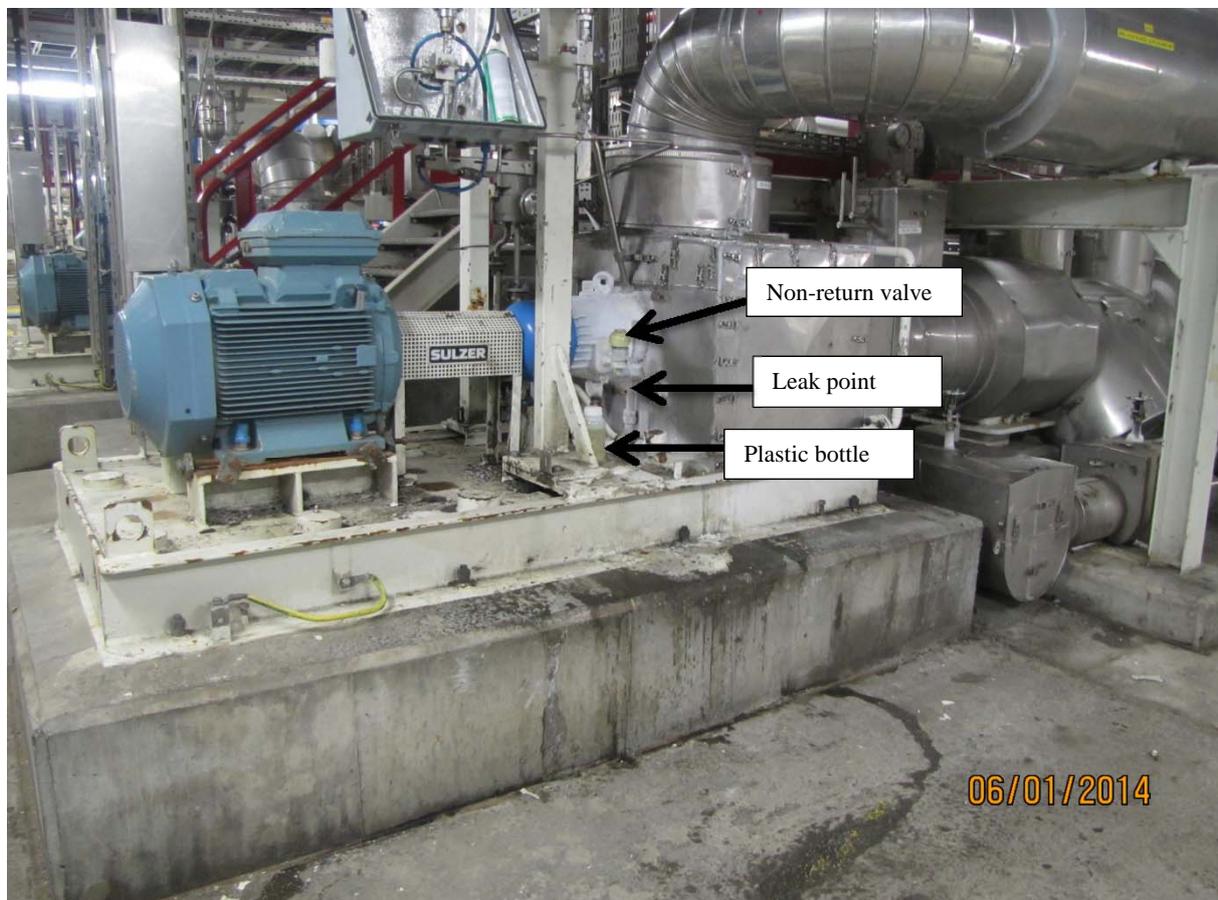
Illustration 3. The leak site.

The leak site was determined to be through the stuffing box for pump 25-PA-102B. Wear was observed on one of the gaskets in the box. The underlying causes of this wear have not been clarified.

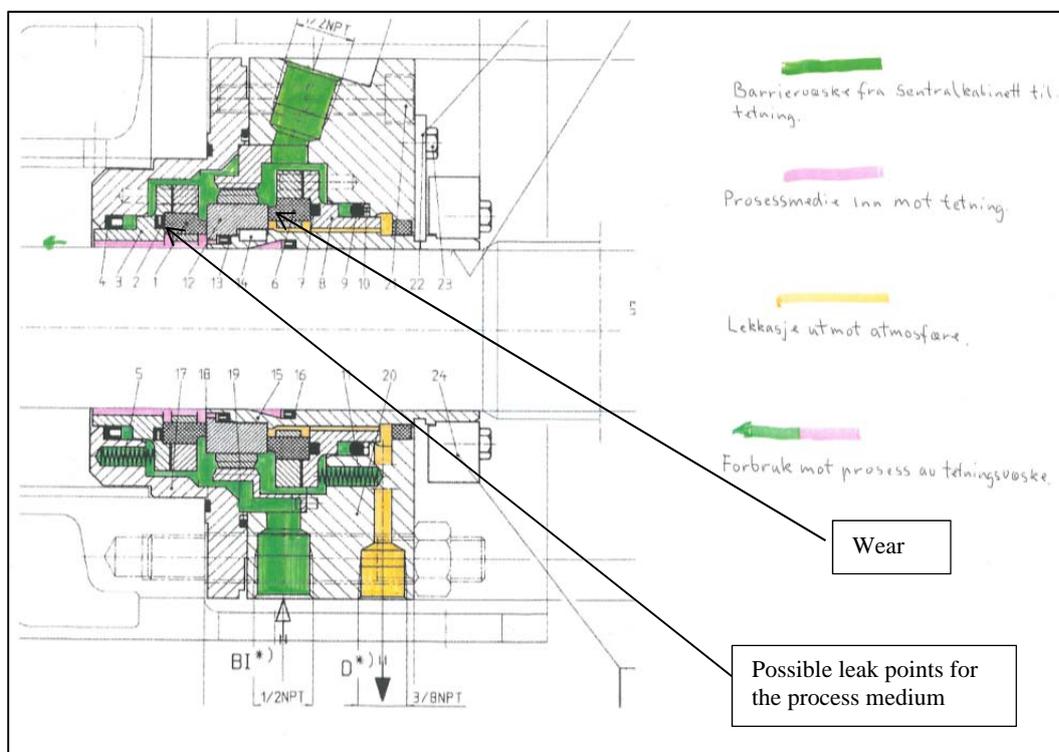
Illustration 6. Cross-section of the stuffing box.

Pump 25-PA-102B was disassembled and taken to the workshop on Tuesday 14 January, where the stuffing box was removed from the shaft and broken open to look for damage. Deposits were found in the box which should not be there, along with some small visible damage to wear rings and gaskets. Statoil resolved to send the stuffing box to the manufacturer for closer examination. This work began on 29 January 2014 at EagleBurgman in Wolfratshausen. This investigation showed 0.8 mm of wear on the gasket at position 6. See the cross-section in illustration 7. That means an opening will occur in the stuffing box there. The n-pentane sealing liquid has leaked out via this route. The liquid has a normal operating pressure of 73 bar, while the process medium pressure is 60 bar. That provides an overpressure of 13 bar in relation to the medium. When the sealing liquid disappeared, pressure fell to around 15 bar. The stuffing box depends on overpressure from the sealing liquid to maintain its sealant function against the process. With an overpressure of 45 bar, the process medium has several opportunities for leaking into an area where sealing liquid is normally present. Some of these opportunities are at positions 1, 2 and 12 on the cross-section in illustration 6. The process medium leaks out via the same route as the sealing liquid.

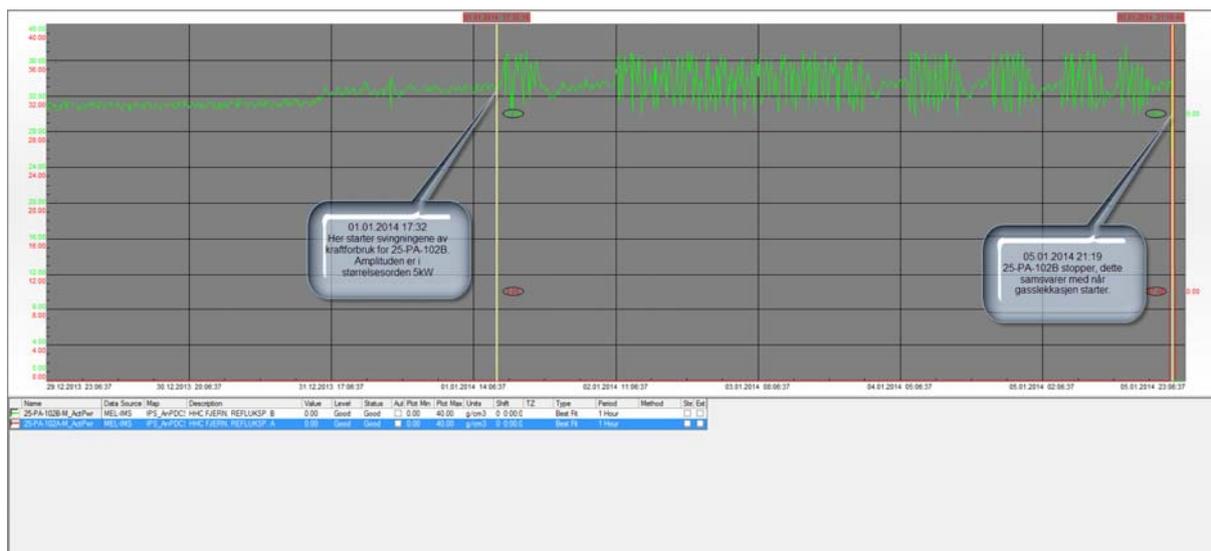
Illustration 8. Trend for energy consumption.

The trend for pump 25-PA-102B showed a clear increase in fluctuations in energy consumption over the five days before the incident. See illustration 8.

Trend data is not used actively in combination with maintenance history. In the continuous monitoring and operation of the facility, data for essential equipment are not extracted regularly or subject to qualified technical analysis and assessment.

The power consumption trend for the electric motor driving pump 25-PA-102B shows a clear increase in power consumption fluctuations over the five days between the incident.
