Investigation report

Report	
Report title Updated report of the investigation into personal injuries on Heimdal on 28 November 2019	Activity number 001036022

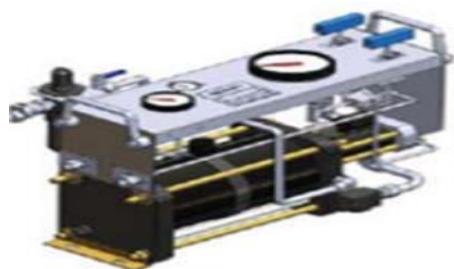
Figure 3: Booster pump. (Source: Safety Alert/Equinor)

The pump involved in the incident had neither pilot nor safety valve for limiting maximum delivery pressure. Given a delivery pressure from the central nitrogen gas system of about 130 barg and a maximum available pressure for working air of close to nine barg, delivery pressure could be varied from about 250 to 805 barg by adjusting air pressure. Other than that adjustment, this pump does not permit presetting the desired delivery pressure. Reducing air pressure into the pump will also extend the time required for pressurisation.

This pump has a self-limitation of 1 000 barg.

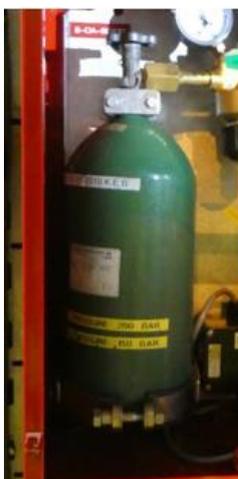
Used only for manual release of CO₂, the type of cylinder involved in the incident is certified for an operational pressure of 200 barg and has a test pressure of 348 barg.

Figure 4: A 3.4 litre nitrogen gas cylinder. (Source: Safety Alert/Equinor)

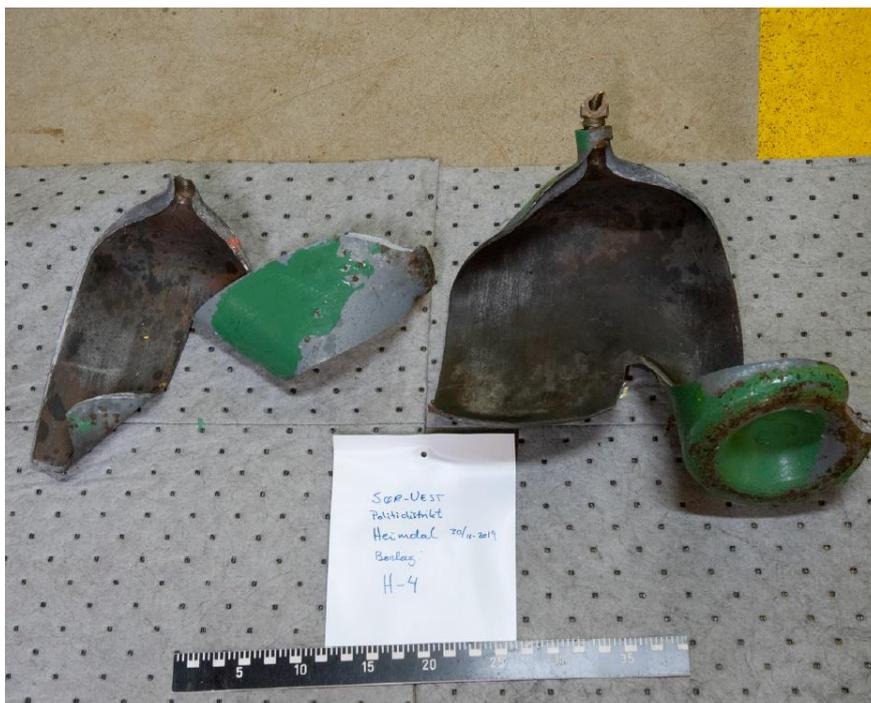
Figure 6: The burst cylinder. (Source: the police)

The direct cause of the incident was that the nitrogen gas cylinder burst during pressurisation because it was probably exposed to a pressure significantly above its design level.
