Investigation report

Report	
Report title Investigation of lifting incident with personal injury on Heidrun	Activity number 001124036

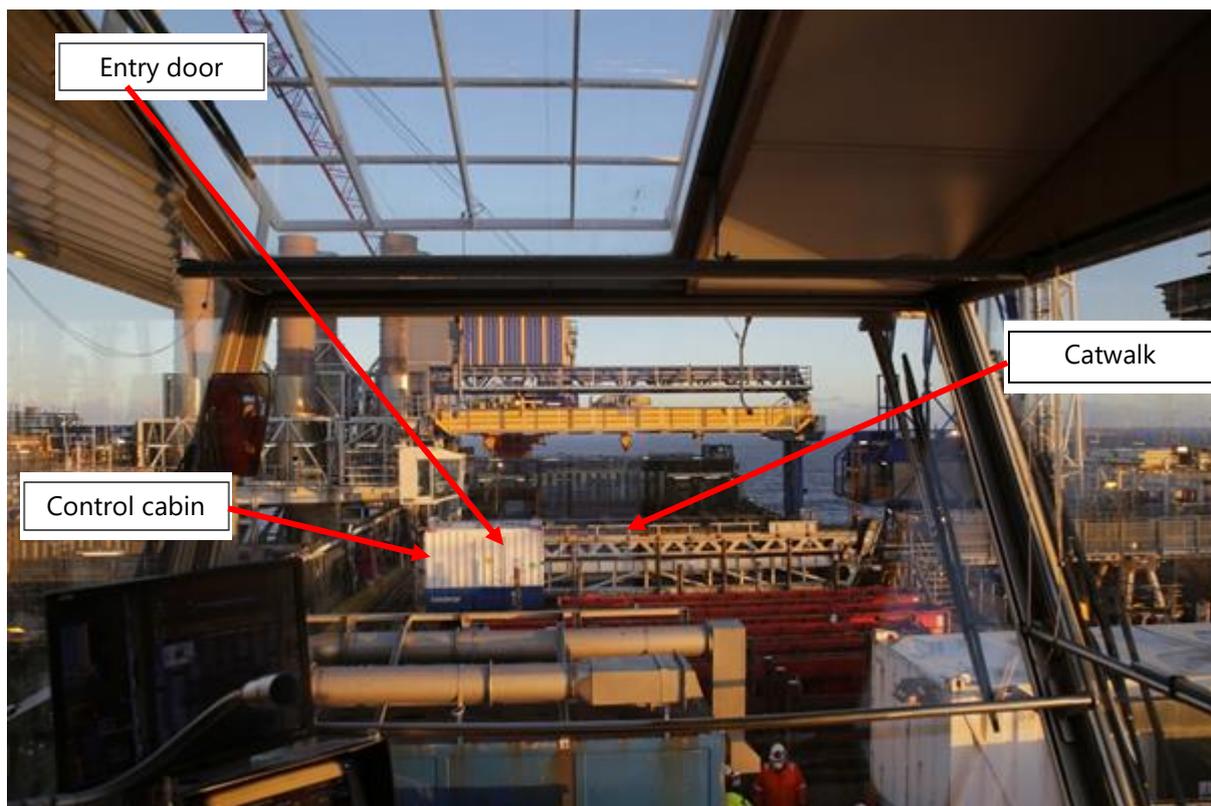
When the incident occurred, the first of the four loads – the control cabin – had been lifted onto the pipe deck and positioned correctly in the pre-planned area. The cabin was installed with the personnel door facing the west offshore crane, and with its wire rope lifting sling laid on the opposite side to the door opening, looking east towards the catwalk and away from the crane operator. This was intended to avoid the sling coming into conflict with the entrance door on the west side. See figure 2 below.

Figure 2: Photographed from the west crane in the position it occupied during the incident. The control cabin is the white and blue structure to the left, with the catwalk behind it. Source: police.

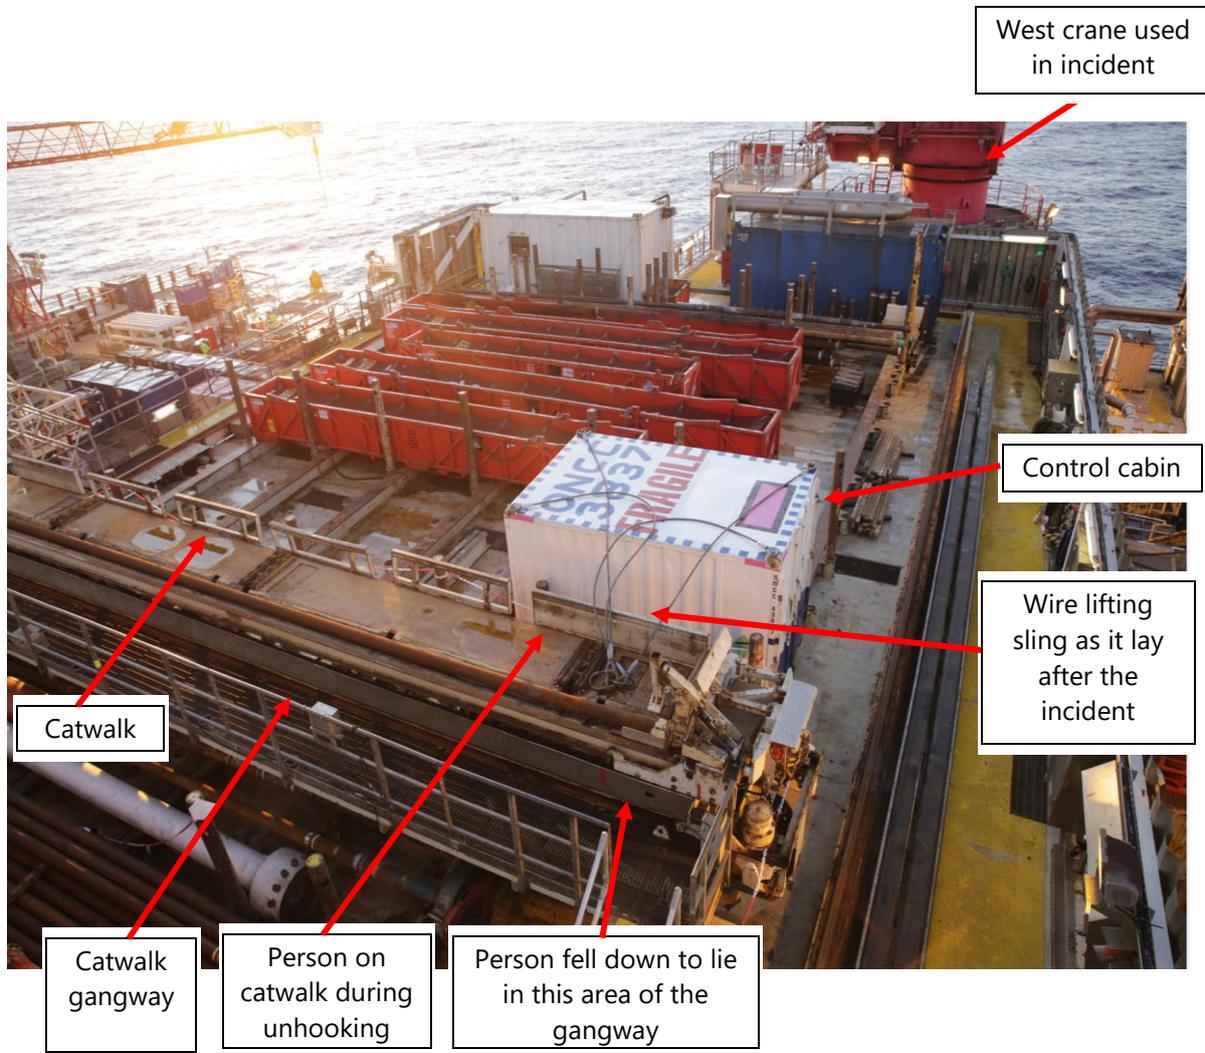
Figure 3 - Overview of pipe deck with catwalk and cabin, with west crane in the background. Source: police.

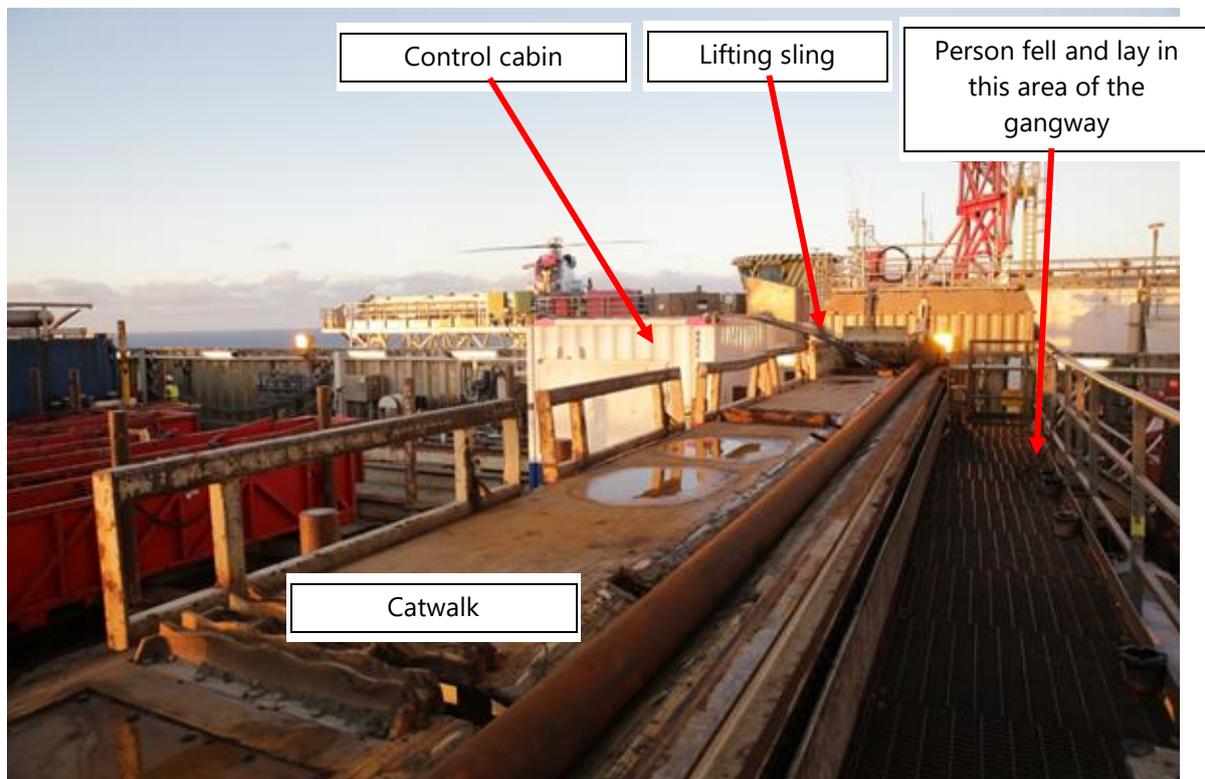
Figure 4: Where the slinger was located. Cabin visible to the left of the catwalk. Source: police.

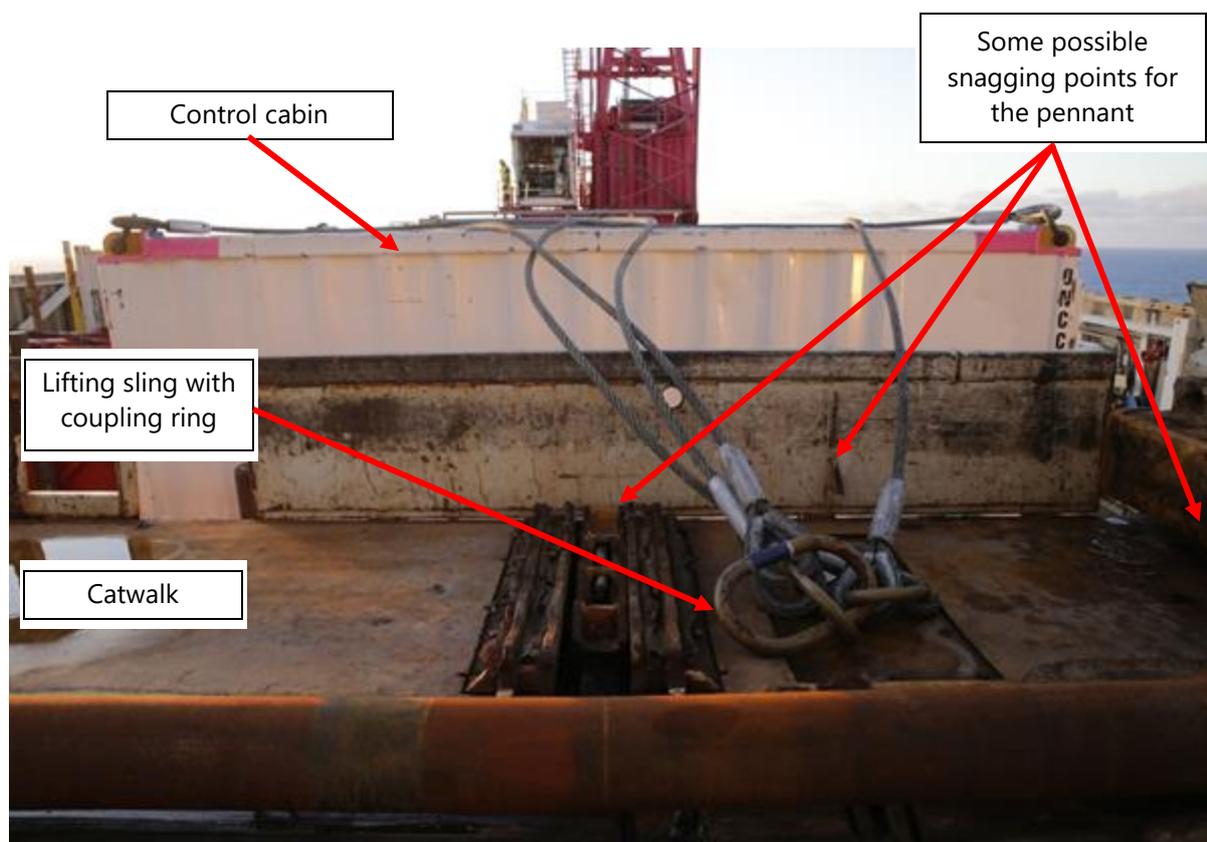
Figure 5: Location of wire rope sling during the PSA team's inspection of the incident site. The west offshore crane is visible in the background. Source: police.
