# Konstruksjonsdagen 2023

## Undersøkelser av grout-forbindelser på Gyda

Morten Bærheim, Repsol Norge AS.  
Andrew McVey, DNV  
Ørjan Nordhus, Aker Decom

## Gyda jacket post-life inspection

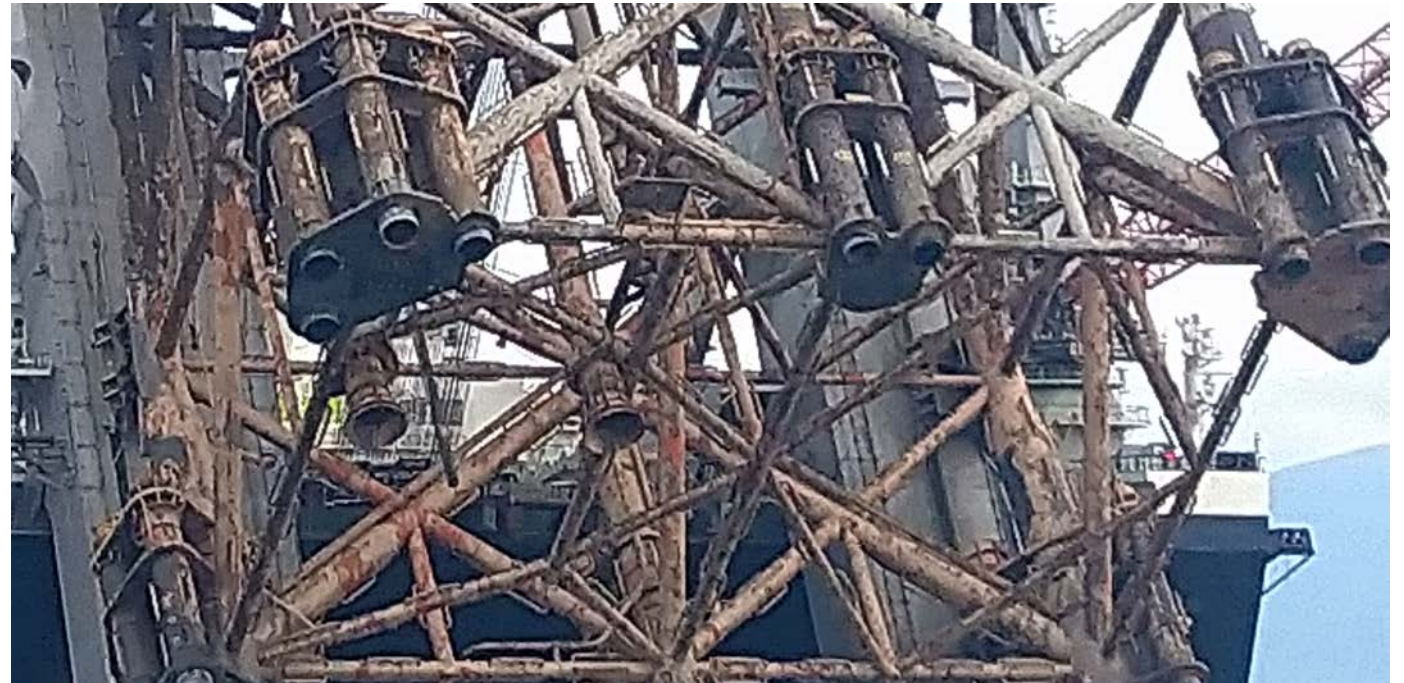
## Inspection of joints with short fatigue lives

- 6 joints were inspected by DNV UT specialist without any reportable findings
- This was expected since design was done with conservative assumptions, especially for SCFs

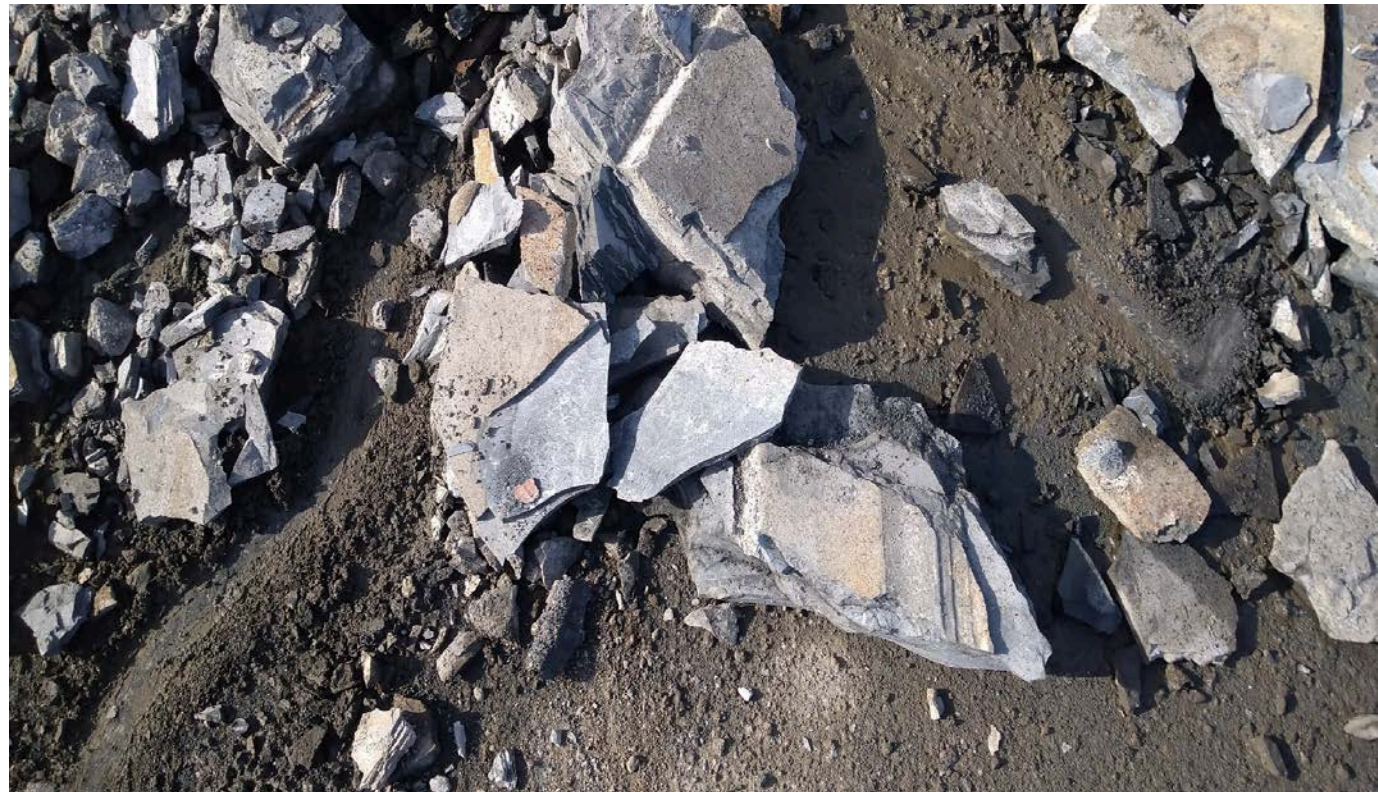
- The grout was in areas found to be layered – not isotropic as expected
- The extent of layering varied from only the lower part to nearly the full height of the pile sleeves

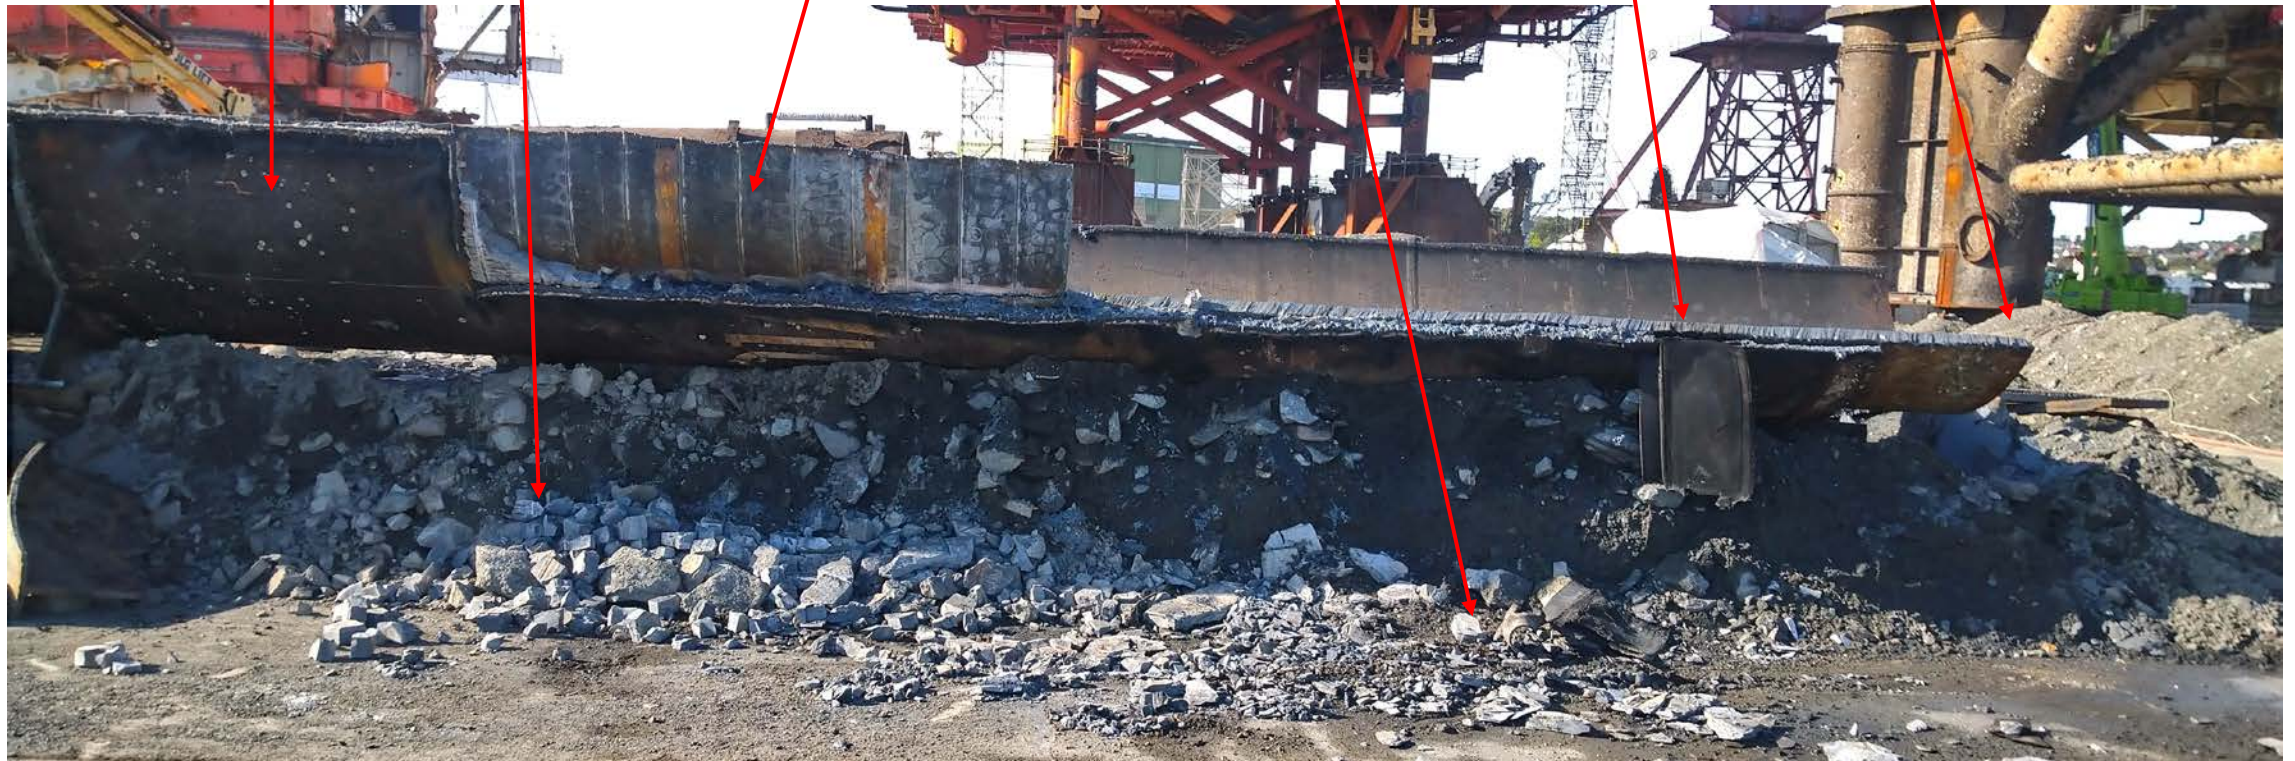
Initial Repsol observations during early decom site visit before DNV testing:

Pile sleeve

Isotropic grout

Pile with grout beads

Layered grout

Grout packers

Pile cut level

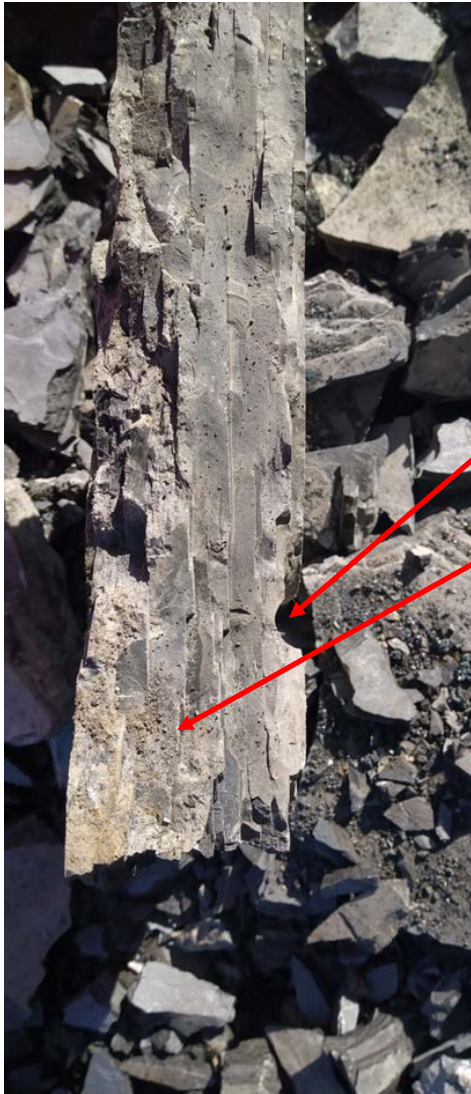
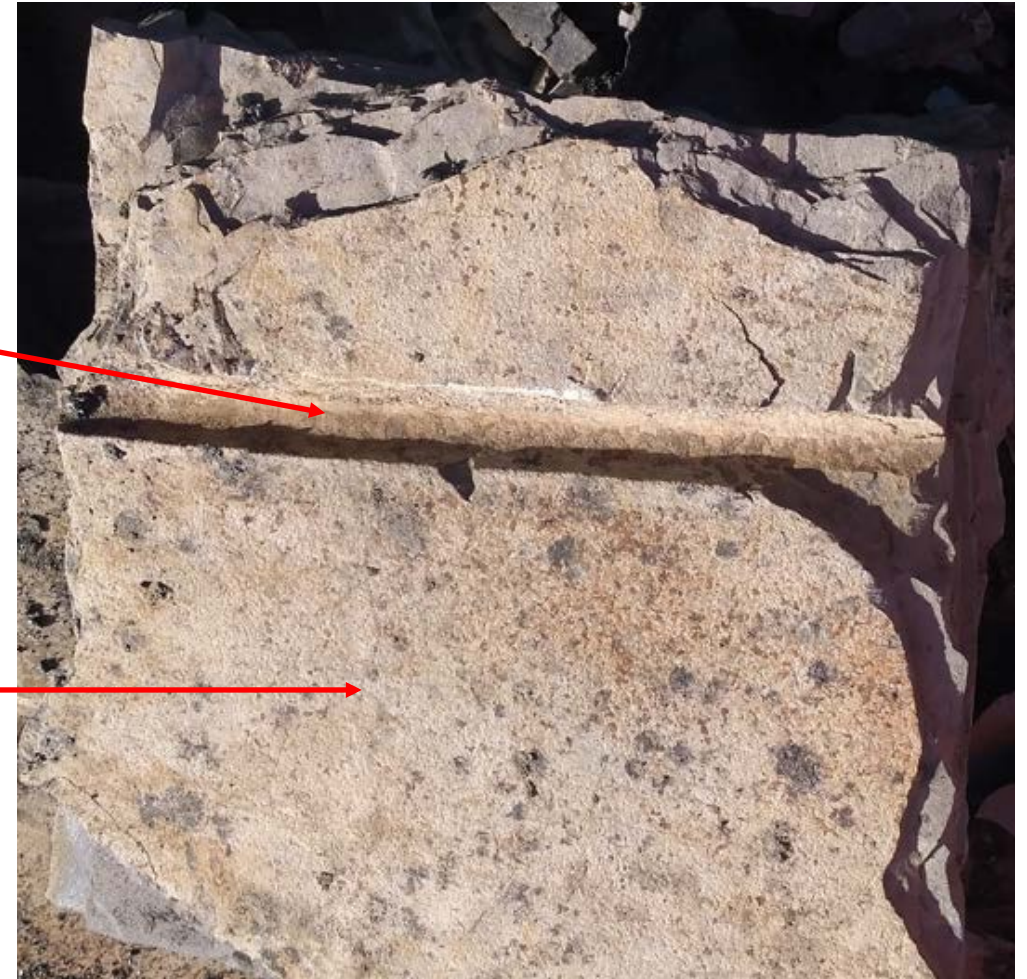
- Intact grout around bead marks
- Some strength between grout layers
- No visible sliding between steel and grout

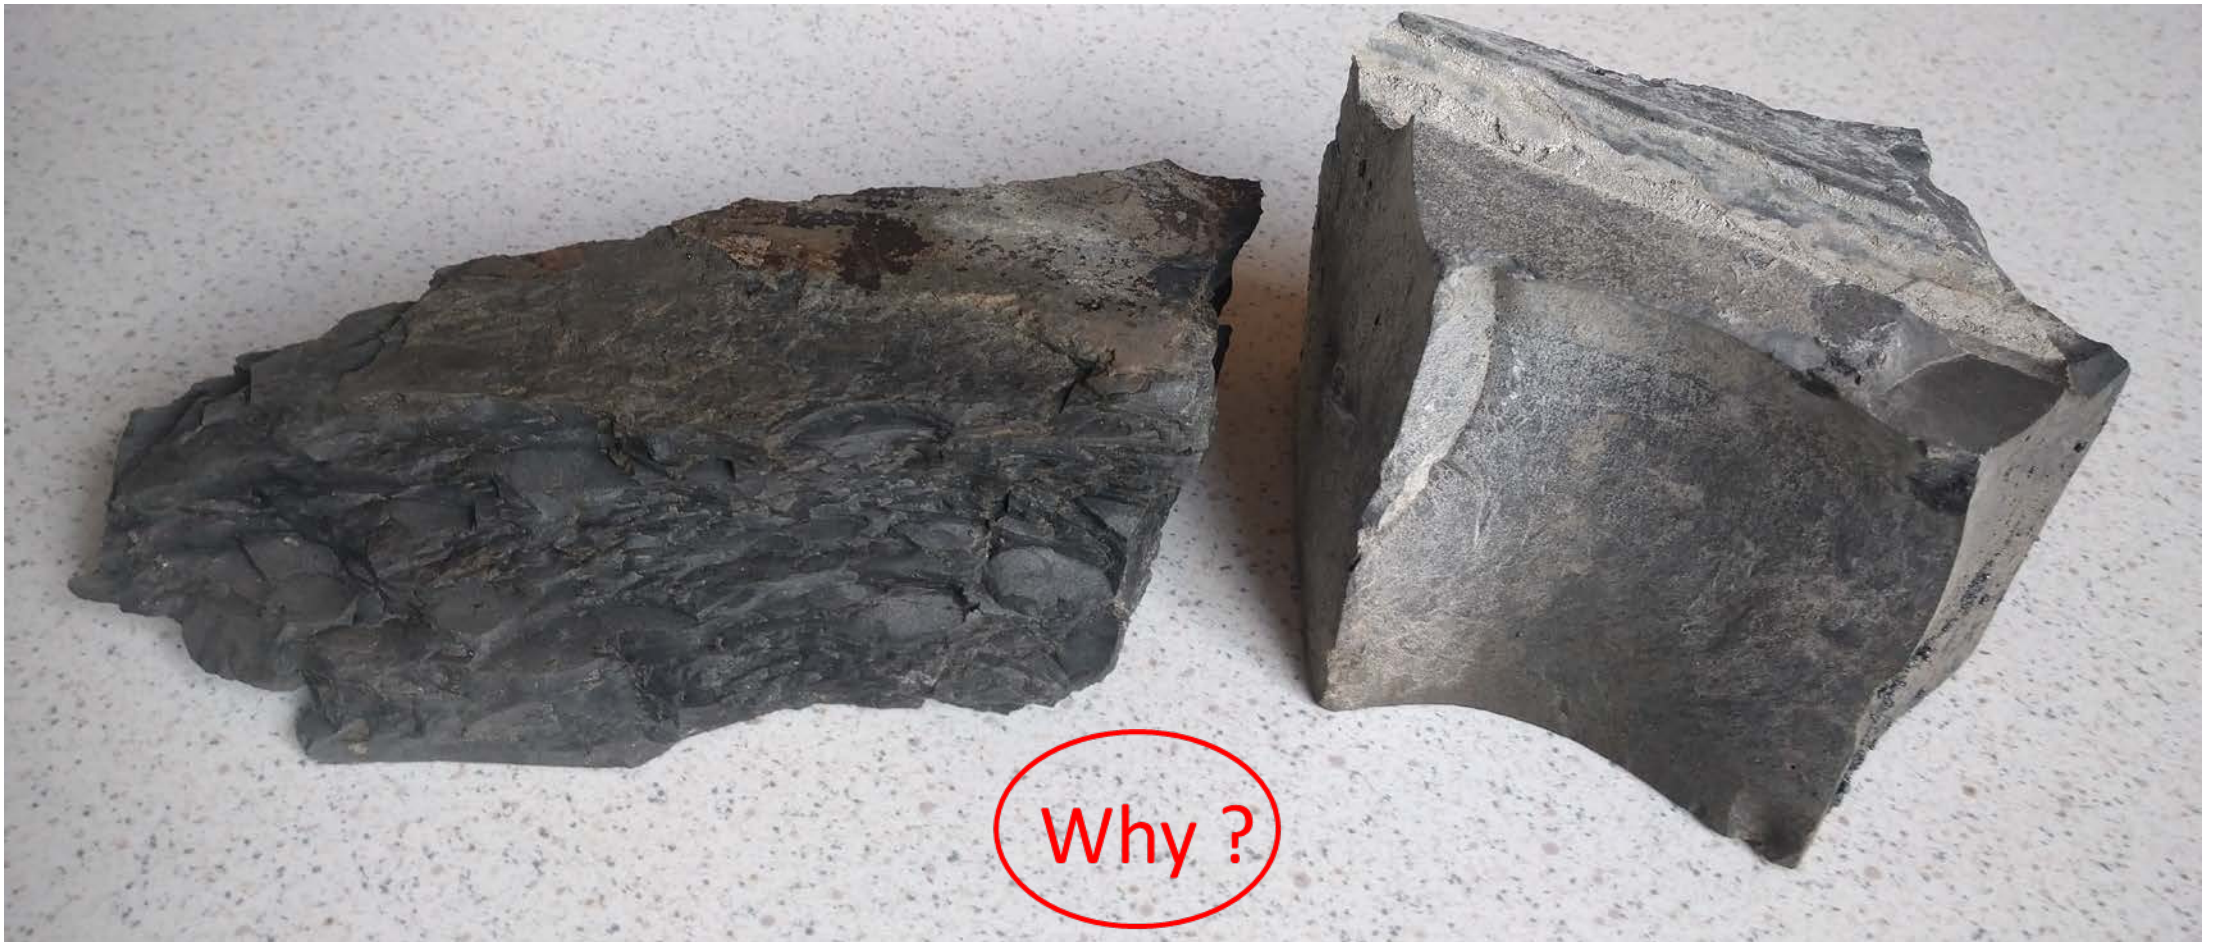
Layered grout from lower part of sleeve

Isotropic grout from upper part of sleeve

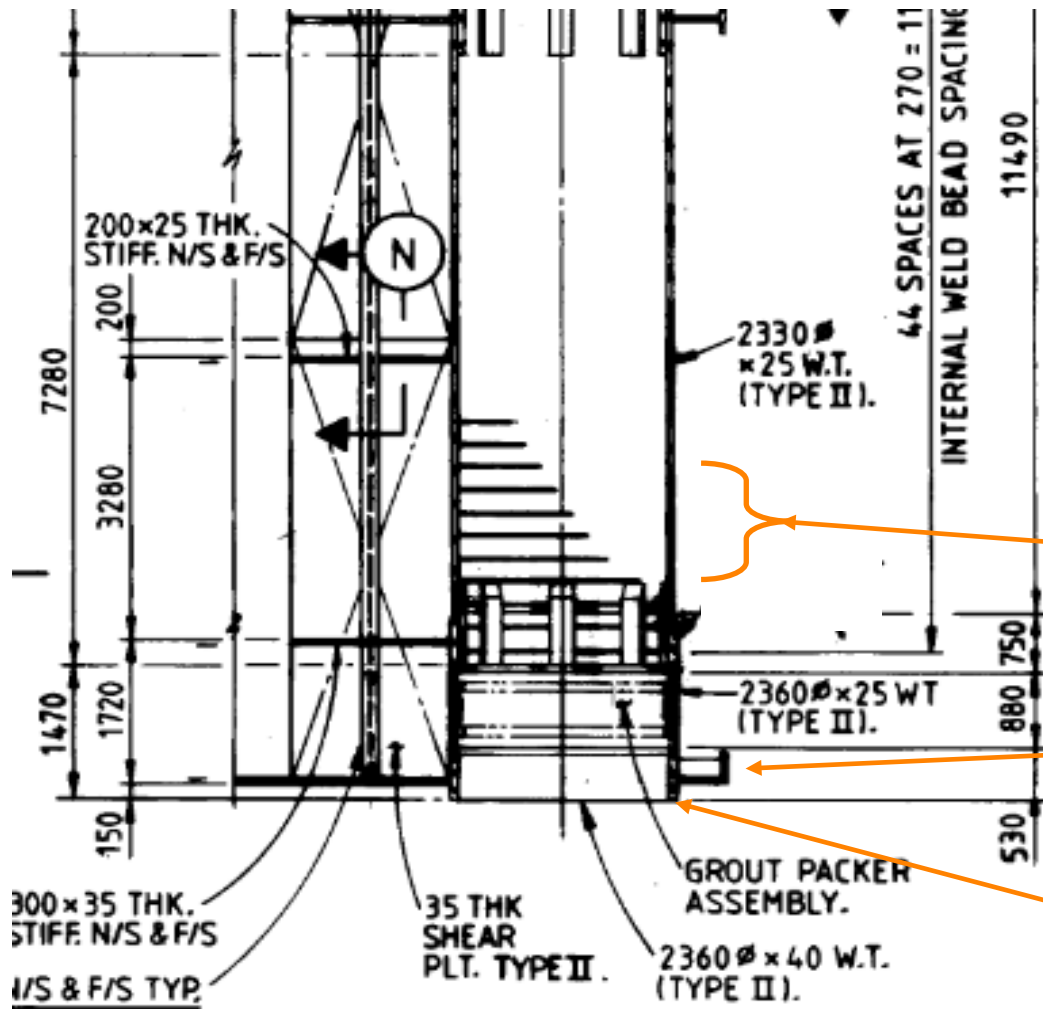
Pile grout Gyda - Pile sleeve

Location of test samples

No skirt on mudmat

Sleeve extends approx 200 mm below mudmat

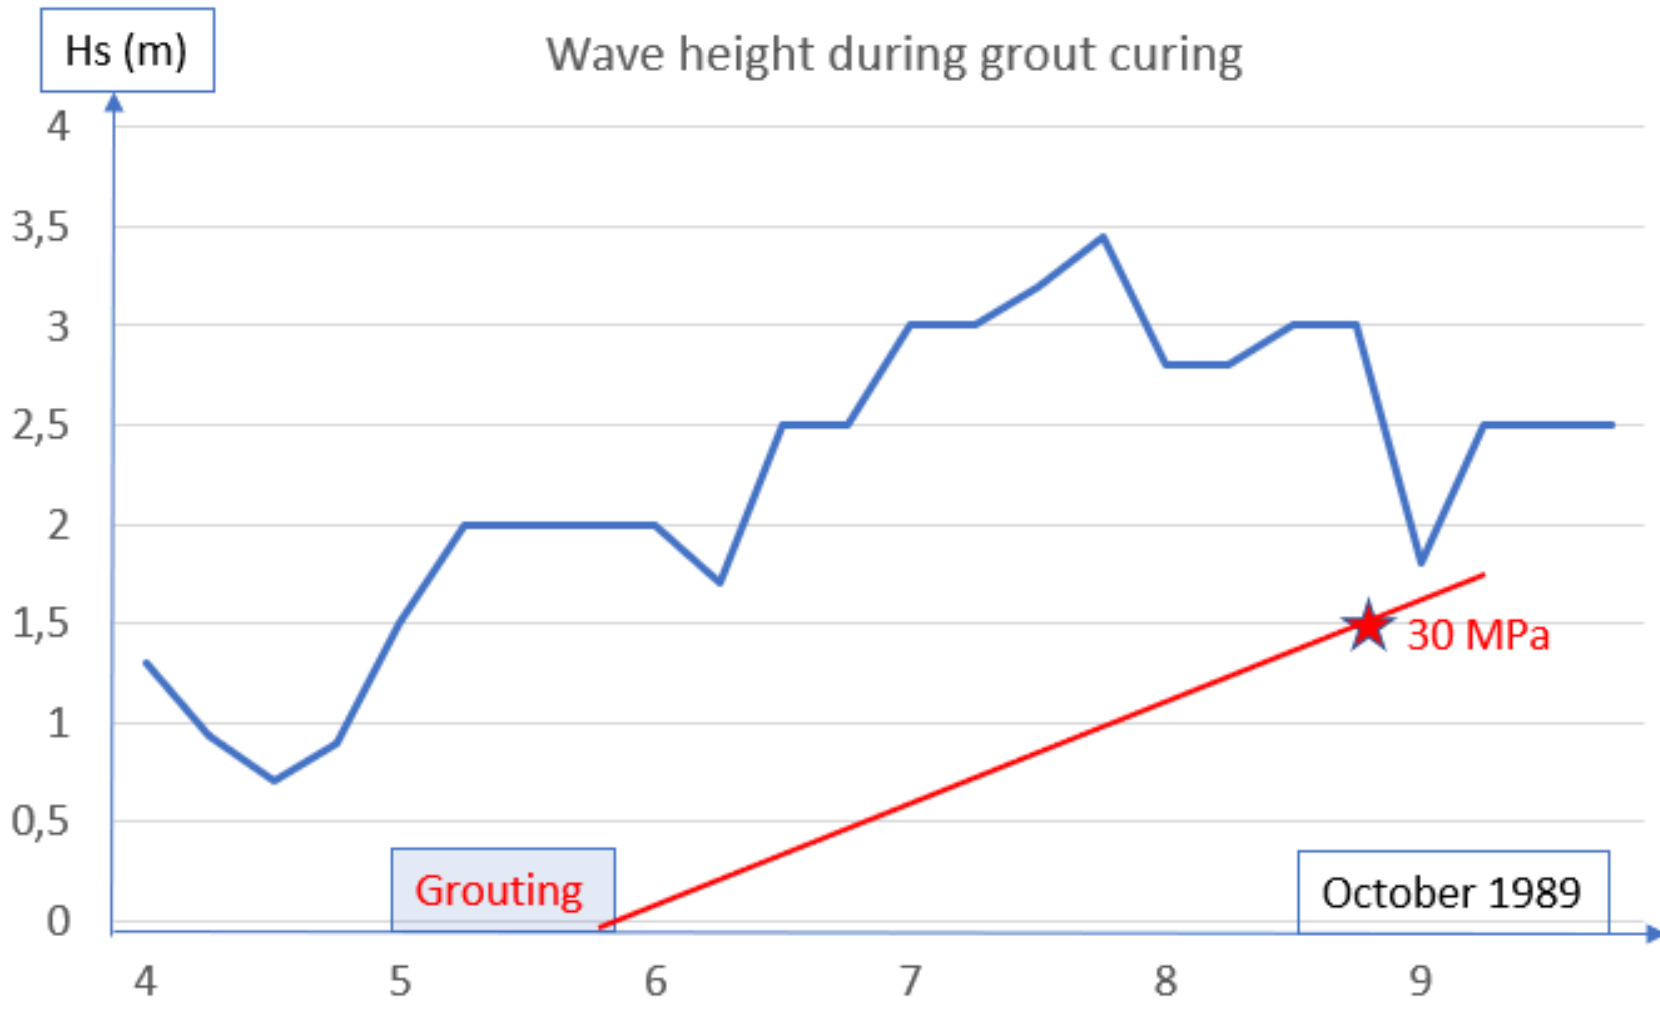
# Pile grout Gyda - Gyda jacket installation 2

Weather conditions were not ideal but still considered to be acceptable
