# Investigation report

Report	
Report title Investigation of the incident in well 7132/2-1, unintentional disconnection of the lower marine riser package (LMRP) on <i>West Hercules</i> , 16 January 2019	Activity number 404008005

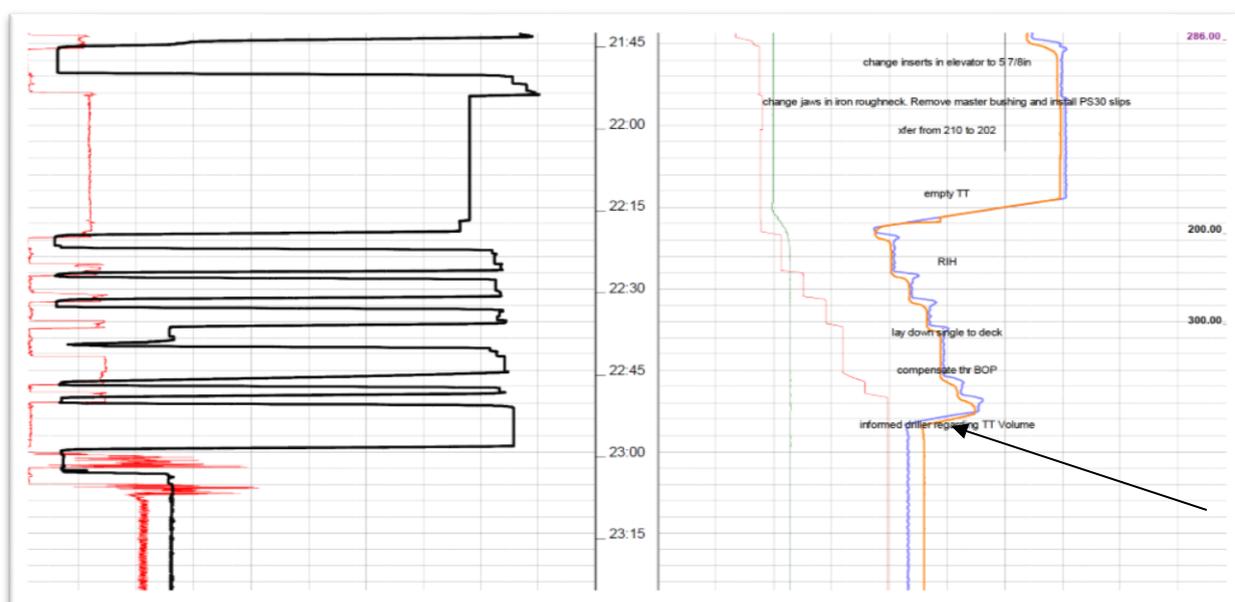
An unusual noise heard at 22.51 coincided with a rig movement. Loss of drilling fluid from the trip tank was then observed.

Figure 8: Activity log and loss of fluid. (Source: Seadrill)

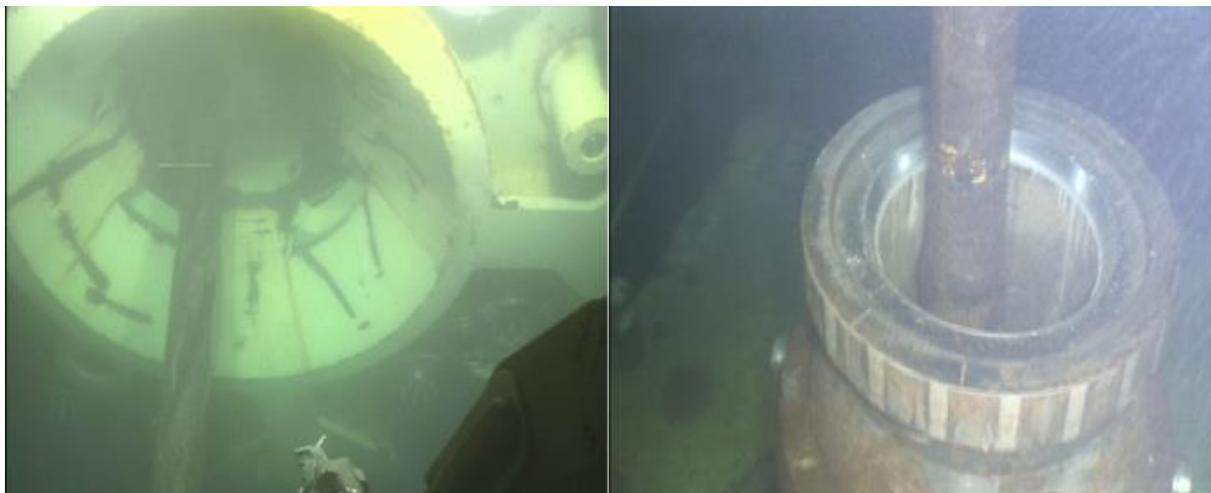
ROV surveys confirmed that the LMRP was disconnected. The drill string was centred and stuck in the BOP. Later investigations showed that automatic closure of the BSR had been activated because of the disconnection

*Figure 9: Images taken by ROV after the unintentional disconnection. (Source: Seadrill)*

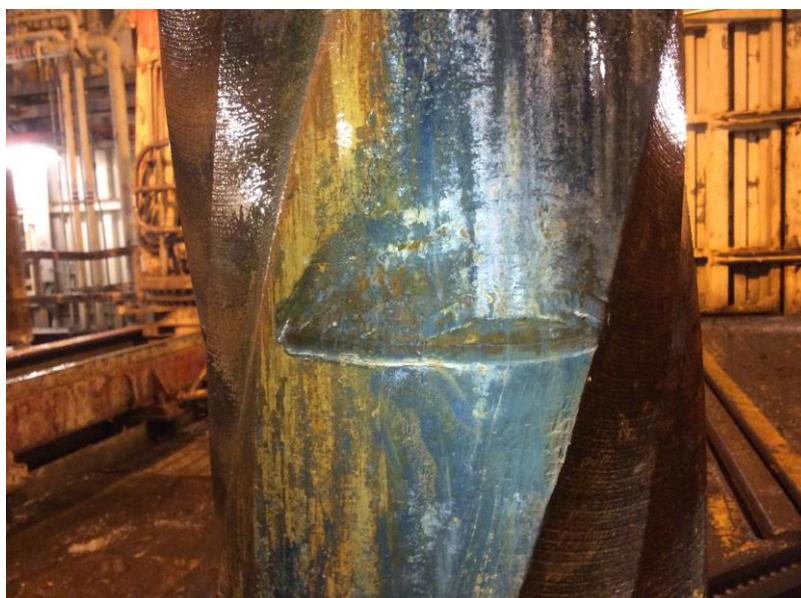
The eight-inch drill collars forming part of the BHA were caught in the BSR when the latter was automatically activated. These collars cannot be cut and were therefore stuck in the BOP's partially closed BSR.

*Figure 10: This image of an eight-inch drill collar on deck after the incident shows damage after the collar was crushed in the BSR. (Source: Seadrill)*
