Investigation report

Report title Report of the investigation into an incident on <i>Transocean Barents</i> on 4 March 2015 when a person was injured	Activity number 402009004
---	------------------------------

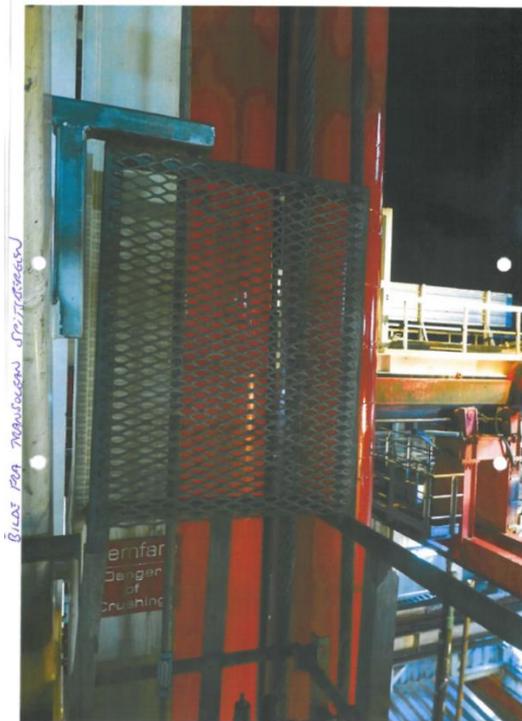
Illustration 1, from *TO Spitsbergen*.

- Protection has been installed on sister rig *TO Spitsbergen* to prevent crushing injuries, and warning signs have been posted (illustration 1). When this was done is unclear.

A grating has been installed on *Transocean Spitsbergen* as illustrated in photograph 1.

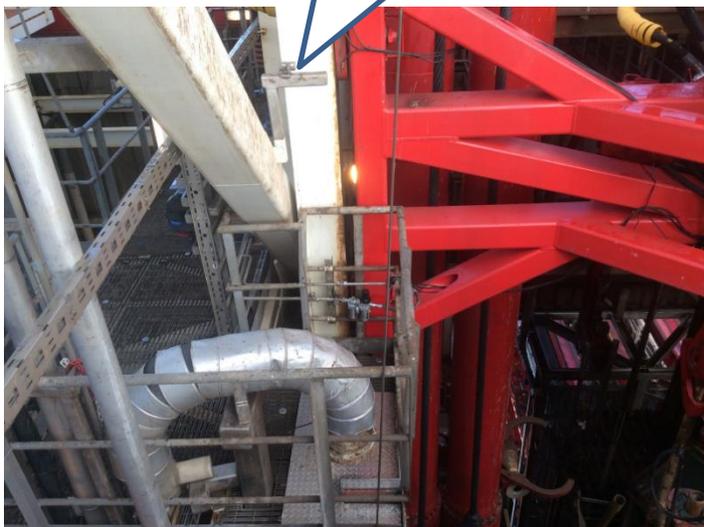
Illustration 2, from *TO Barents*.

The distance from the work platform railing to the top-drive yoke is about 9cm and thereby poses a danger of crushing injuries. Work had begun on *TO Barents* to install a grating similar to one on *Transocean Spitsbergen*, but had come to a halt.

- Fixing brackets for a grating similar to the one on *TO Spitsbergen* had been installed on *TO Barents*, but the work was not completed. No written information on this was available in Transocean's organisation.

Bracket for a grating installed
on *TO Barents*.

Work had started on *TO Barents* to install a grating similar to one on *TO Spitsbergen*. The grating had not been installed, only the bracket.
