Investigation report

Report	
Report title Odfjell Technology – Linus – Investigation of an incident on 10 November 2022 – personal injury from dropped object	Activity number 426001003
Security grading	
<input checked="" type="checkbox"/> Public	<input type="checkbox"/> Restricted
<input type="checkbox"/> Not publicly available	<input type="checkbox"/> Confidential
<input type="checkbox"/> Strictly confidential	
Involved	
Team T-F	Approved by/date Irja Viste-Ollestad/27 January 2023
Members of the investigation team [REDACTED] [REDACTED]	Investigation leader [REDACTED]

On Thursday 10 November 2022, a person was subjected to crushing during repair work on a cantilever drag chain (linked cable/pipe tray).

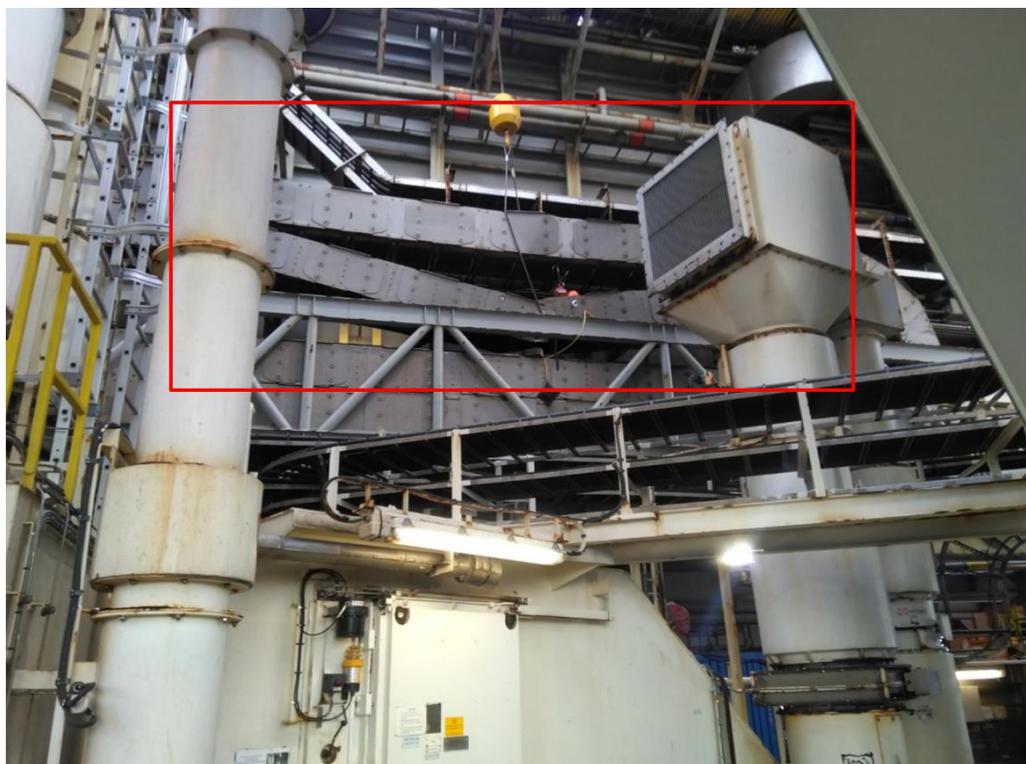
Figure 2 The collapsed drag chain and the surrounding area after the IP had been freed. Source: Odfjell Technology

The direct cause of the incident was that the IP loosened bolts on the upper drag chain plate whilst lying between the upper and lower parts of the cable tray. When several of the nuts had been removed, the side plate came loose and the drag chain collapsed onto the IP.

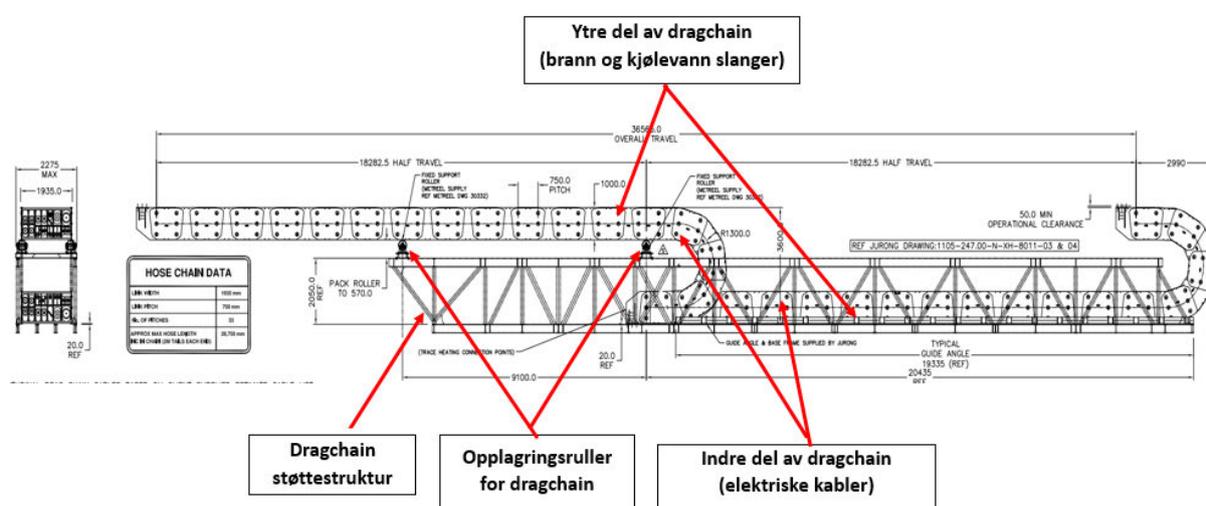
A new skid of the cantilever conducted on 9 November 2022 placed the damaged side plate on the drag chain in a new position between two fixed support rollers. It was about five metres from the nearest fixed support.

Figure 4 The port drag chain when the cantilevered drilling module is in the innermost (parked) and outermost (over the sea) positions. At the time of the incident, the drag chain was roughly in the centre position. Source: Odfjell Technology

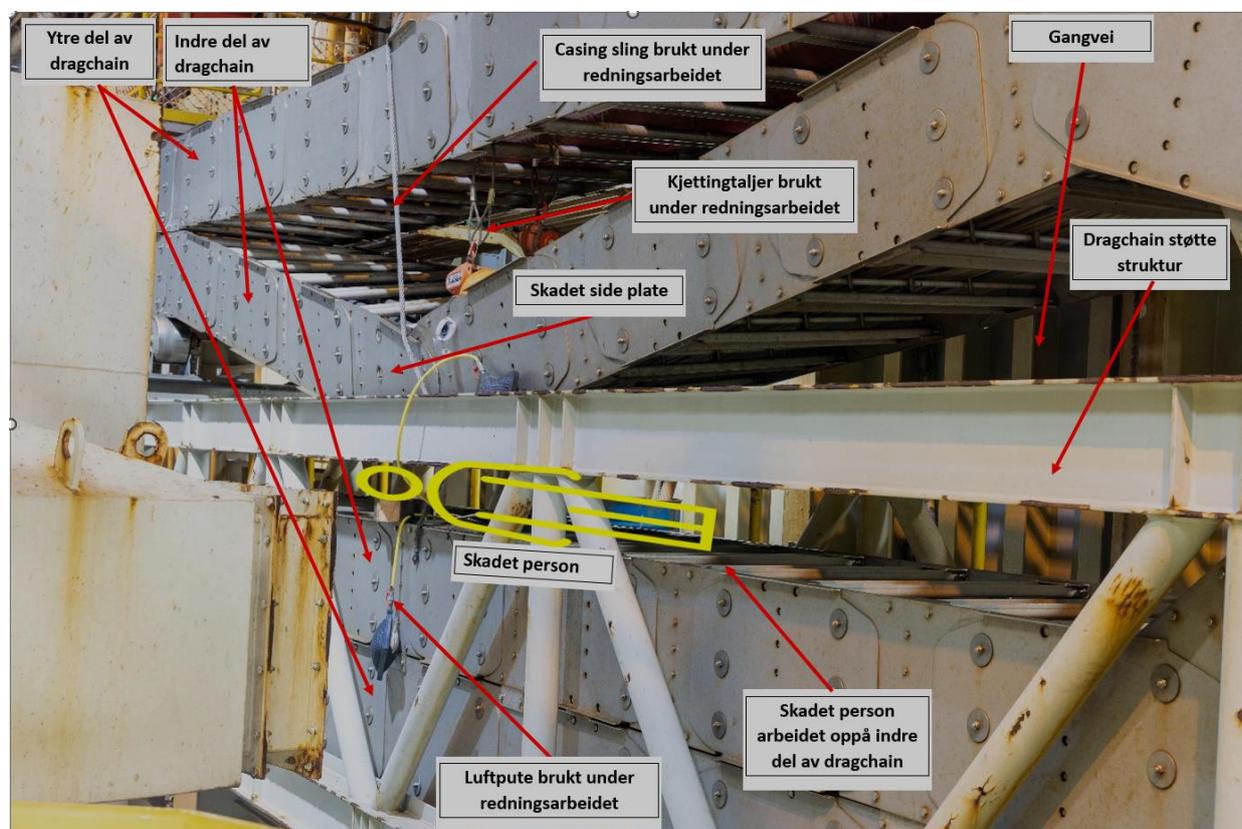
Figure 6 The port side of the gangway after the drag chain was raised, moved to one side and laid on the support structure in order to free the IP (before safeguarding access to permit investigation of the site). Source: South-west Norway police district

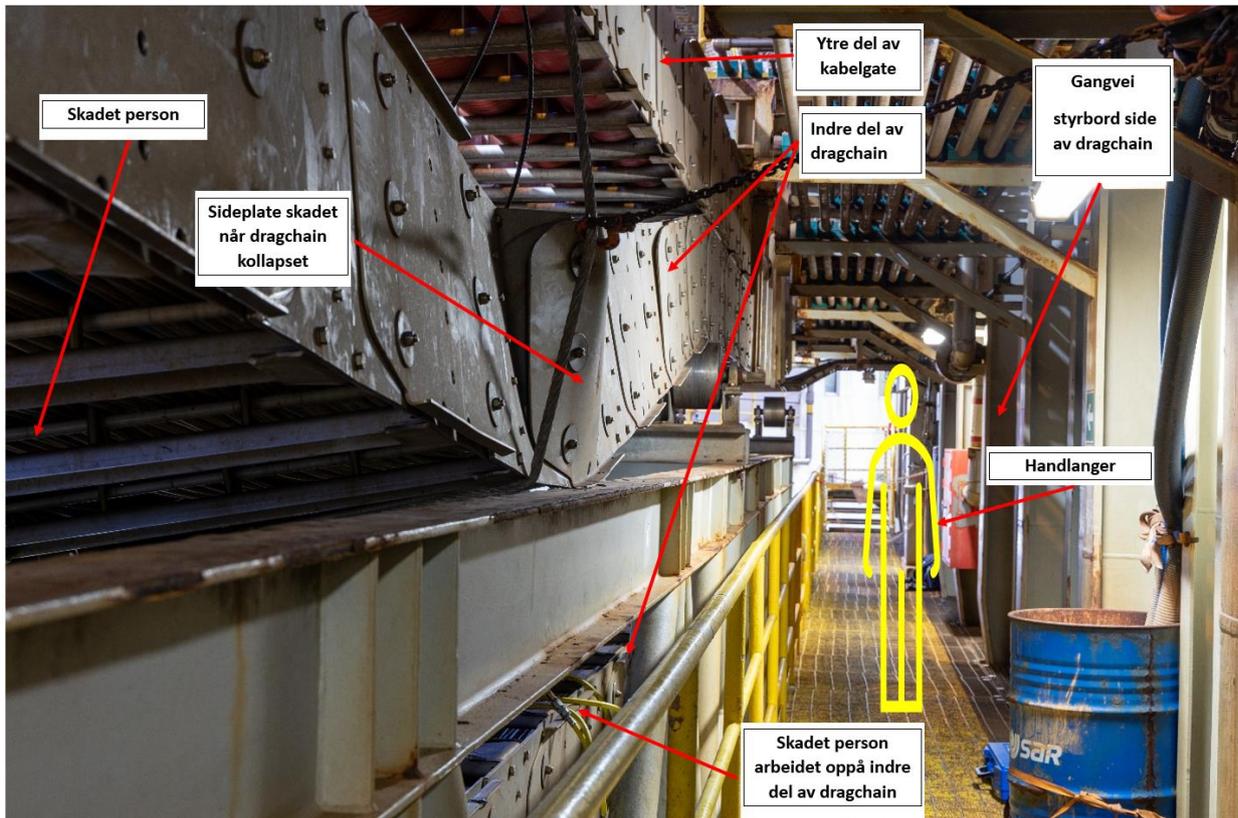
Figure 7 Port side of the drag chain and gangway. This is after the drag chain had been raised, moved to one side and laid on the support structure in order to free the IP (before safeguarding access to permit investigation of the site). Source: South-west Norway police district

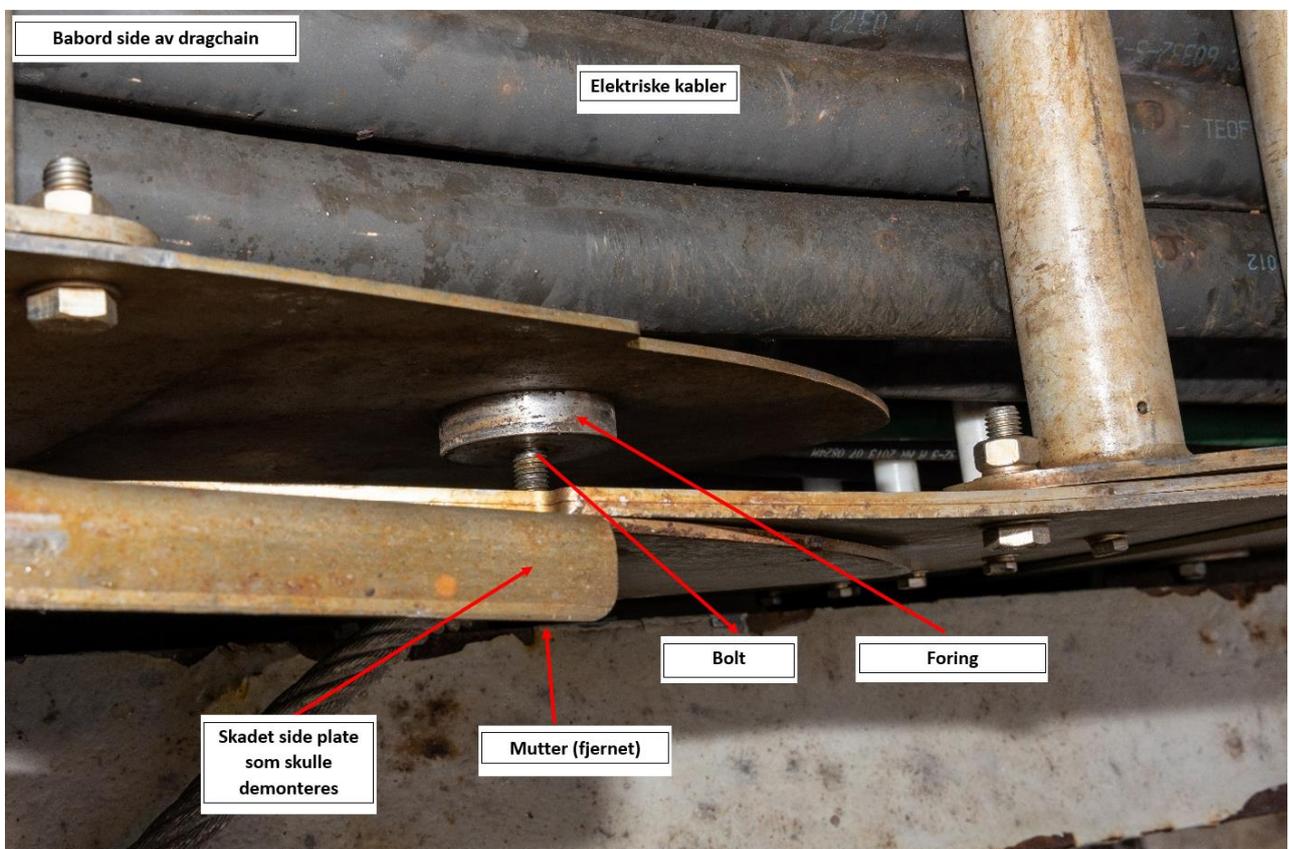
After skidding the cantilever on 3 November 2022, damage to the port drag chain in the form of a bent side plate was discovered. A temporary repair was carried out on 4 November 2022.

Figure 8 The chain link following the incident with the plate which was to be removed (after the drag chain was safeguarded for access to permit investigation of the site). Source: South-west Norway police district
