Investigation report

Report title Report of the investigation into the walkway incident on Tambar	Activity number 054065006
---	------------------------------

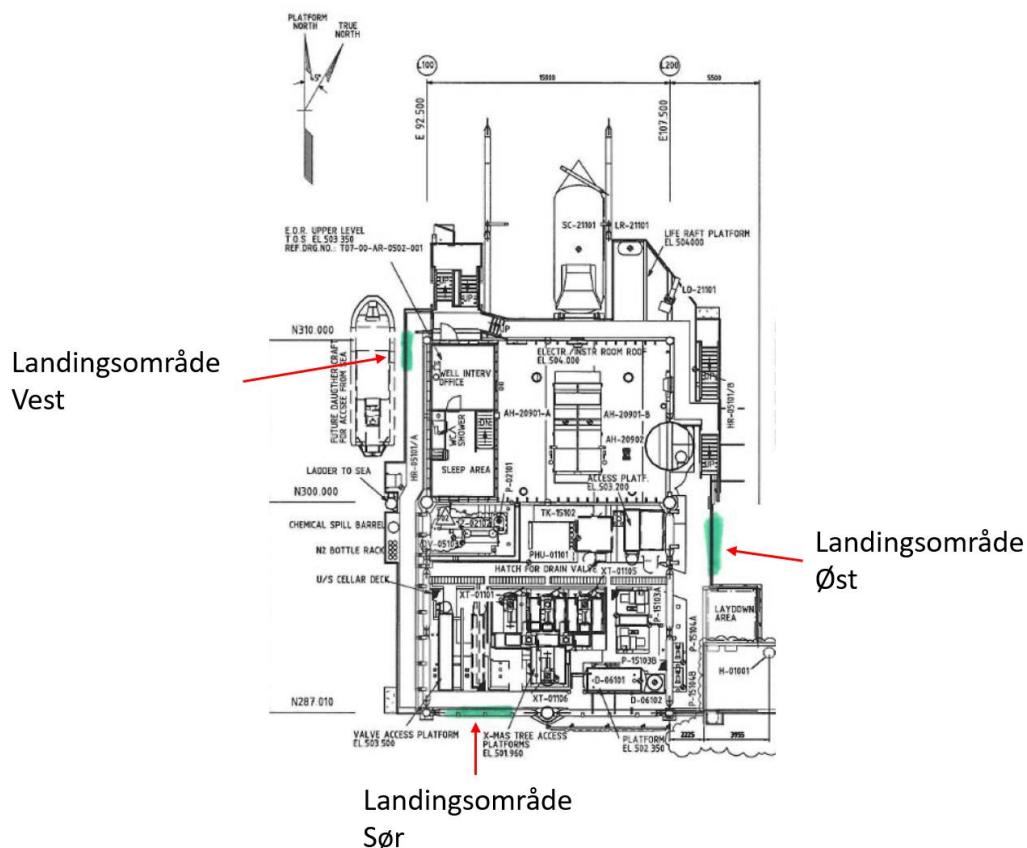
Figure 4 Overview of the three landing areas on the Tambar facility. (Source: Aker BP).
