# Corrosion and corrosion fatigue learnings

Anders Kloven

# Incident

Anders Kloven, Principal Engineer Platform Technology, 04.12.19

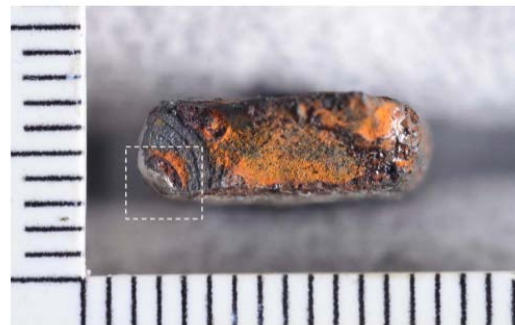
# Dissection – damaged tensile wires

- **Outer** tensile layer
  - 30 % fatigue fractures
  - Fatigue fractures mainly in one sector
  - Fractures, ductile and fatigue, mostly aligned with gaps in the anti-wear tape
- **Inner** tensile layer
  - 53% fatigue fractures
  - Fatigue fractures mainly in one sector
  - Fractures, ductile and fatigue, mostly aligned with gaps in the anti-wear tape

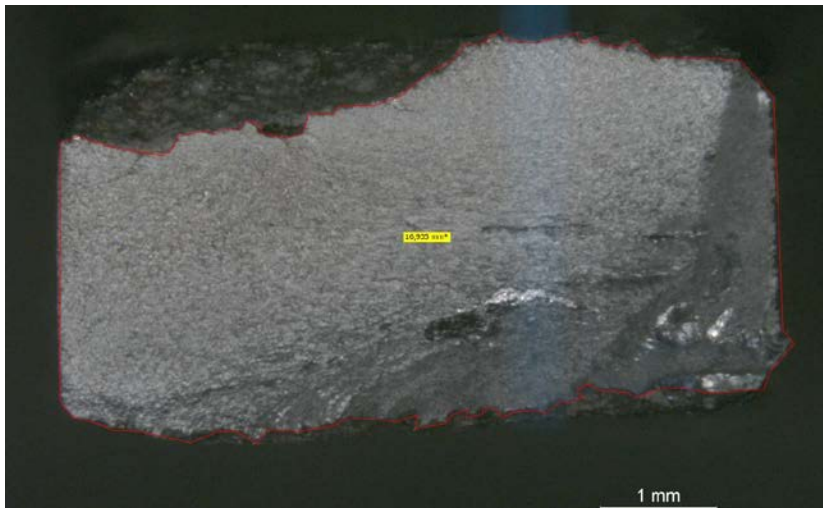
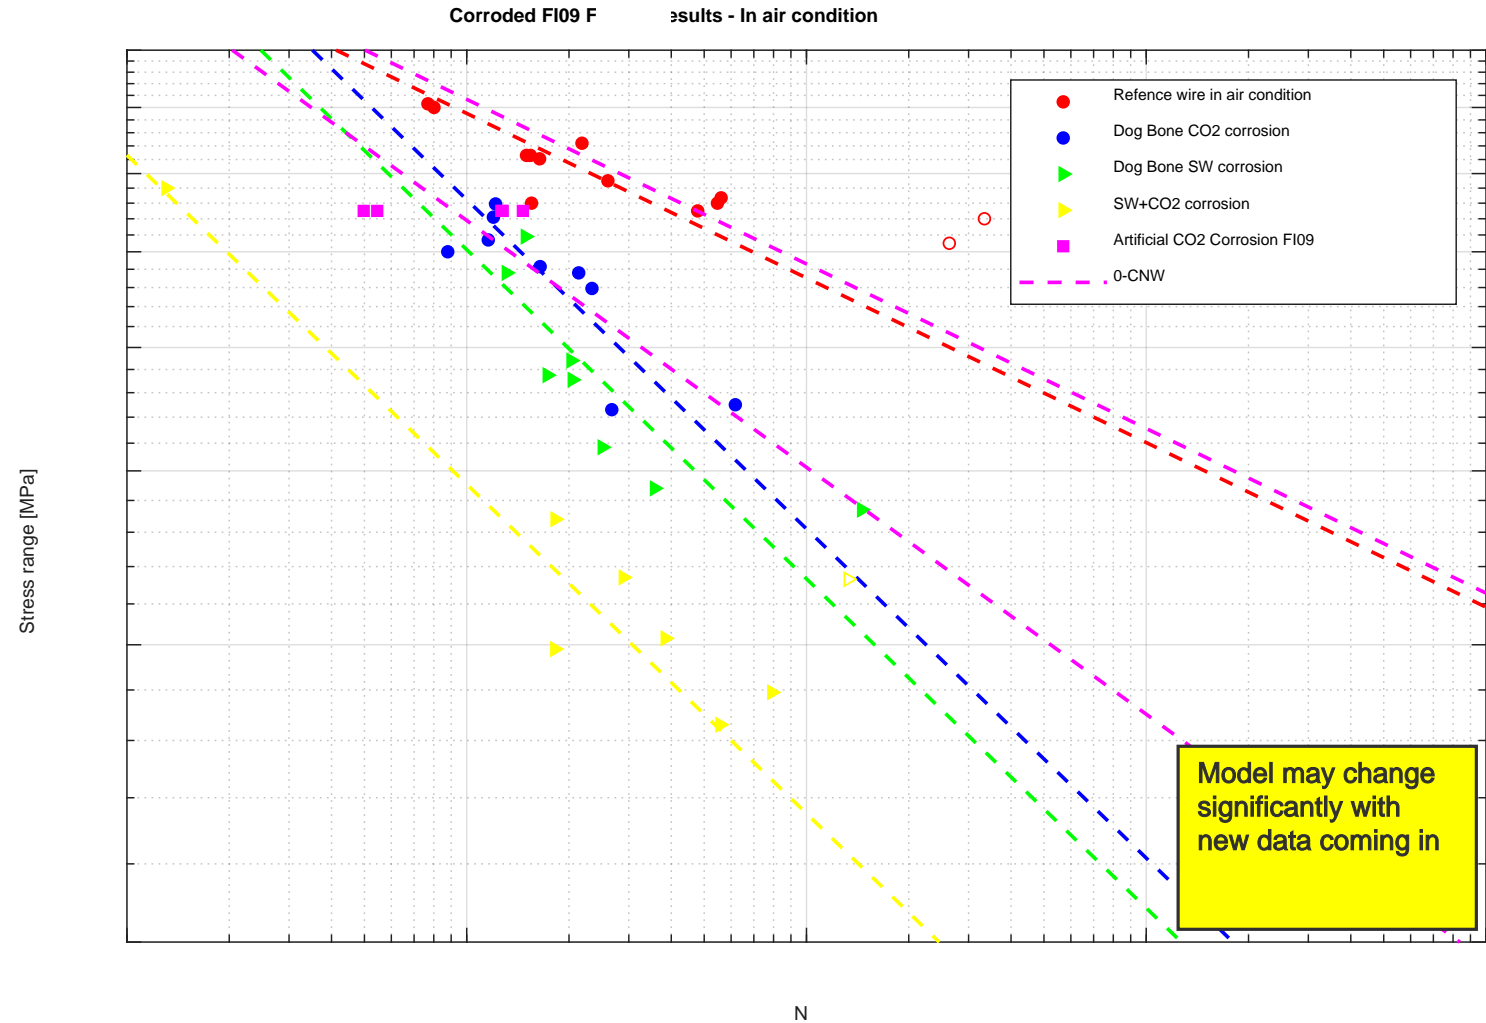
# Fatigue curves

For each S-N point:

- Cross section at failure
- Average-max cross section
- Stress recorded for minimum area
- Imposed slope

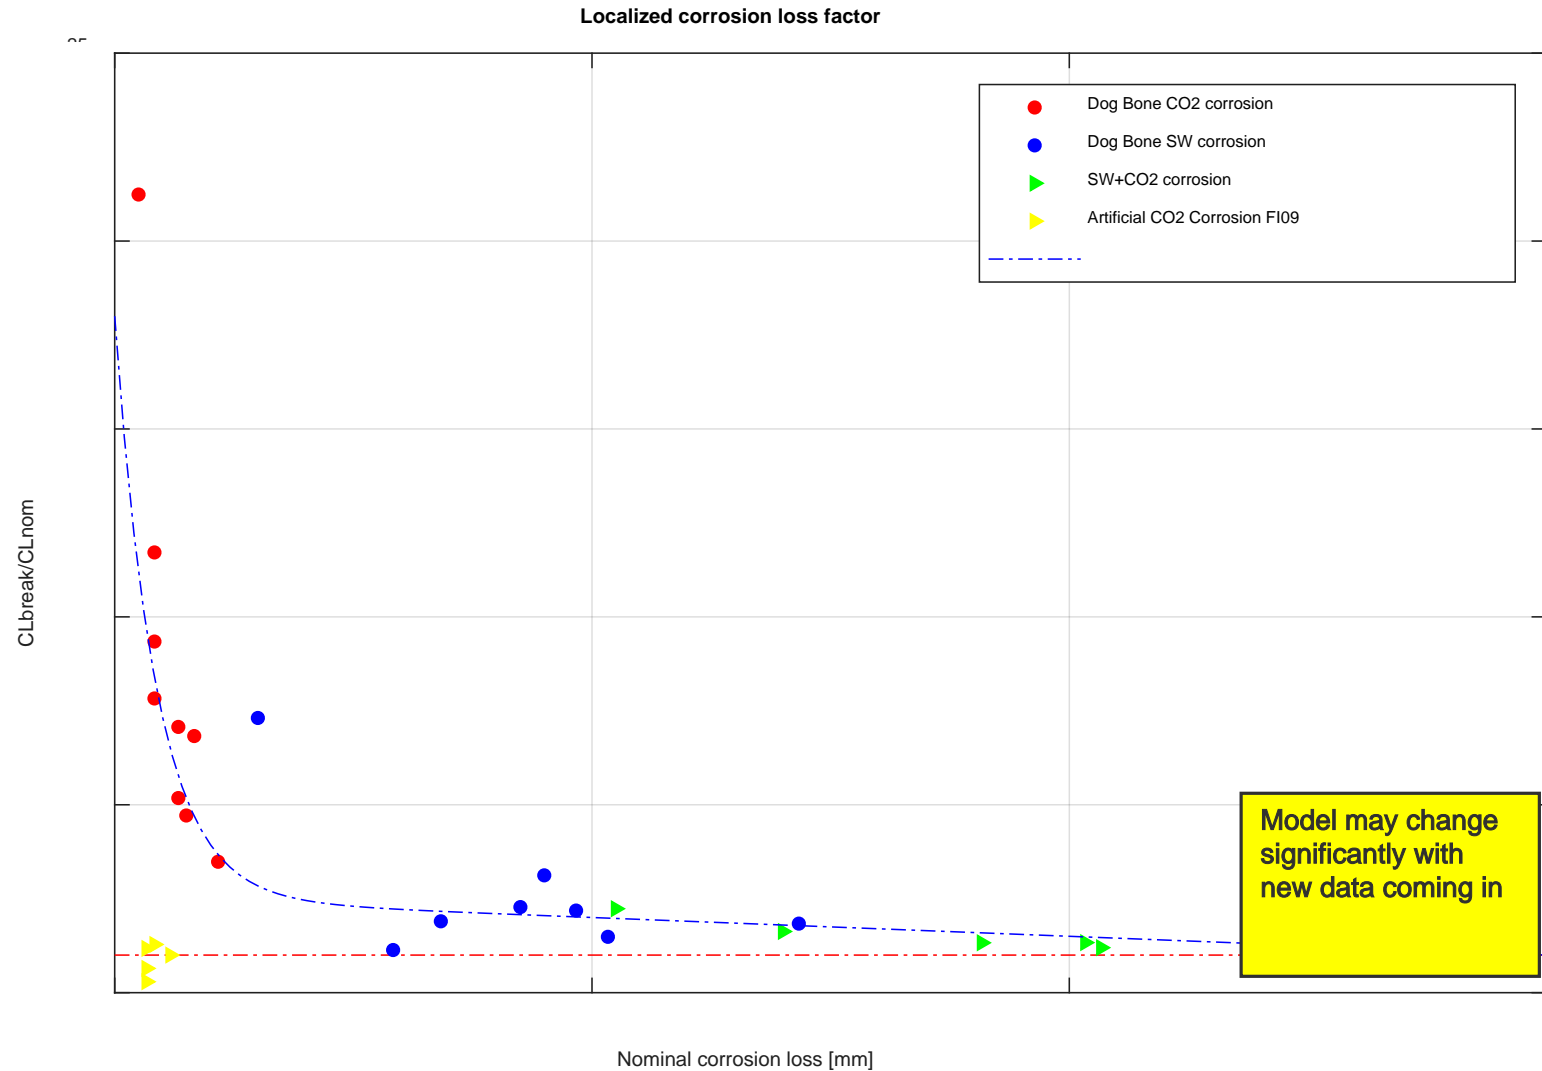
# Local cross section loss

Loss factor:

- Corrosion loss at failure compared to average corrosion loss of sample
- $f_{CL} = CL_{frac} / CL_{nom}$
- Amplification of CL due to localized corrosion early in corrosion process?

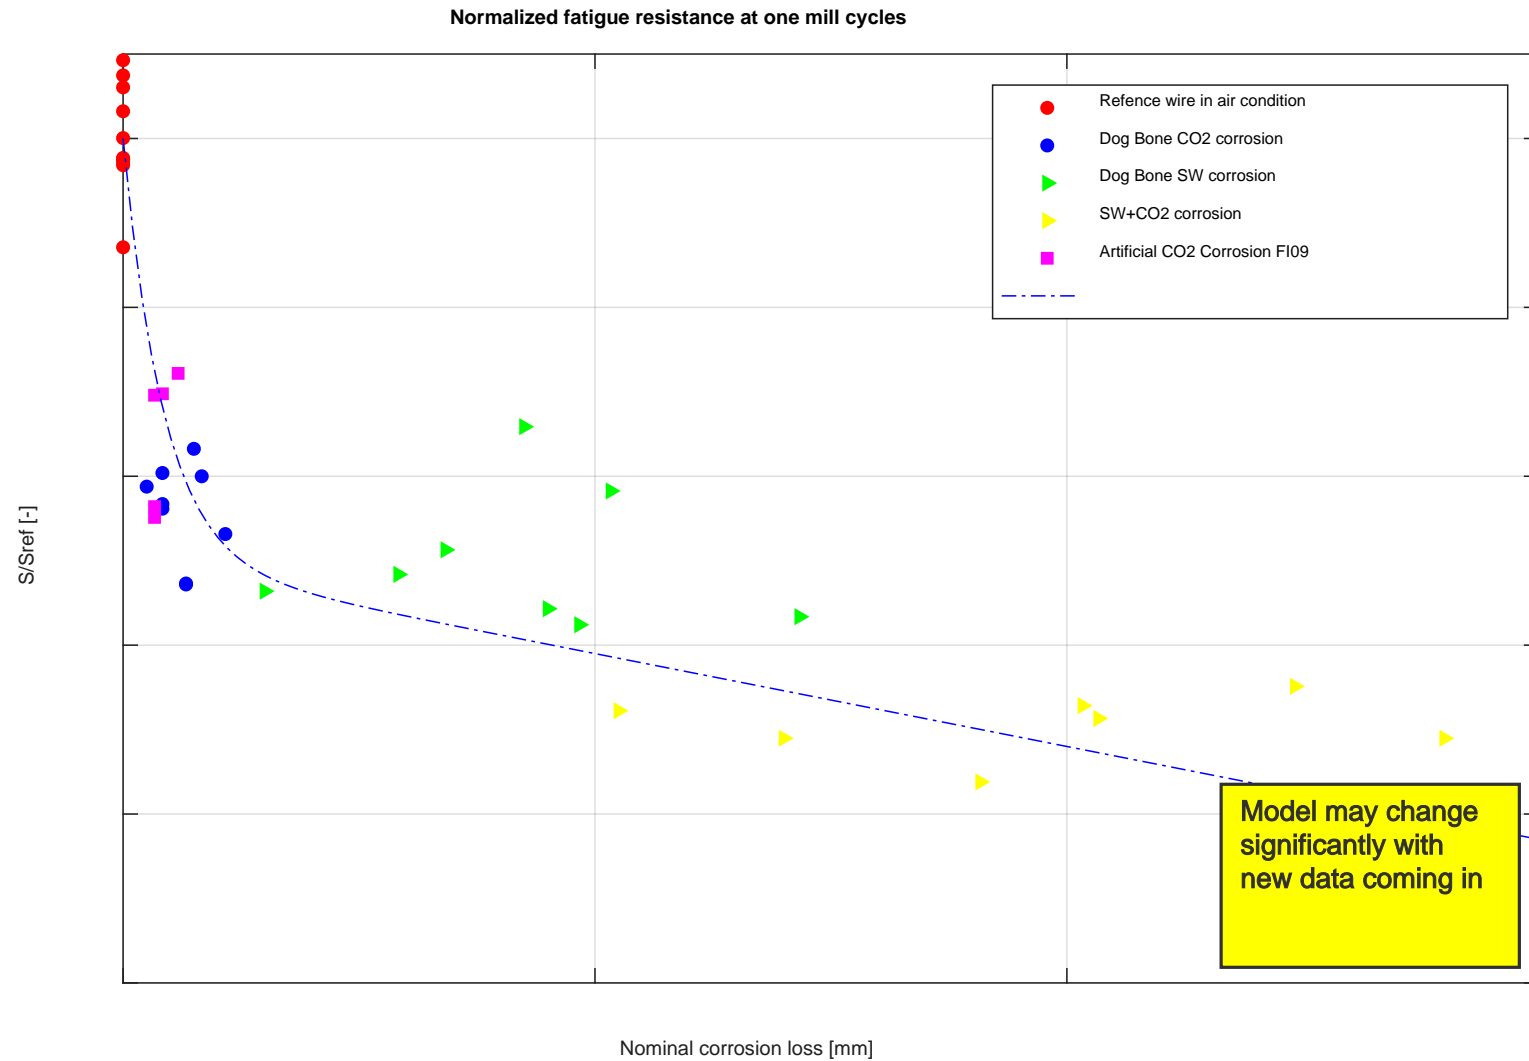
# SN-curve level at $10^6$ cycles

Notch factor at  $10^6$  cycles:

- Normalized for reference SN-curve
- Largest decline at small corrosion losses due to localized attacks?

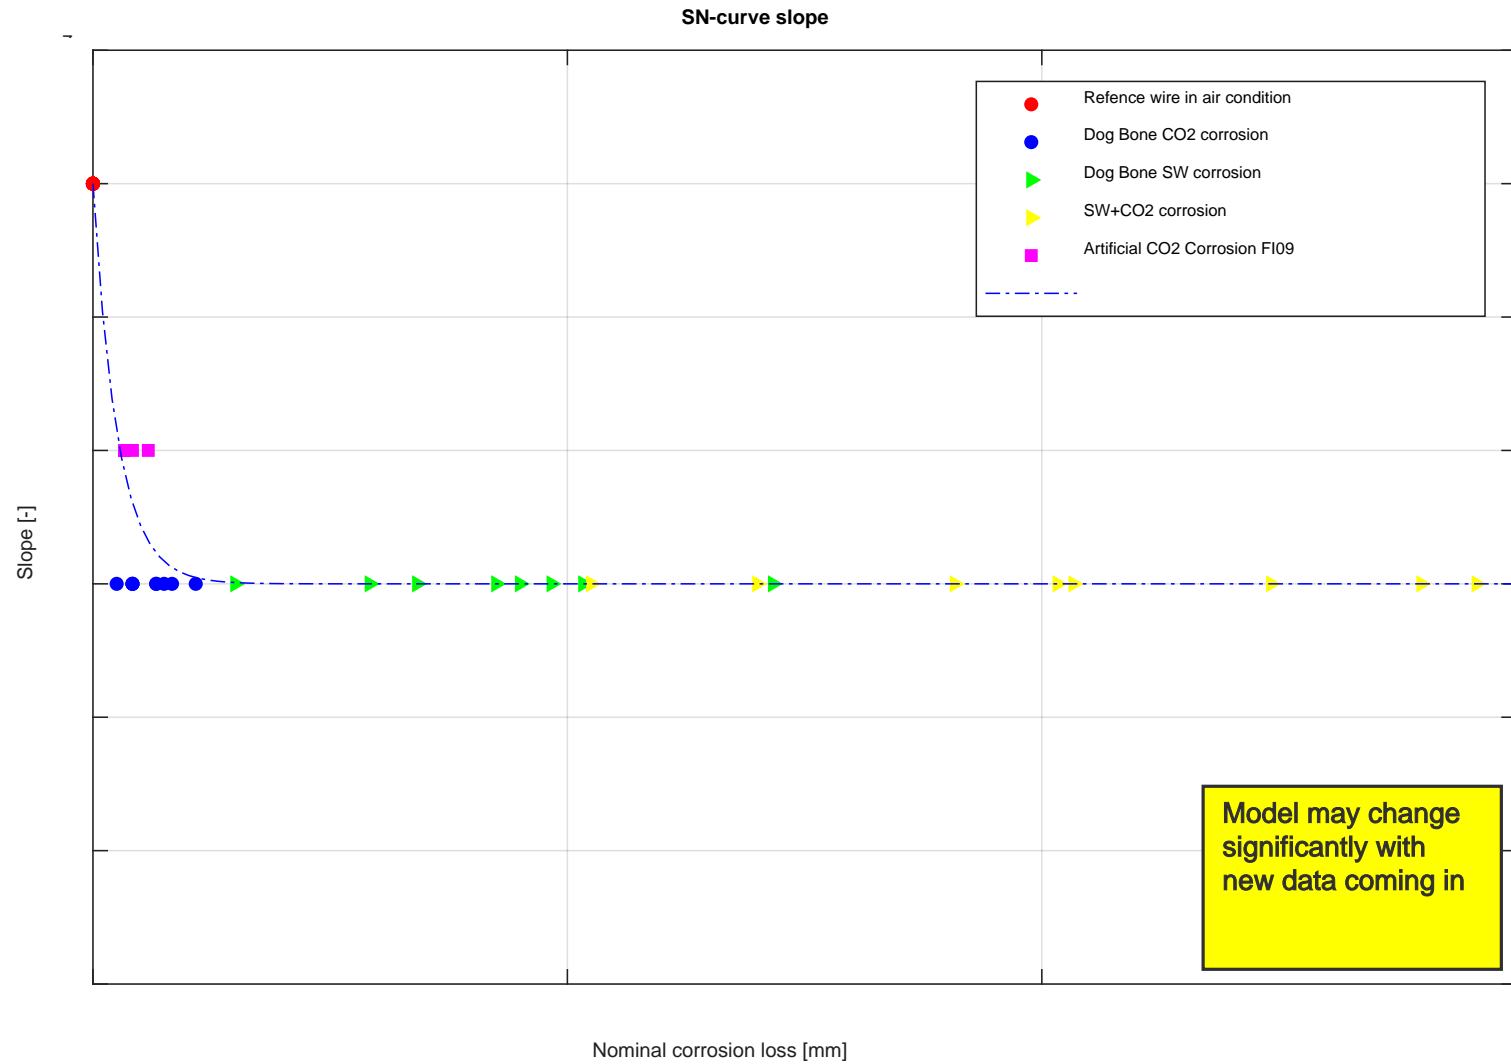
# Slope of SN-curve

- Corroded wire seems to follow a slope of 3

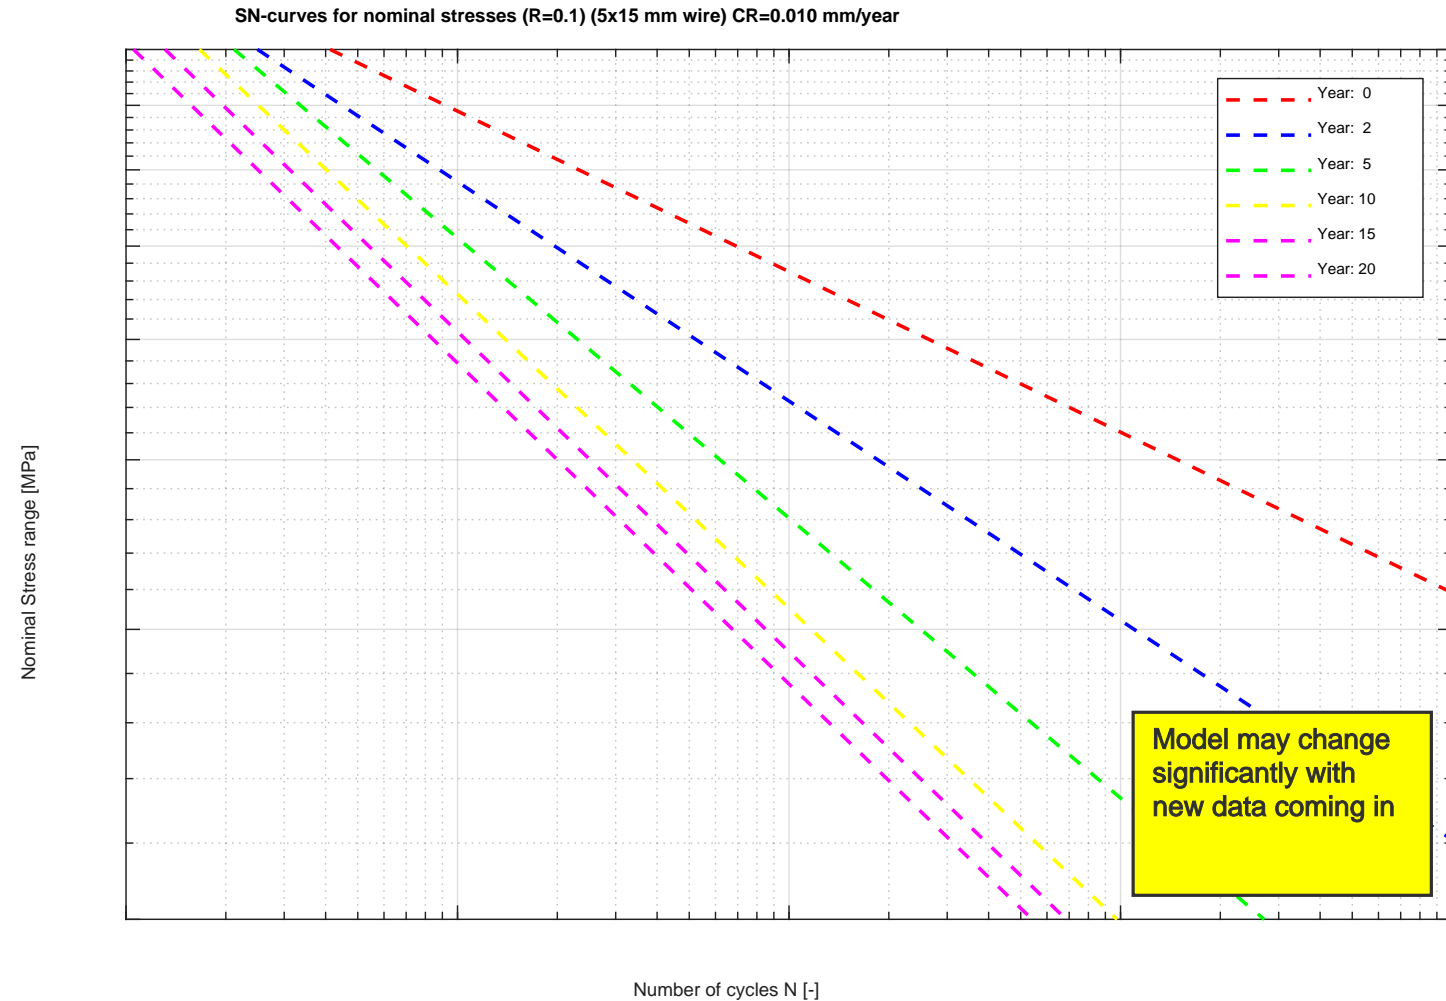
# Applied to standard corrosion rate (mean curve)

- CR=0.01 mm/year
- Mean stress correction not included
- Chemical effect not included
