# Investigation report

Report	
Report title Lifeboat incidents on Veslefrikk B and Kristin	Activity number 001052005

Summary
<p>Problems with releasing FF1000S-type freefall lifeboats were identified during testing on the Kristin and Veslefrikk B installations in December 2008 and January 2009. These incidents led to the FF1000S-type lifeboats on both installations being taken out of service on 7 January 2009, with a consequent workforce reduction on Veslefrikk B and a workforce reduction and production shutdown on Kristin. The faults identified during testing have caused no harm to people or the environment.</p> <p>The potential consequences should it have been necessary to evacuate the installation(s) with the aid of lifeboats during the period between the last test of these craft and their removal from service are likely to have been serious injury or loss of life. That would naturally have depended on the circumstances which gave rise to the possible requirement for evacuation.</p> <p>The investigation team's most important observations can be summarised as follows:</p> <ul style="list-style-type: none"> <li>• Deficient or faulty design of the FFH13 release mechanism.</li> <l

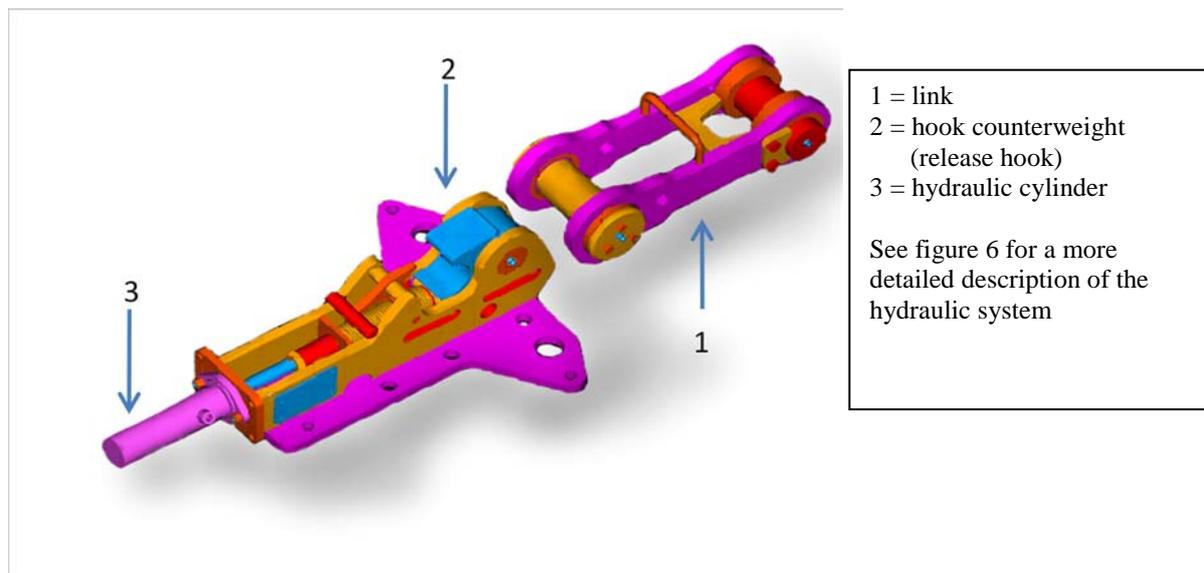
Figure 3. Release system, release hook and link (Source: USH, ref /11/)

The FFH13 comprises three principal components: the link (attached to the installation and the release hook), the release hook (attached to lifeboat and link) and the hydraulic system (in the lifeboat, connected to the release hook). In operational condition, the lifeboat hangs by the release hook attached to the link and will be released from the link during an evacuation.

In operational condition, the weight of the lifeboat will help to keep the hook counterweight in its locked position. In addition, the release rod held in place by the spring system will lock the counterweight in a secure position. As an extra barrier, SH requires the safety bolt to be permanently mounted in operational condition.
