Investigation report

Report	
Report title Undesirable incident with HTV Eagle pipehandling crane – Statoil Gullfaks B – 7 March 2017	Activity number 001050062

Summary
<p>The incident occurred at 15.25 on 7 March 2017 on the Gullfaks B (GFB) installation. The boom on the horizontal to vertical (HTV)) Eagle pipehandling crane, which weighed about 14.4 tonnes, fell 10 metres to the pipe deck after the steel rope failed. Two people had adjusted the grippers on the crane's gripper yoke down on the pipe deck immediately before the incident occurred.</p> <p>Drilling facilities on GFB were upgraded with a new HTV Eagle crane in 2015. This was part of a big project executed for Statoil by Aibel. MH Wirth was Aibel's subcontractor for the pipehandling equipment. Operations resumed after the upgrading in September 2015. KCA Deutag (KCAD) is the drilling contractor on GFB.</p> <p>The direct cause of the crane boom falling down was fatigue in the steel rope. This was one of the main components in the arrangement for the crane's vertical up and down movement.</p> <p>The underlying cause was weaknesses in the design of the crane's hoisting arrangement, which consists primarily of the winch, she

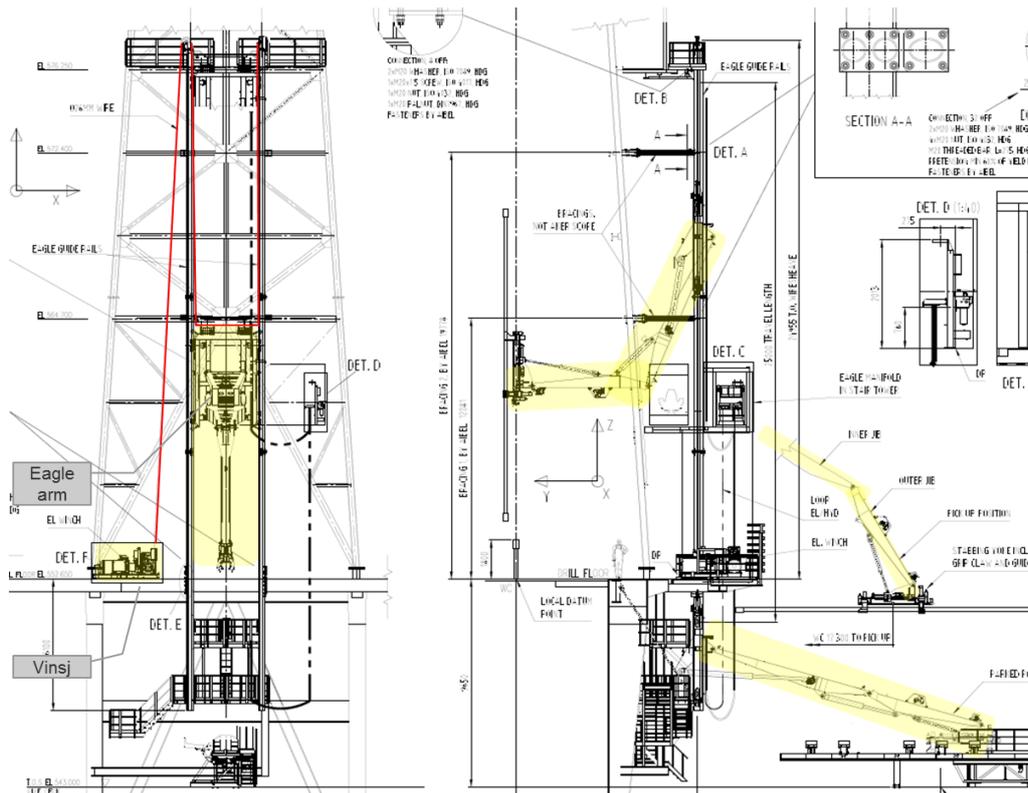
In the hoisting arrangement, steel rope from an electric winch runs over a sheave at the top of one guide beam and under two sheaves on the dolly to its anchoring point on top of the other beam. A load cell is installed as part of the anchoring arrangement. See figures 1 and 2 for the arrangement of the HTV Eagle crane.

Figure 1 HTV Eagle arrangement, with the steel rope in red. (Statoil's investigation report)

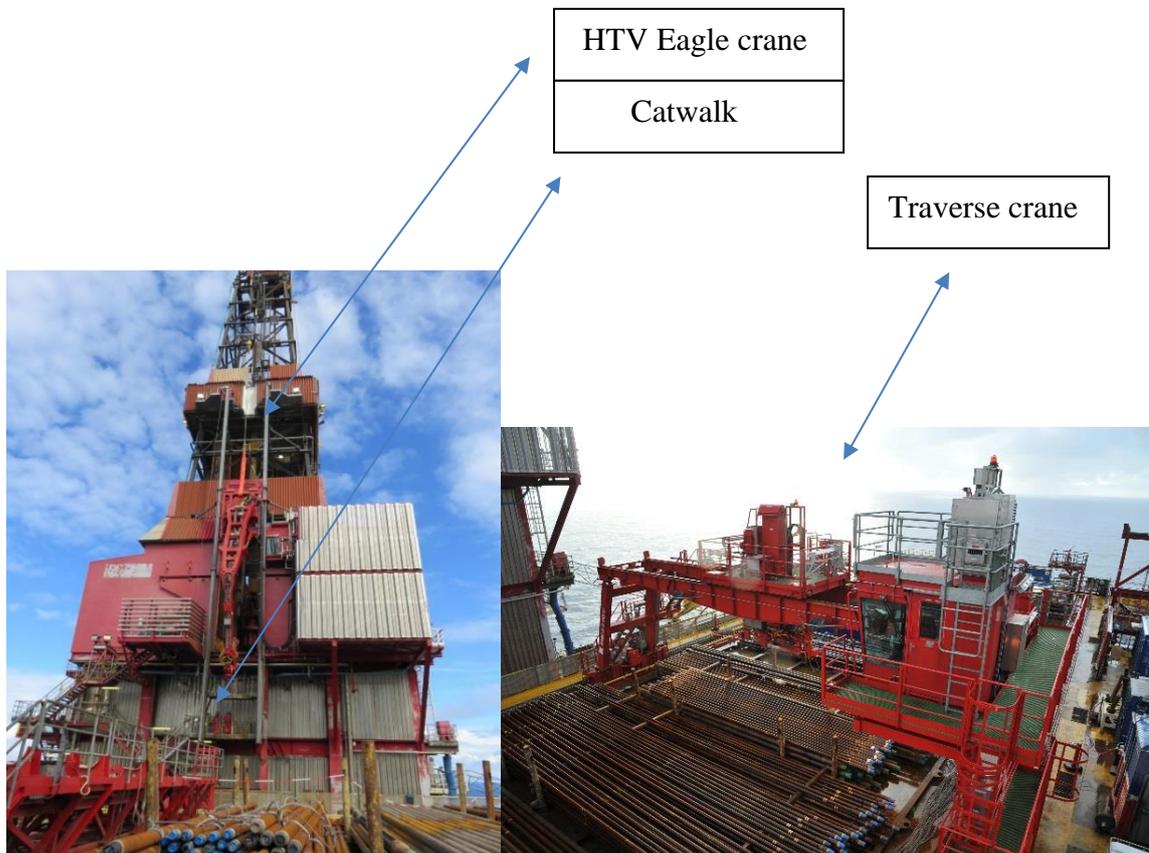
Figure 2 The HTV Eagle crane in the derrick and the traverse crane on the pipe deck.

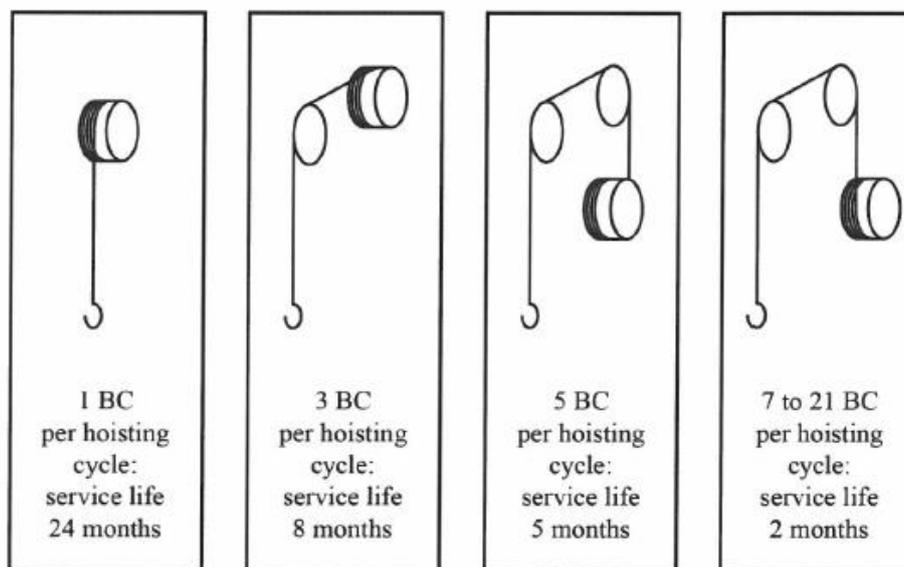
The average service life for steel rope will depend on the number of sheaves and the spooling direction in a hoisting arrangement. See figure 8.

Figure 8 An example of the average service life of steel rope, depending on the number of sheaves and the direction of the rope. (Casar)
