Investigation report

| Report title Report of the investigation into the man-overboard incident on <i>Scarabeo 8</i> on 20 February 2015 | Activity number 401003010 |

A man fell overboard from the mobile drilling unit *Scarabeo 8* at about 04.08 on Friday 20 February 2015. The Petroleum Safety Authority Norway (PSA) was notified at 05.45 on the same day.

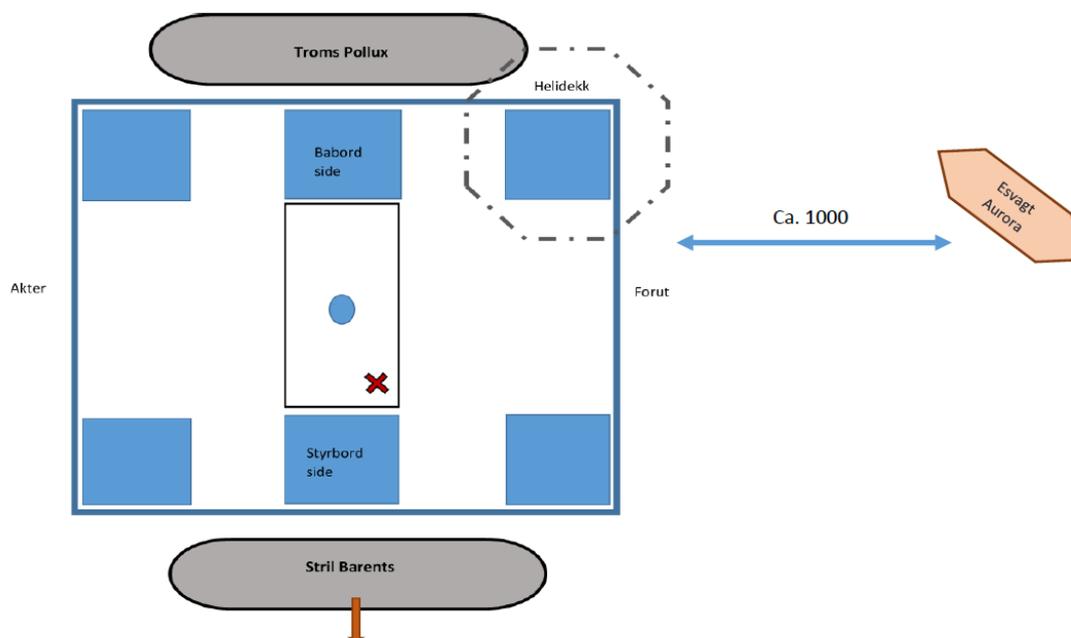
Wave height 2.1 metres Hs, ref data from *Scarabeo 8*.

Figure 5 Overview of columns, ships and site around 04.00 on 20 February 2015. The red arrow shows the move of Stril Barents at the request of Scarabeo 8 after the incident occurred.

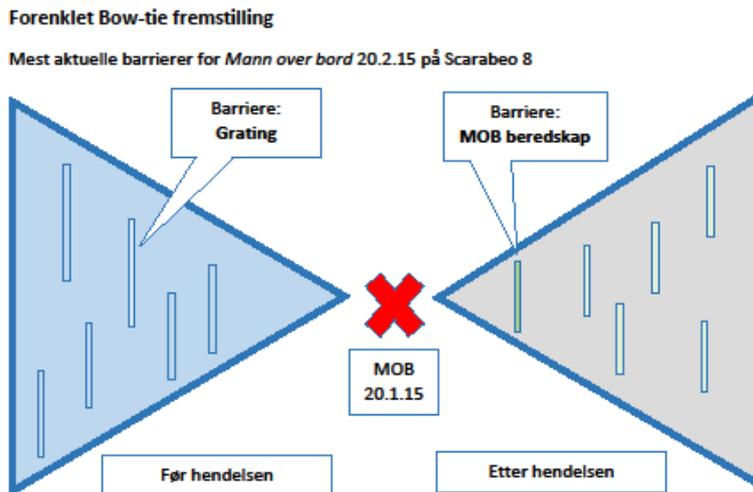
The investigation has not identified failed barriers other than those mentioned above in chapter 6. The grating and MOB preparedness barriers are presented below in a simplified bow-tie figure. These barriers are presented in appendix C. A bow-tie provides a visual way of displaying the course of events with relevant barriers before and after the incident.

Figure 9 The **grating** and **MOB preparedness** barriers are described in more detail from an HTO perspective in appendix C.
