Investigation report

Report	
Report title Hammerfest LNG Melkøya – LNG leak from road tanker, 17 June 2018	Activity number 001901036

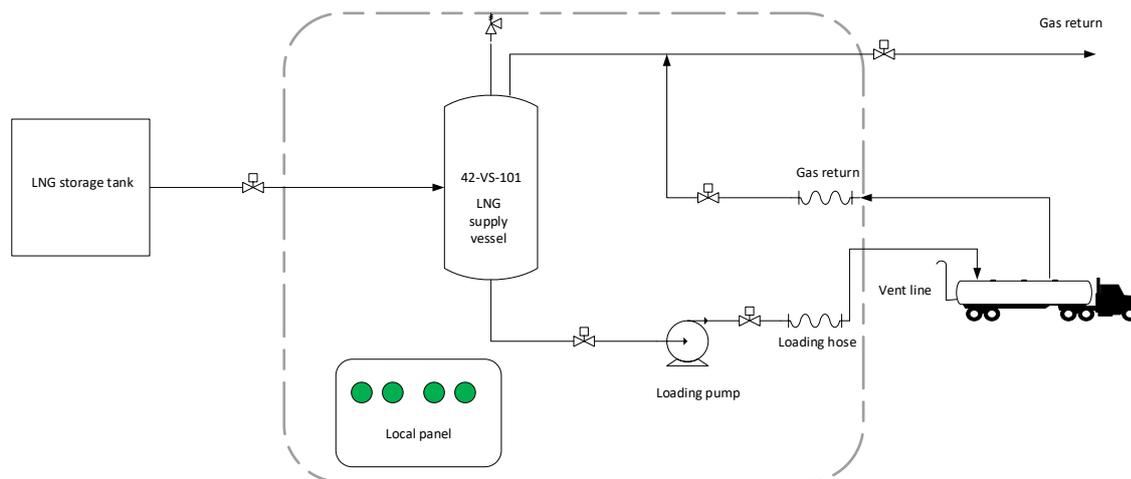
Figure 2 Main components used for road-tanker loading,

The station for loading road tankers with LNG comprises an LNG supply vessel – known as the “thermos” – as well as pumps for transferring LNG to road tankers, connecting hoses and a local control panel used for the actual loading. See figure 2. The filling station is partly enclosed with walls which are open at top and bottom.
