Investigation report

Report	
Report title Investigation of dropped riser joint on <i>West Bollsta</i> on 17 October 2020	Activity number 404011004

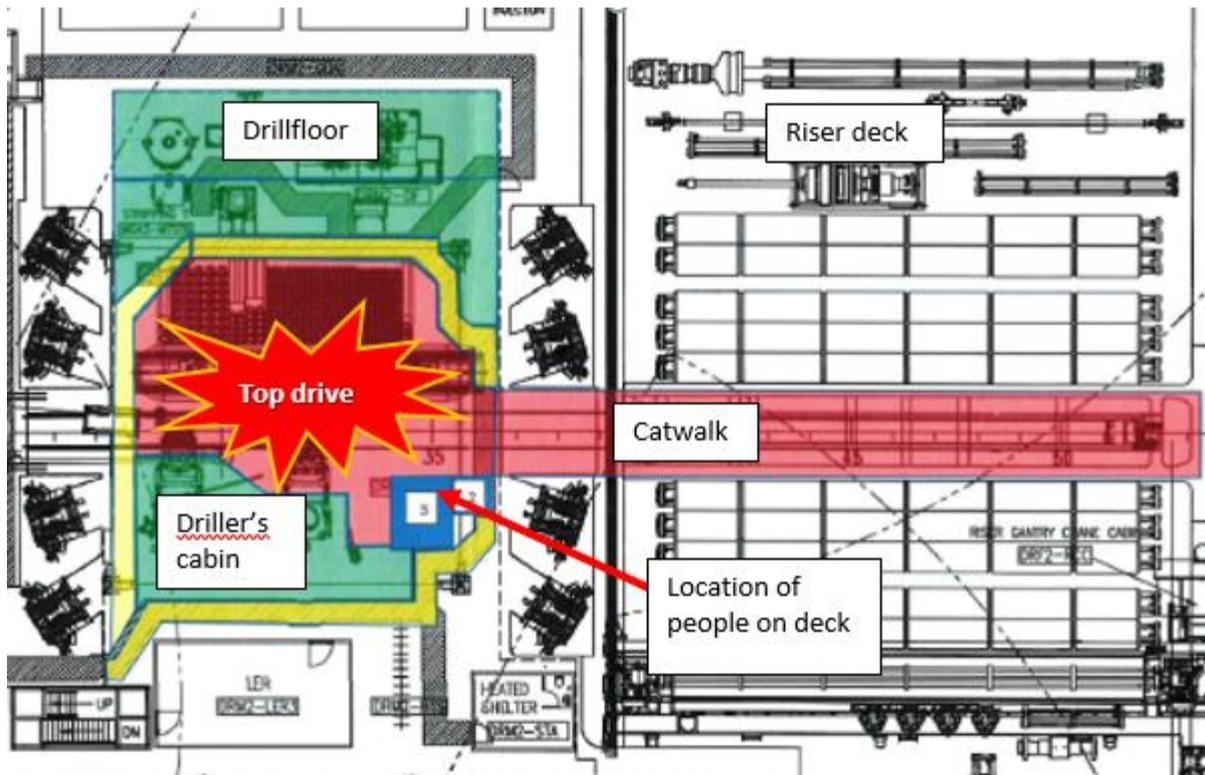
Figure 1: Plan of the West Bollsta drill floor showing the drill floor, riser deck, catwalk, top drive, driller's cabin, safe place for observation during lifting and the area where the joint dropped.

While the first joint was being lifted from horizontal to vertical, it became detached from the HRRT. The joint was almost vertical and dropped to the drill floor where it lay on the spider between the two V doors. It tore off parts of the V door on the other side of the drill floor towards the riser deck, and much of the buoyancy elements around the joint were damaged or ripped off.

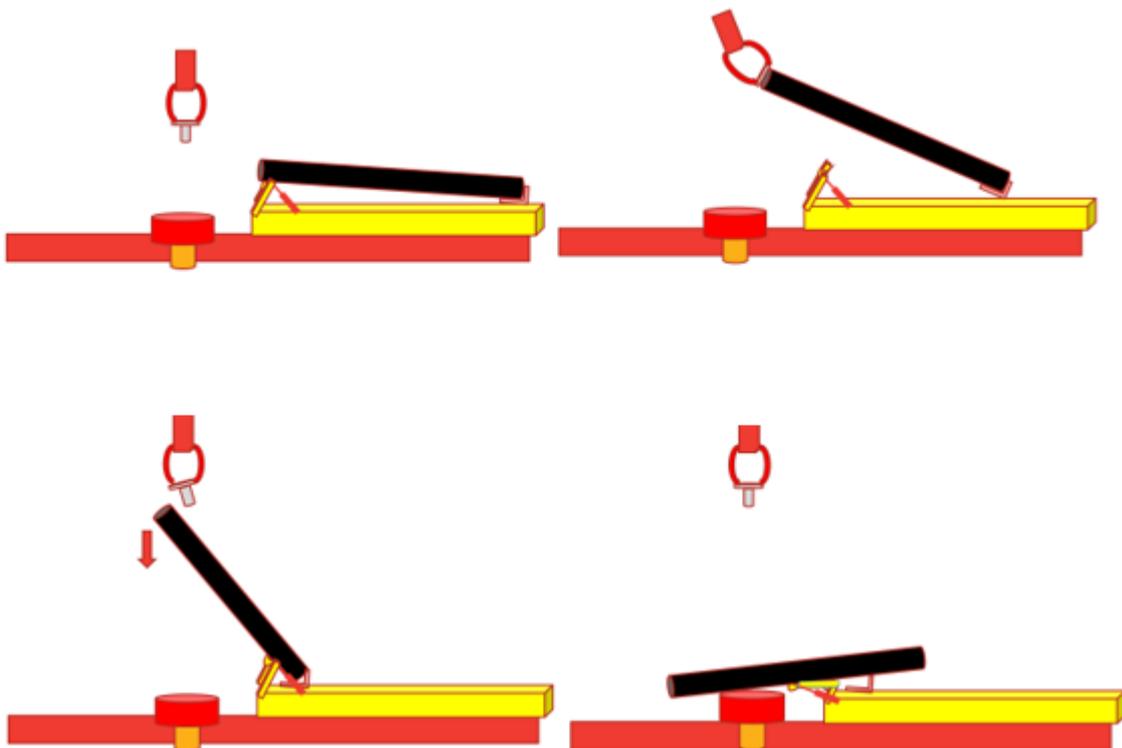
Figure 3 below presents the sequence of events with the joint which was to be raised from a horizontal to a vertical position. The joint lay on the catwalk while its top was attached to the HRRT. At the front end of the catwalk, the joint is guided by "gorilla arms" which support it during the lift. The sequence then shows how the joint became detached from the HRRT and fell to the spider.

Figure 2: The catwalk with joint being lifted by the HRRT. From Lundin's presentation of the incident.

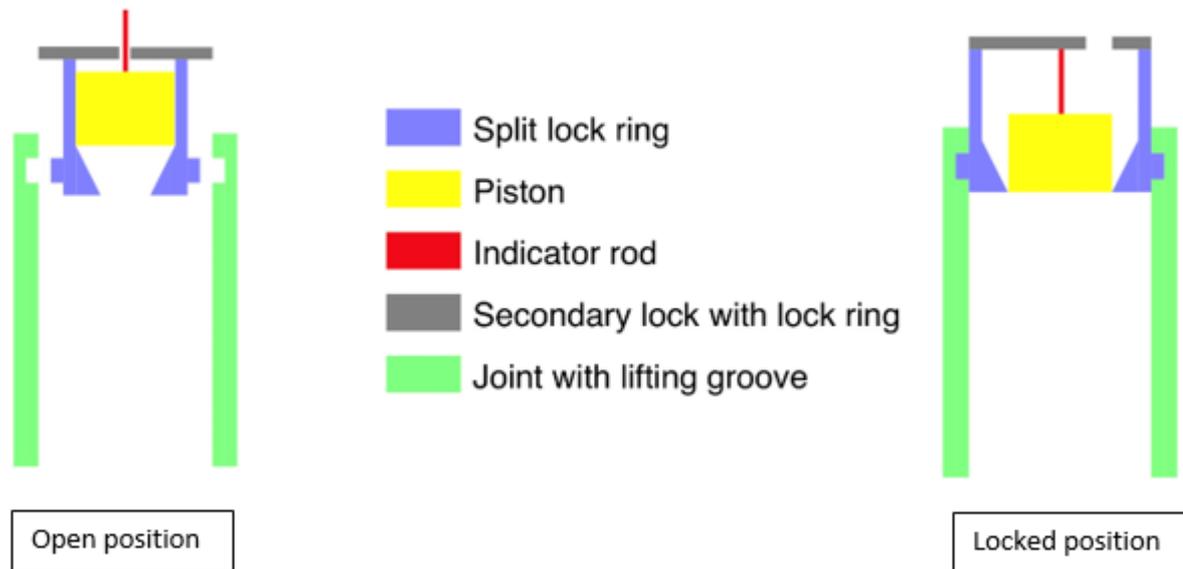
Figure 4 presents a simplified diagram of the way the HRRT connected to the joint. The tool's purpose was to lock to the joint so that the latter could be lifted. The HRRT and its attachment to the joint were supposed to have sufficient strength to lift the whole string with several joints and the BOP when these were made up.

Figure 3: Simplified diagram of the joint in green and the HRRT in lilac, red, yellow and grey.

The HRRT was positioned inside the joint so that the profile on the split lock ring coincided with the groove on the joint's inner wall. Attached spacer blocks ensured that joint and tool were the right distance apart. These spacer blocks are not shown in diagram, but can be seen in photo 6.

Tool and joint were locked together by clamping the profile on the split lock ring to the groove in the joint wall. The split lock ring was expanded with the aid of a piston. This was fitted on top with four indicator rods which moved with the piston. The investigation found no tolerance nonconformities on the HRRT and the joint.

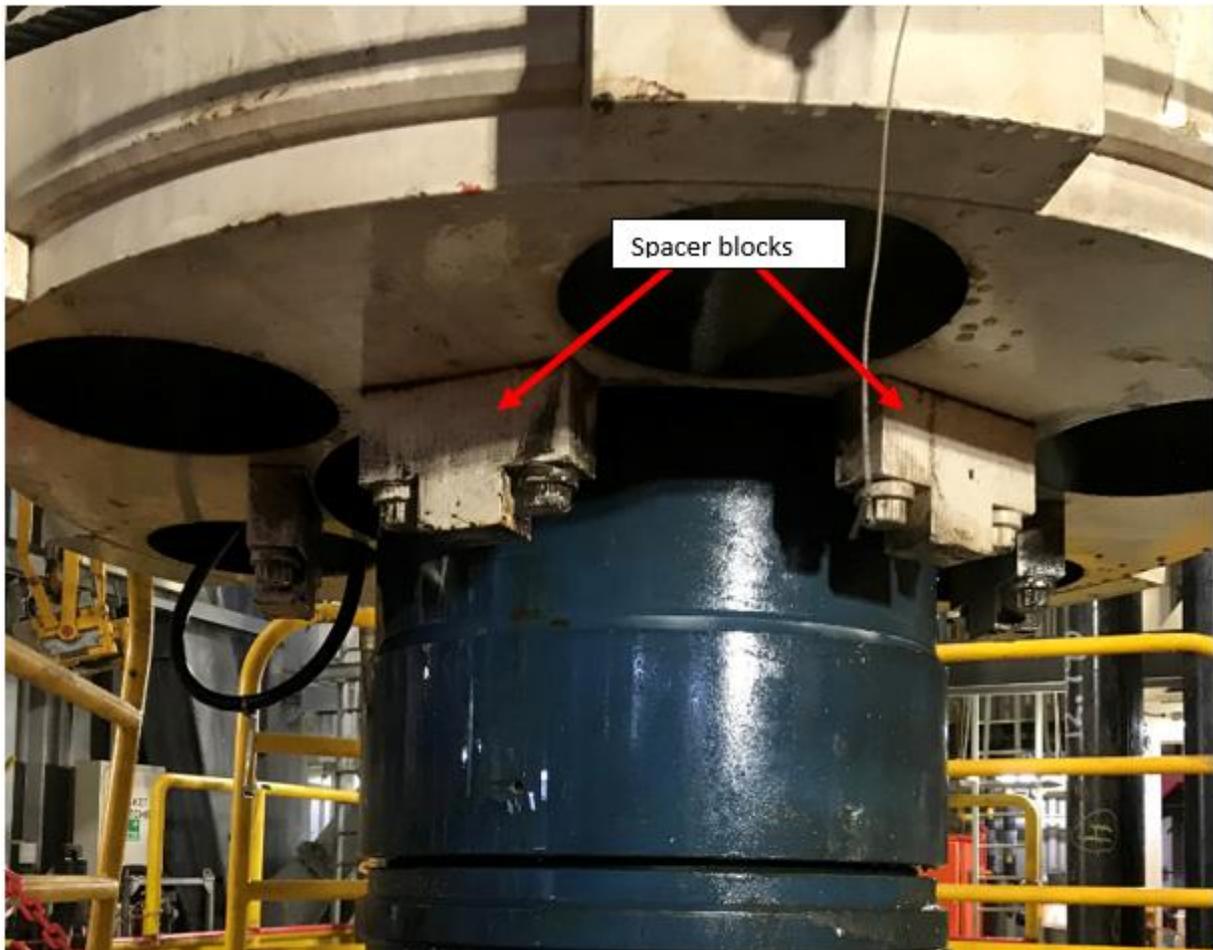
Photo 6: The spacer blocks (red arrows) and part of the split lock ring in blue. Taken on board by the PSA's team.
