# Investigation report

Report	
Report title Nyhamna - Investigation following incidents involving falling objects	Activity number 005921020

Based on the many incidents of falling objects reported to the Petroleum Safety Authority Norway in 2015, it was decided to undertake an investigation of the follow-up of these by A/S Norske Shell and the contractors. Our investigation emphasised the companies' own follow-up of the incidents in relation to established governing documents in the project. The investigation at the facility was performed from 9 to 11 November 2015. In the main, the impression is that Shell and its contractors have performed good investigations of the individual incidents. No non-conformities with the regulations were identified in connection with our investigation. We did however detect some improvement points as shown in chapter 6. These relate primarily to deficient requirements in the governing documents.

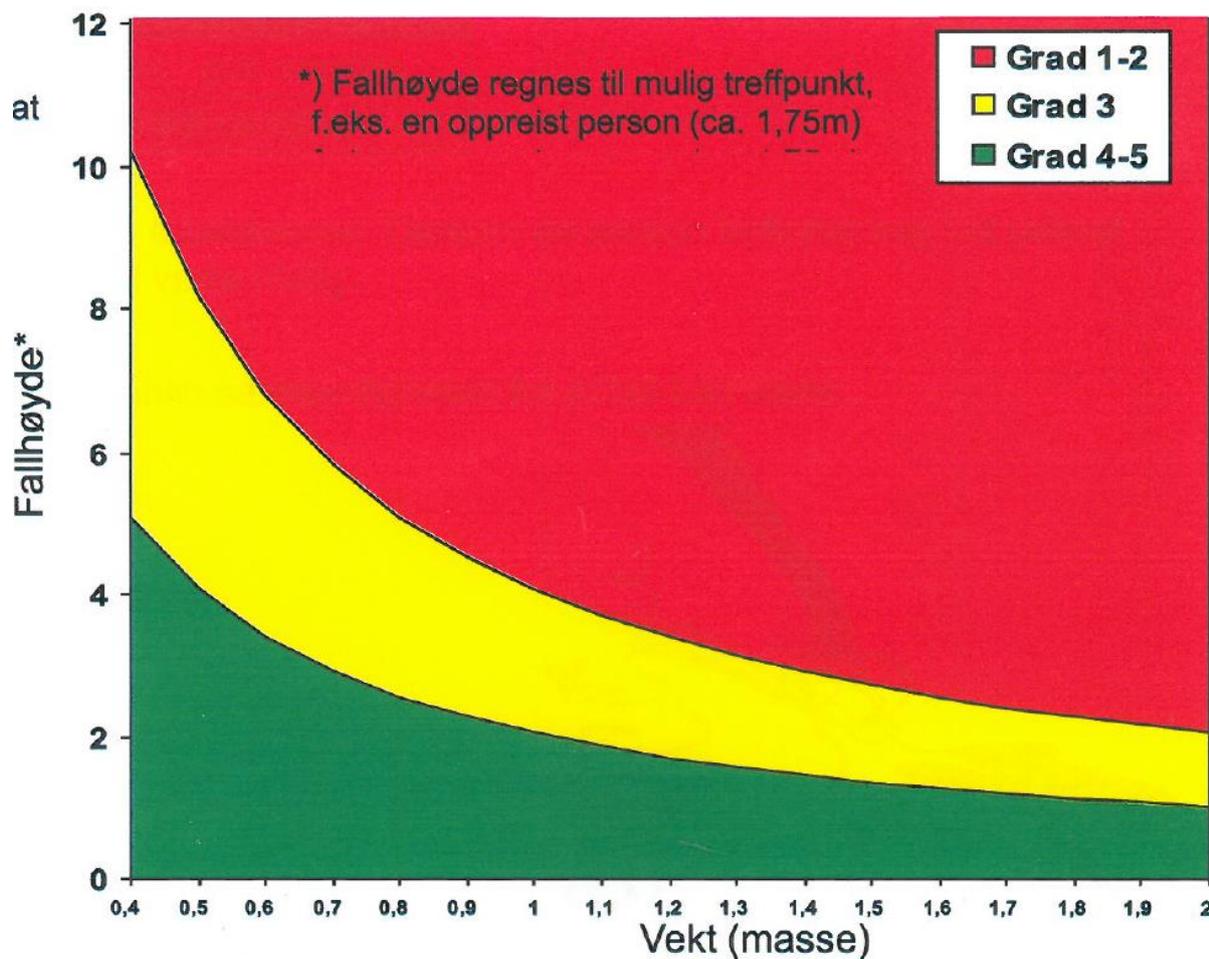
Figure 12 KST's classification of falling objects

In incident reporting to the PSA, the authority assumes that the maximum potential height of fall is stated without any deduction for the height of individuals.

The figure below is taken from KST's procedure for "Processing of HSSE Incidents", where there are "Guidelines for the classification of risk potential", rev. 17, for "Classification of falling objects". The height of fall is here calculated with a deduction for the height of a standing person.
