ODA FLEXIBLE WATER INJECTION PIPELINE EXPERIENCE

Ullandhaug

4/12 - 2019

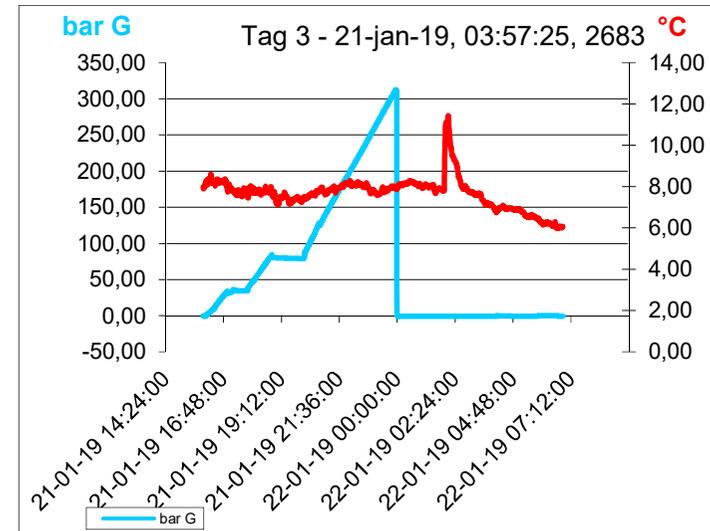
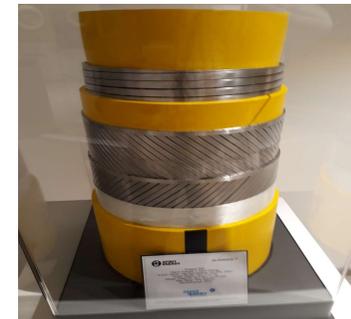
21.01.19
23.59HRS

21.01.2019 @2359 - Loss of Pressure

- During system strength testing of the water injection flexible pipeline from Ula platform to the Oda manifold 21.01.19, an abrupt drop in pressure was noted from 312 barg to 0.5 barg in a few seconds
- At this point 16.8m³ of water had been pumped into the pipeline in addition to the pre-flooded volume. Pressure loss occurred at ~85% of design pressure.
- For reference and clarity:
 - Design Pressure – 365 Bar G
 - Strength Test Pressure – 474 Bar G (1.3 x design - completed successfully during FAT at factory)
 - Target System Strength Test Pressure – 401 Bar G (1.1 x design)

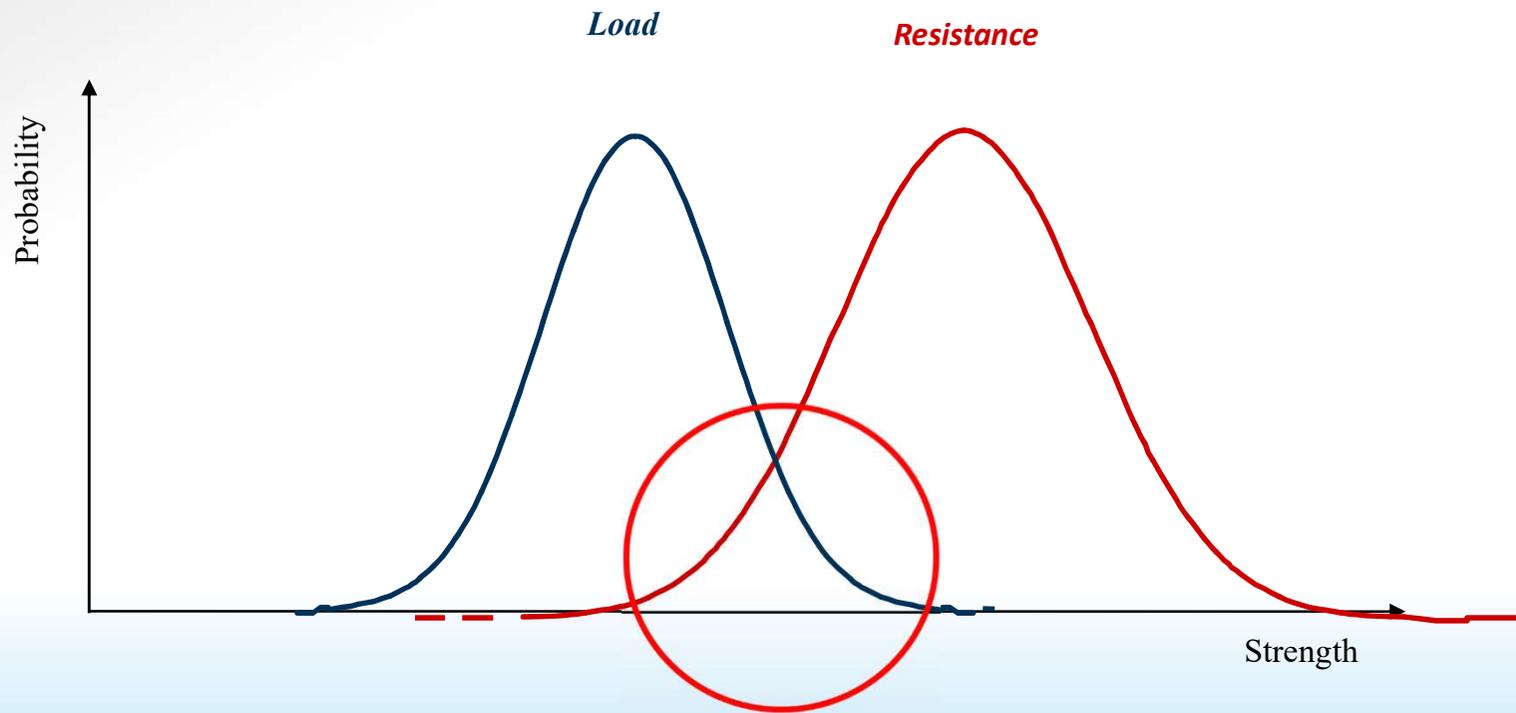
Load and Resistance – Actual?

For a rigid pipeline, the main uncertainties for UHB design (which are the basis for the design safety factors) are:

- **Vertical profile** (imperfection height), and associated survey accuracy;
- **Cover height**, and associated survey accuracy;
- **Cover strength** (geotechnical properties)

The remaining uncertainties relate to the pipe force and resistance, which again stem from the pipe's mechanical properties and dimensions, which have a significantly lower variability than for a flexible pipeline.
