Investigation report

Report	
Report title	Activity number
Report of the investigation of an incident with a ram door blown off a BOP during a connection test on <i>Rowan Stavanger</i> 14 September 2020	Equinor (001025023) Valaris (414002011)

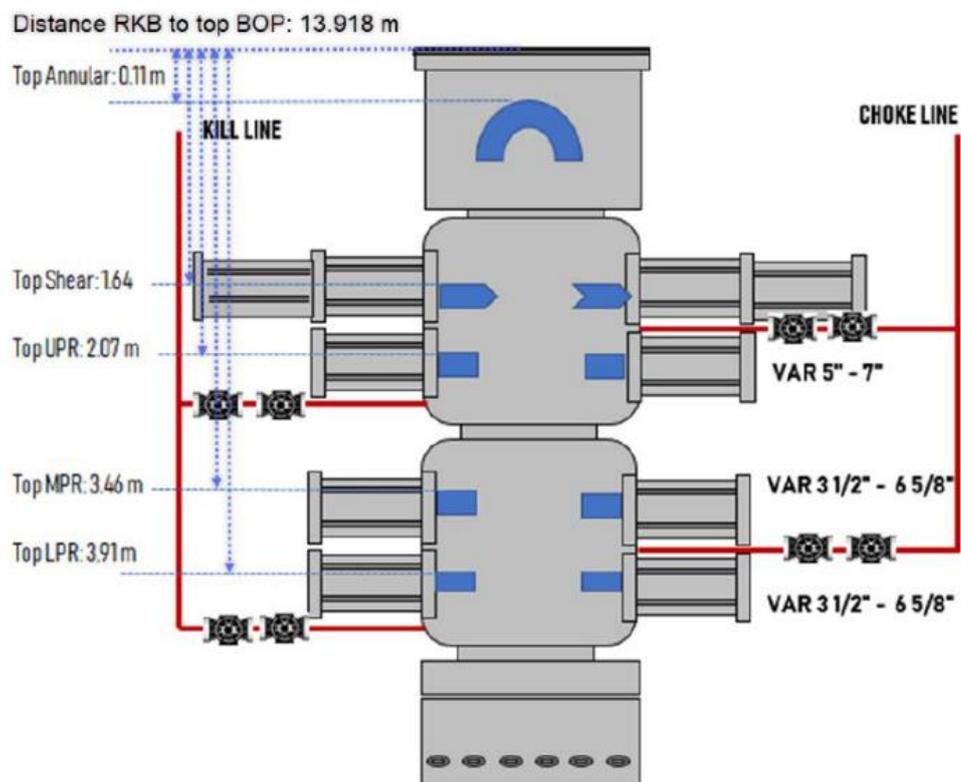
Figure 6: Diagram of the Rowan Stavanger BOP. Source: consent application

As figure 6 shows, the BOP has five main rams. The bottom three of these – the lower (LPR), middle (MPR) and upper (UPR) rams are replaceable. The fourth ram, above the UPR, is the BSR.

The investigation team's assessment is that the incident could have led to the loss of both primary and secondary barriers in the well if the lower pipe ram (LPR – see figure 6) had blown out during MPD. This is because, during MPD operations, the mud weight against the formation pressure is set lower than expected and the remaining pressure differential is regulated with backpressure. Losing the LPR on the BOP could have caused a loss of well control with a big potential for harm to people, the environment and the facility.

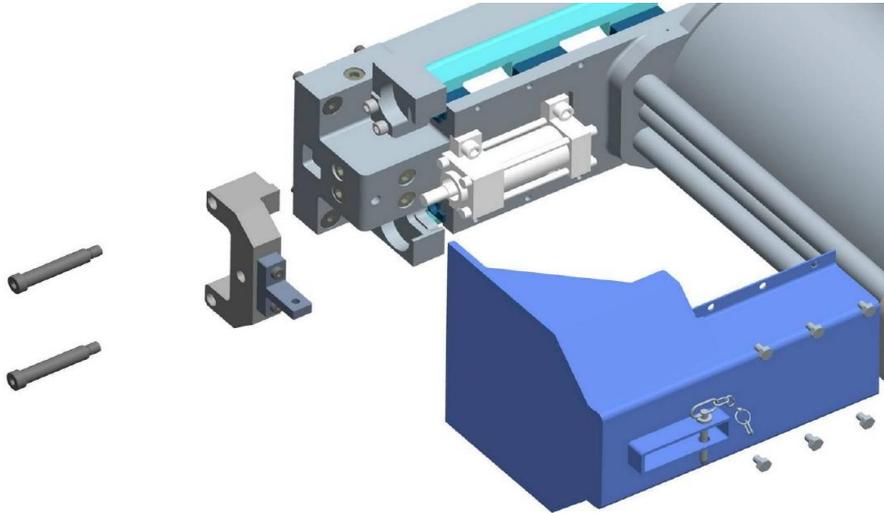
Figure 11: The original design.

On 19 April 2012, NOV issued a product bulletin which provided information on a new design for the lock mechanism on the NXT BOP.

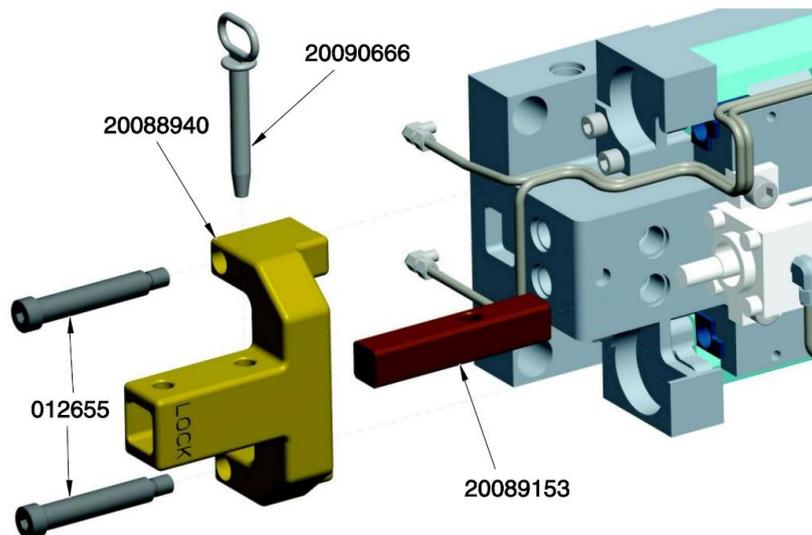
Figure 12: The changes to the design with components 20088940, 20089153 and 20090666.

After an incident involving incorrect use of the locking system, NOV issued a product bulletin on 22 September 2014 to provide information on a new upgrade of the anti-rotation locking bar. Part of the 2012 change, this bar (P/N 20089153) needed to be replaced with a longer version (P/N 10805038-001).

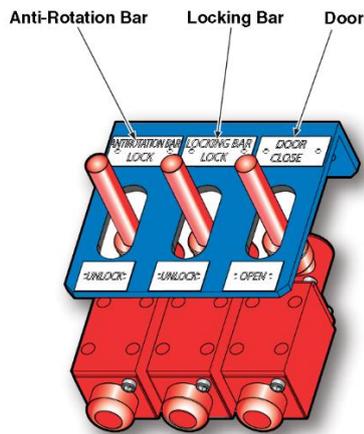
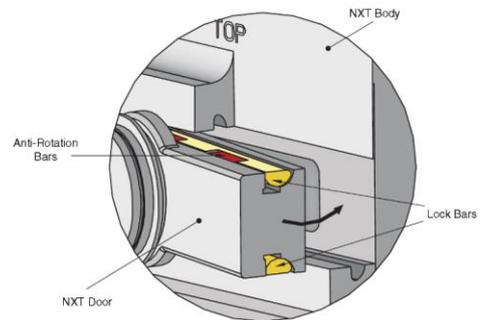
Figure 15 Control panel for the ram door system.

Ram doors in open position with the lock bars in yellow and the anti-rotation bar in red.

BOP ram door in closed position with lock bar being activated.

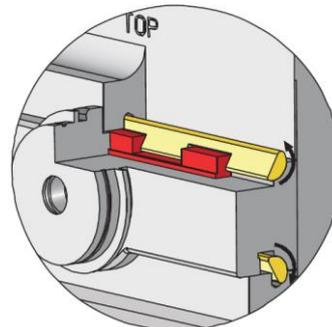
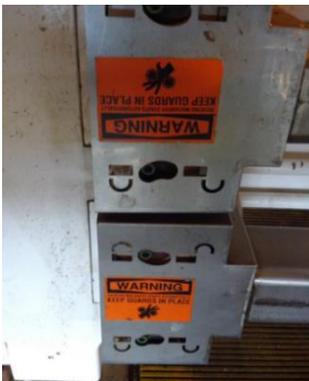
Figure 16 Indicator that the lock bar is in position..

The direct cause of the incident was that the anti-rotation bar was in the wrong position after closing the BOP doors. The incident occurred when the BSR test was to be carried out in combination with the BOP pressure test.
