Investigation report

Report	
Report title Investigation of an incident with personal injury on <i>Askeladden</i> , 10 February 2021	Activity number 419001006

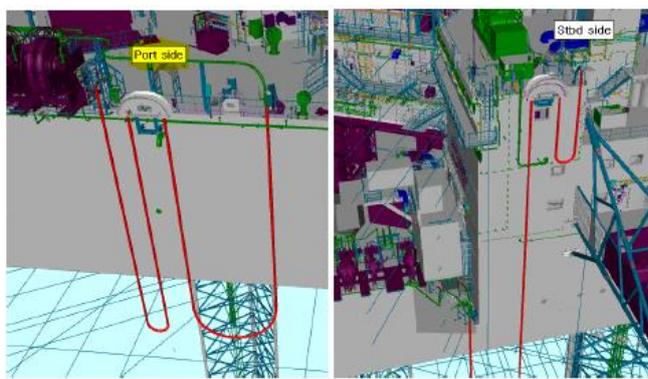
Figure 4.1 Free-hanging cuttings hoses, port and starboard sides (source: KCA Deutag).

In connection with its review of the cuttings systems in 2015, KCAD wanted the cuttings hoses to be installed on reels. According to the project team, no reels able to take the specified hose type were available on the market. A solution was therefore chosen where the hoses were suspended in hang-off saddles. See figure 4.1.

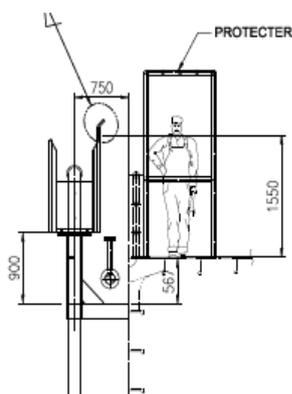
The construction drawings for port and starboard saddles appear in revision B of the drawings issued for company review on 22 August 2014. Drawings approved for construction (AfC), revision 5, of 24 March 2016 show the port protector right against the railing. See figure 4.2. Positioning of the saddle shows that a pipe track on the hull exterior creates a gap of 750 mm from railing to saddle centre. The construction drawings AfC, revision 8, of 17 August 2016 sets the port protector back into the deck at a distance from the railing. See figure 4.3.

Figure 4.2 Port protector on construction drawing AfC 24 March 2016, revision 5 (source: Samsung/Statoil).

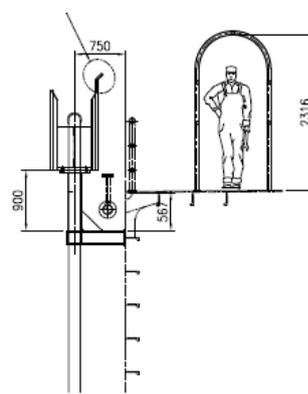
Figure 4.3 Port protector on construction drawing AfC 17 August 2016, revision 8 (source: Samsung/Statoil).

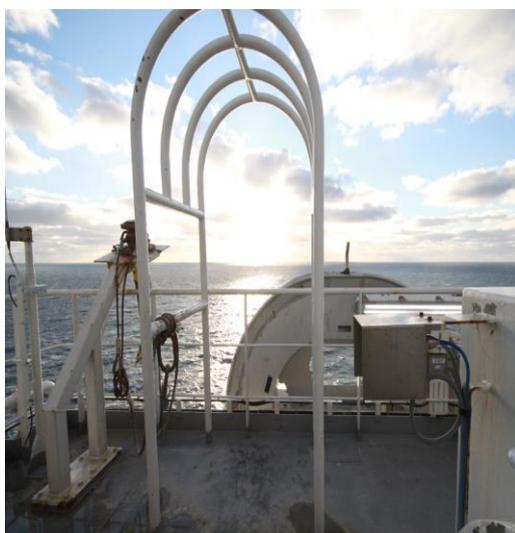
The protector is offset in relation to the centre of the saddle. See figure 4.5. On the port side, it is positioned further to on the deck because of a cable tray along the base of the railing and a drain in the deck. A pipe track running along the upper part of the hull on the port side means the saddle is positioned further out from the hull. See figure 4.4.

Figure 4.5 Saddle and protector on the starboard side (photo: police).

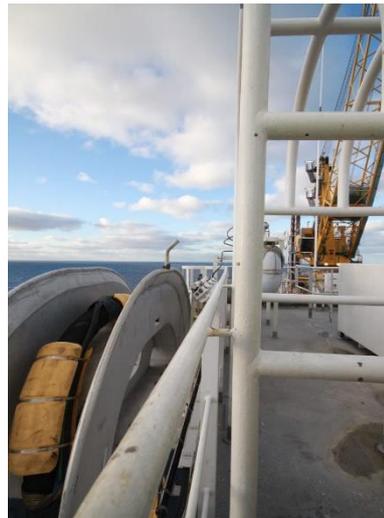
Figures 4.6 and 4.7 show how the protectors and saddles are positioned in relation to the railing. Measurements by the police give a gap of about 90 cm from port protector to the saddle bracket.

Figure 4.7 Starboard protector and saddle (photo: police).

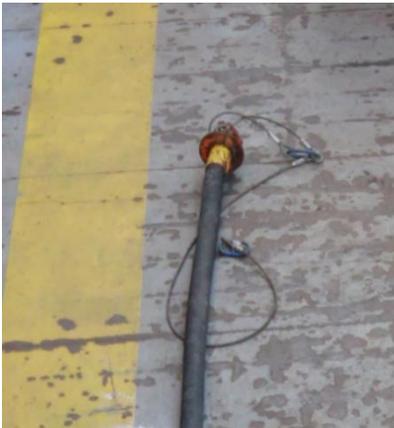
When the hose is placed in the saddle, the buoyancy elements will be positioned immediately beneath it. The saddle design means that these elements can easily snag on the underside of the saddle or other structures in the vicinity. A lifting collar is installed at the free end with steel wires which have a SWL of two tonnes. See figure 4.11. This is used when lifting the hose down to the vessel.

Figure 4.11 Lifting arrangement for lowering to the vessel (source: police).

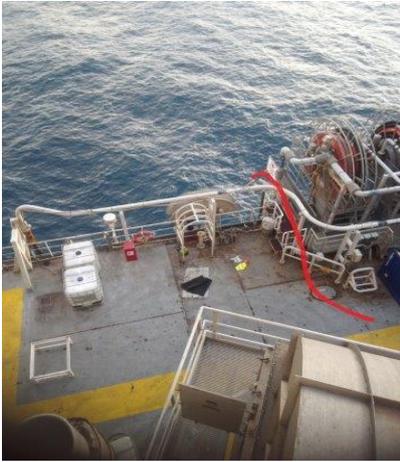
During disconnection, the hose is raised using the auxiliary lift to the area near the hang-off bracket and sections are laid over the deck. See figure 4.13. The hose is then secured with a ratchet tie-down strap to structures in the vicinity of the bracket to prevent it moving. The section now laid on the deck is broken down at the flanges.

Figure 4.13 How the hose is laid in over the deck (source: police).
