Investigation report

Report	
Report title Report following the investigation of a turbine breakdown with subsequent fire at Tjeldbergodden on 2 December 2020	Activity number 001904026

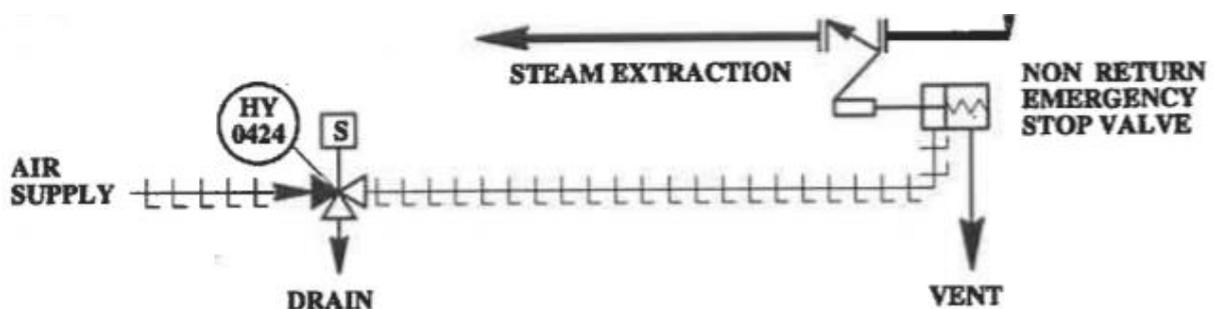
Figure 5 Flintstone valve (source: vendor documentation).

In the event of a PSD, the Flintstone valve will also receive a closure signal. Two functions close this valve. One involves passive closure as a non-return valve if upstream pressure falls in relation to downstream pressure. In that case, steam backflow will close the valve. The other is an auxiliary function comprising a spring-loaded actuator arm which keeps the valve closed. This arm is controlled by a pneumatic solenoid valve governed in turn by an electromagnet. When the latter loses its supplied voltage of 24V, the solenoid valve will change position and cause the air holding the arm in position to bleed off through it. The actuator arm will close the Flintstone valve with the aid of the spring force. Figure 6 provides a simplified diagram

The passive non-return valve function can be tested by moving an arm mounted on a weight. This is attached directly to the same shaft in the valve as the damper. The design of the arm is the reason why the valve is locally nicknamed a Flintstone.

Actuator movement was noticed in October during a logging tour of the plant. The Flintstone valve's solenoid had probably been damaged by a sandblasting job in the vicinity. A temporary repair was made with a non-original piston seal and some new O rings while the plant was in operation.

The valve was entered in SAP as "serious ill". It was assumed that the impairment could cause unintentional closure but not that it could fail in the event of a closure signal. The Flintstone valve functioned as intended in connection with a shut-down in November, when a repair (tightening) was made to the pack box to avoid external steam leaks.
