# Konstruksjonsdagen 2023

## Undersøkelser av grout-forbindelser på Gyda

Morten Bærheim, Repsol Norge AS.  
Andrew McVey, DNV  
Ørjan Nordhus, Aker Decom

## Gyda jacket post-life inspection

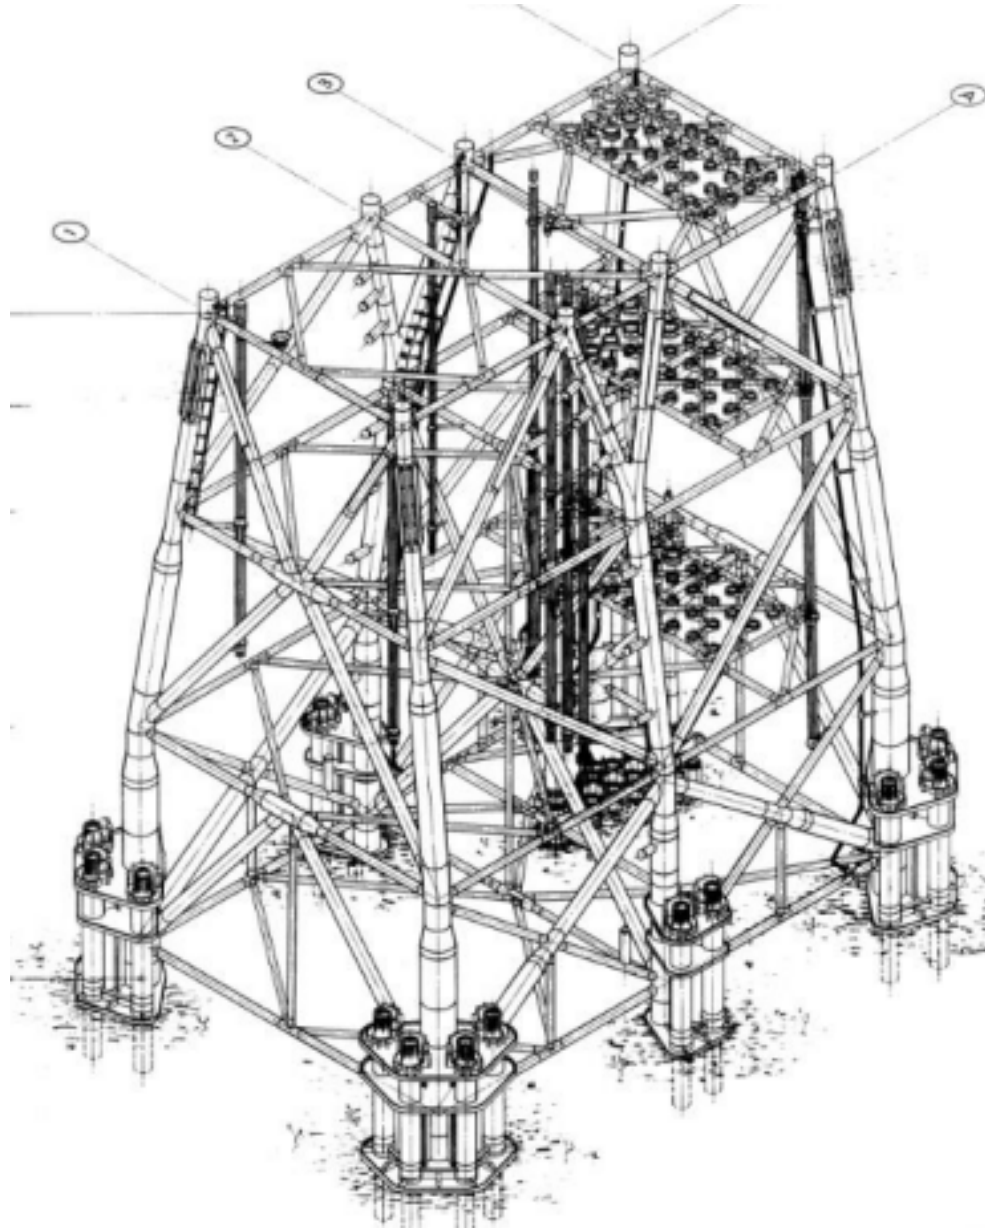
- 6 leg jacket
- 67 m water depth Southern North Sea
- Built, transported, installed and removed vertically
- Installed 1989
- Some 10 000 t at removal
- 20 piles
- Docked over template
- No skirt below mud-mat
- Double packer system in sleeve above mud mat
- Grout starts above packers (1 m above mudmat)
- Piles may be in tension during storms

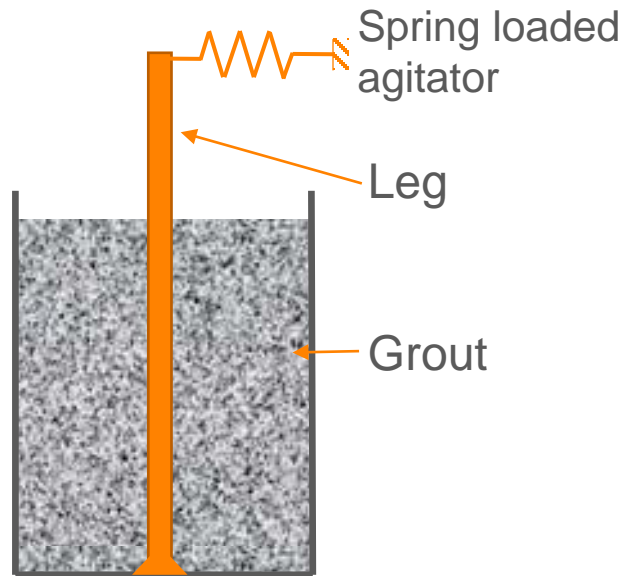
Test of unbraced large diameter tubular grouted to sleeve  
(Note: high strength grout) done in 1998.

- Test performed to investigate grout curing during motions
- Start: Leg moves freely with minimal deflection in spring
- Intermediate: grout cures and spring start to absorb motions
- End: Leg is fixed and spring absorbs motions
- Grout inspected and tested after end of test
