# Investigation report

Report	
Report title Investigation of the incident in well 7132/2-1, unintentional disconnection of the lower marine riser package (LMRP) on <i>West Hercules</i> , 16 January 2019	Activity number 404008005

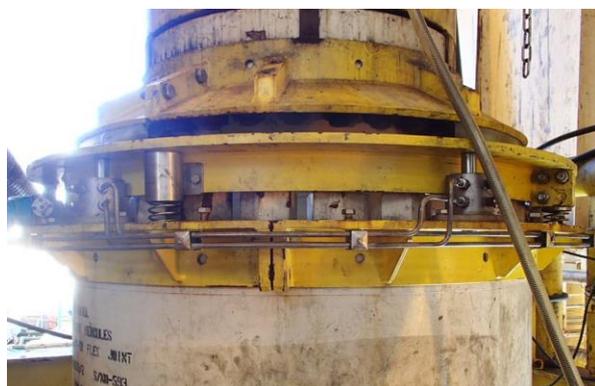
Figure 6: The ADS installed on the West Hercules flexjoint. (Source: Seadrill)

The direct cause of the incident was a fault in the ADS which sent a signal to disconnect the LMRP from the BOP.
