Investigation report

Report	
Report title Odfjell Technology – Linus – Investigation of an incident on 10 November 2022 – personal injury from dropped object	Activity number 426001003
Security grading	
<input checked="" type="checkbox"/> Public	<input type="checkbox"/> Restricted
<input type="checkbox"/> Not publicly available	<input type="checkbox"/> Confidential
<input type="checkbox"/> Strictly confidential	
Involved	
Team T-F	Approved by/date Irja Viste-Ollestad/27 January 2023
Members of the investigation team [REDACTED] [REDACTED]	Investigation leader [REDACTED]

On Thursday 10 November 2022, a person was subjected to crushing during repair work on a cantilever drag chain (linked cable/pipe tray).

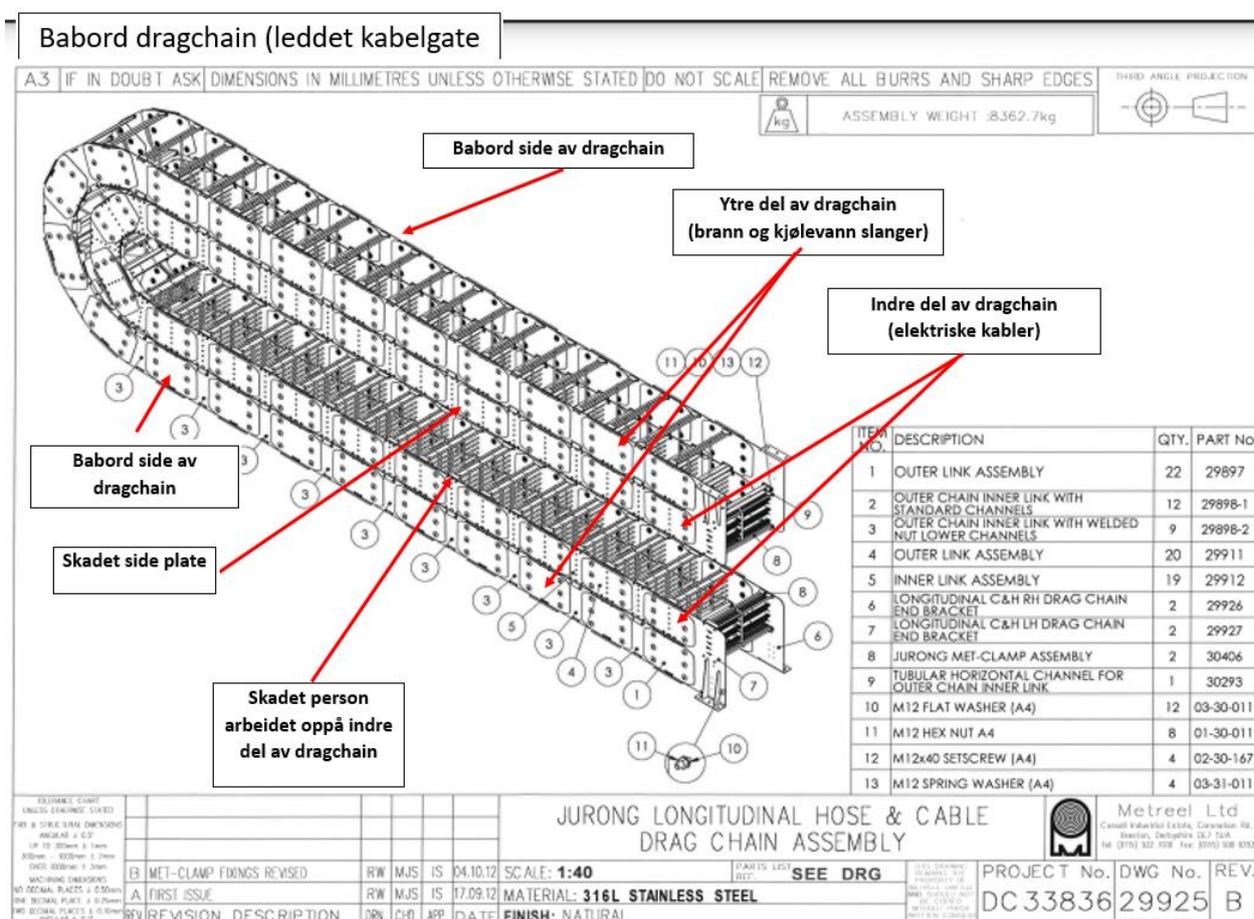
Measuring 193.5 cm wide, the port drag chain comprises a number of links made up from four metal plates bolted two and two to bushing. The outer plates, including the damaged (bent) one to be removed, are about 92 cm long by 50 cm broad.

Six holes for the bushing have been cut in each plate. The bushing allows the linked cable tray to move from the lower to the upper level so that it can follow the rig between various well slots.

Figure 3 The drag chain (linked cable tray) in its centre position. Electrical cables and hoses are not shown in this diagram. Source: Odfjell Technology

After skidding the cantilever on 3 November 2022, damage to the port drag chain in the form of a bent side plate was discovered. A temporary repair was carried out on 4 November 2022.

A new skid of the cantilever conducted on 9 November 2022 placed the damaged side plate on the drag chain in a new position between two fixed support rollers. It was about five metres from the nearest fixed support.
