**Anchor line failures
Norwegian continental shelf
2010-2014**

Rapporttittel Anchor line failures- Norwegian Continental Shelf - 2010-2014	Rapportnummer 992081
---	-------------------------

Organisasjonsenhet F-konstruksjonssikkerhet	Godkjent av Bjørn Thomas Bache
Forfatter/saksbehandler Arne Kvitrud	Dato 21.8.2014

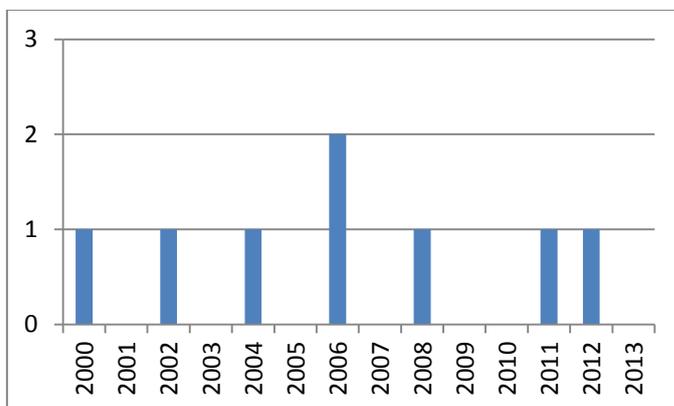
Figure 1: Number of cases with two or three line failures in the period 2000-2012 on the NCS. The cases are related to failures of lines, pay out from the winch, or significant dragging in combination with a line failure.

The cases with two or three line failure in Figure 1 are:

- 13.06.2000 *Bideford Dolphin*. Described briefly above.
- 24.12.2002 *Scarabeo 6*. One anchor dragged, caused the second to be torn off.
- 14.12.2004 *Ocean Vanguard*. Described briefly above.
- 24.11.2006 *Borgland Dolphin*. Two lines payed out.
- 31.10.2006 *Bideford Dolphin*. A chain failed due to fatigue, followed by another line paying out.
- 23.12.2008 *Scarabeo 5*. Two lines failed. Possible cause was loss of anchor, anchor dragging and line failure.
- 20.6.2011 *Navion Saga*. Described in detail above.
- 25.1.2012 *COSLPioneer*. Described in detail above.

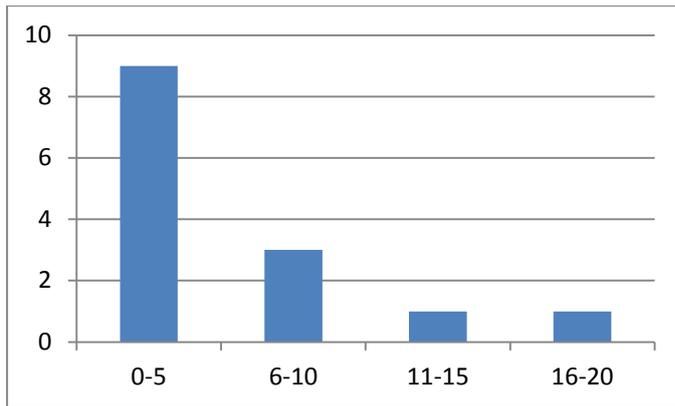
Figure 2: Number of failures as function of the age of the failed elements. The two double line failures are counted as one failure case.
