OMAE2022-81289

SEMISUBMERSIBLE IN SERVICE EXPERIENCES ON THE NORWEGIAN CONTINENTAL SHELF

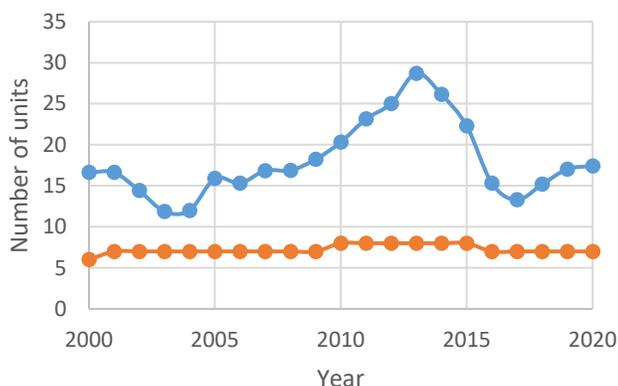
Figure 1: An estimate of the annual number of mobile semisubmersible units (blue) and semisubmersible production units (red) used on the NCS in the period 2000-2020.

Figure 1 gives an estimate of the annual number of semisubmersible platforms on the NCS. The mobile units includes both drilling units and flotels. For mobile units, the estimate is based on the number of days in activity on the shelf. In addition, as shown in Figure 1, 6-8 semisubmersible platforms have been used as production platforms.

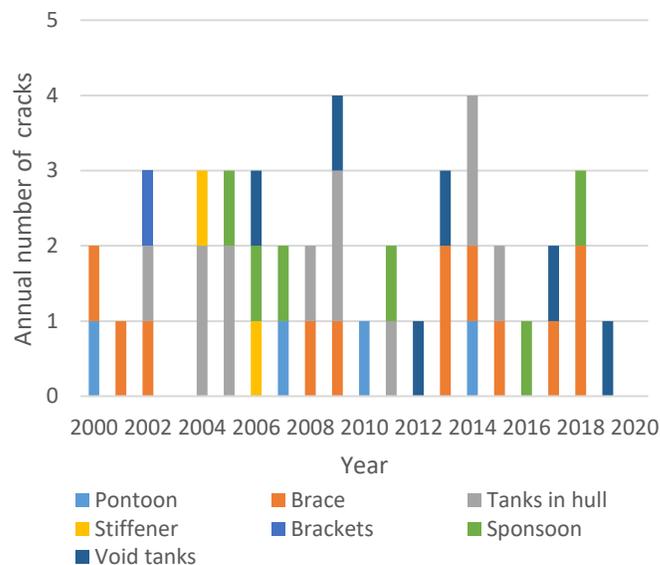
Figure 2: Production semi-submersibles and mobile offshore units: The annual numbers of cracks classified as major and minor on semis on the NCS in the period 2000-2020

The annual numbers of cracks classified as major and minor on all types of semisubmersibles on the NCS in the period 2000-2020 are shown in Figure 2.

As can be seen from Figure 2, a total of 43 major and minor cracks are reported (through thickness cracks towards the sea or severe cracks inside the hull or braces). There is no specific trend in the data from this period, but the average number of reported cracks per year is close to two. Local fatigue sensitive details are found in all parts of the hull. However, the majority of the experienced cracks are localized in the columns.

From the reported incidents we can see that the majority of the major cracks are located in or around horizontal braces, as expected, while very few cracks have been reported in other areas classified as major. Some annual peaks can be identified in the Figures 2-4, which may be caused by scheduled classification intervals, inspection campaigns or winter seasons with particularly harsh weather.

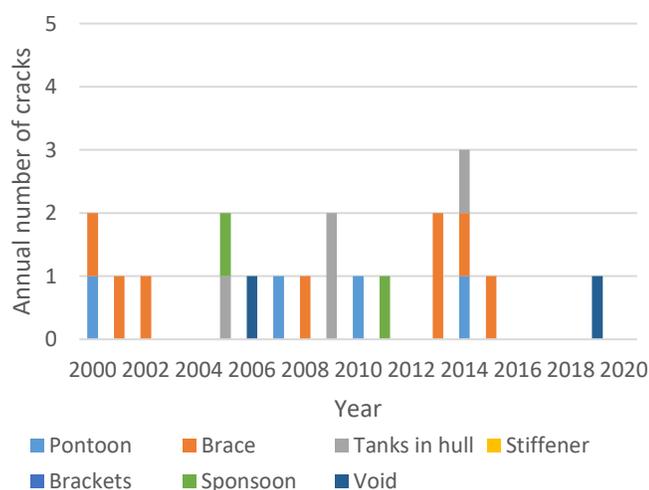
Figure 3: Mobile offshore units: The annual numbers of cracks classified as major and minor on semis on the NCS in the period 2000-2020.

For the mobile offshore units, the annual numbers of cracks classified as major and minor in the period 2000-2020 is shown in Figure 3. When comparing Figures 2 and 3, it can be seen that production units contribute with half the number of cracks reported. Interestingly, only two production semis have reported cracks during the relevant period and are hence contributing significantly to the statistics. One of these have been out of service since 2016 (for refurbishment), while the other is planned to be demobilised in 2022. It can also be seen that the number of cracks in mobile offshore units, seems to flatten out.

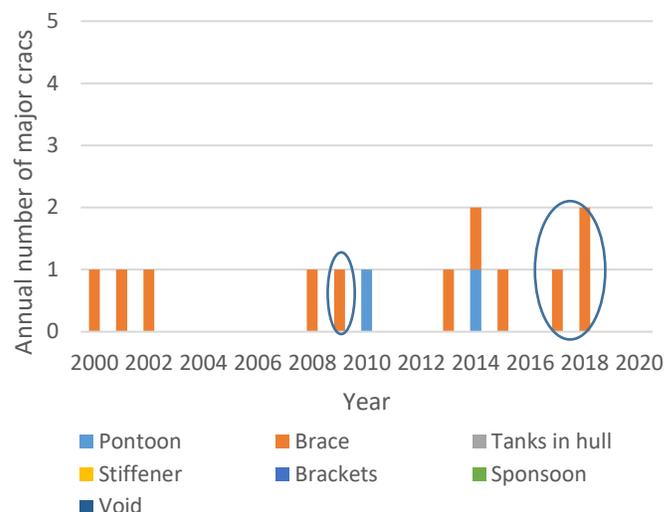
Figure 4: Major cracks on production and mobile offshore units: The annual numbers of cracks classified as major in the period 2000-2020. The occurrences on production units are marked.

Figure 4 shows the occurrence of major cracks only, with indication of the cracks found on production units. As can be seen, the occurrence of major cracks on mobile and production units is not particularly frequent and is rather equally distributed in the time period from 2000 to 2020. The majority of major cracks (70%) have been reported for mobile offshore units. However, taking into account the number of MOUs versus FPU's, the occurrence frequency is slightly higher on FPU's.

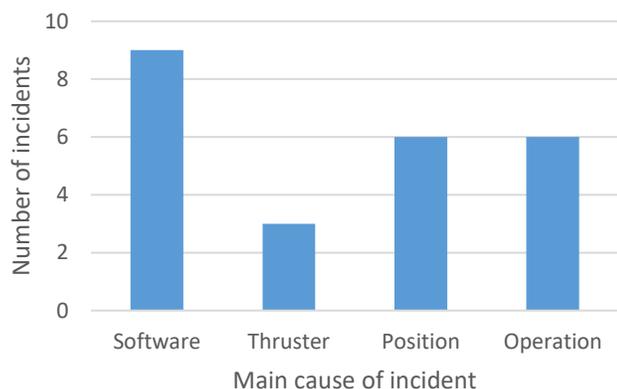
Figure 5: The number of incidents relating to the dynamic positioning system in 2014-2020 and main causes. Several incidents have more than one main cause.

Figure 5 illustrates the number of incidents based on the assumed cause of the incident. Software and hardware computer errors are referred to as “Software”, lack of thruster capacity is classified as “Thruster”, wrong understanding of position is labelled “Position”, and operational or procedure failures are referred to as “Operation”.
